# New York State Department of Transportation General Bridge Inspection Report

*Inspection Date:* October 08, 2019

*BIN:* 3306370

*Feature Carried:* BATTEN-DUGAN ROAD

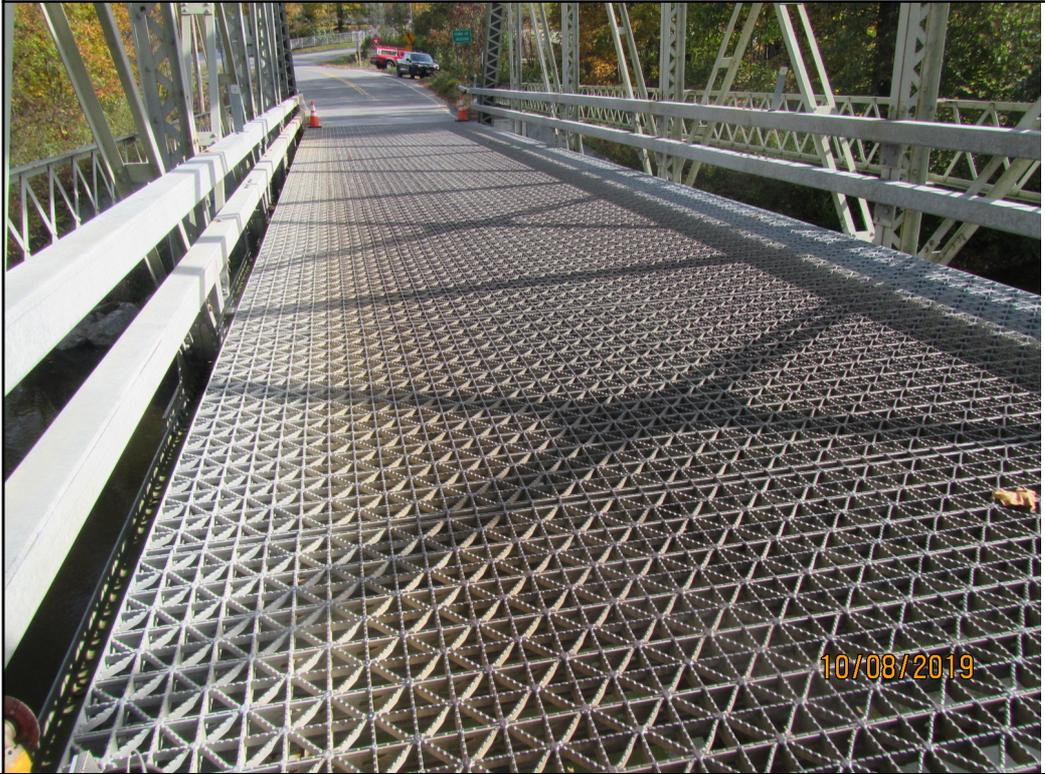
Photo Filename: 1.JPG

The paint on the steel grid deck has failed along the center but gets progressively better towards the fascias.

**Attachment Description:**  
Steel deck looking towards  
Begin

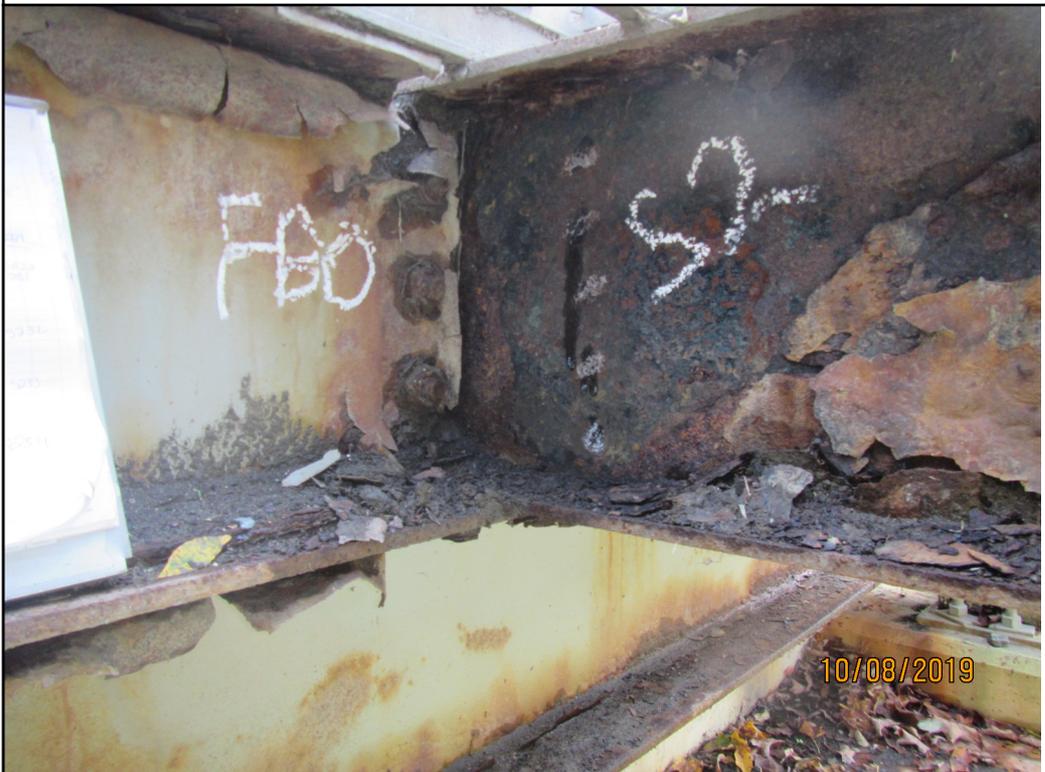
Photo Number: 2

Panel 1 at Begin Abutment, Stringer S2: Web loss (Shear) 25%; (Photo 2)  
 Panel 1 at Begin Abutment, Stringer S3: Web loss (Shear) 15%;  
 Panel 3 at Floorbeam FB2 (End face), Stringer S3: Web loss (Shear) 30%;(Photo 3)  
 Panel 5 at Floorbeam FB4 (End face), Stringer S2: Web loss (Shear) 20%;  
 Panel 5 at Floorbeam FB5 (Begin face), Stringer S2: Web loss (Shear) 15%;  
 Panel 5 at Floorbeam FB4 (End face), Stringer S3: Web loss (Shear) 30%;(Photo 4)  
 Panel 8 at Floorbeam FB7 (Begin face), Stringer S3: Web loss (Shear) 30%;(Photo 5)  
 Panel 8 at End Abutment , Stringer S1: Web loss (Shear) 20%;  
 Panel 8 at End Abutment , Stringer S2: Web loss (Shear) 20%;  
 Panel 8 at End Abutment , Stringer S3: Web loss (Shear) 30%;(Photo 6)

**Attachment Description:**  
Panel 1 at Begin Abutment  
Stringer S2

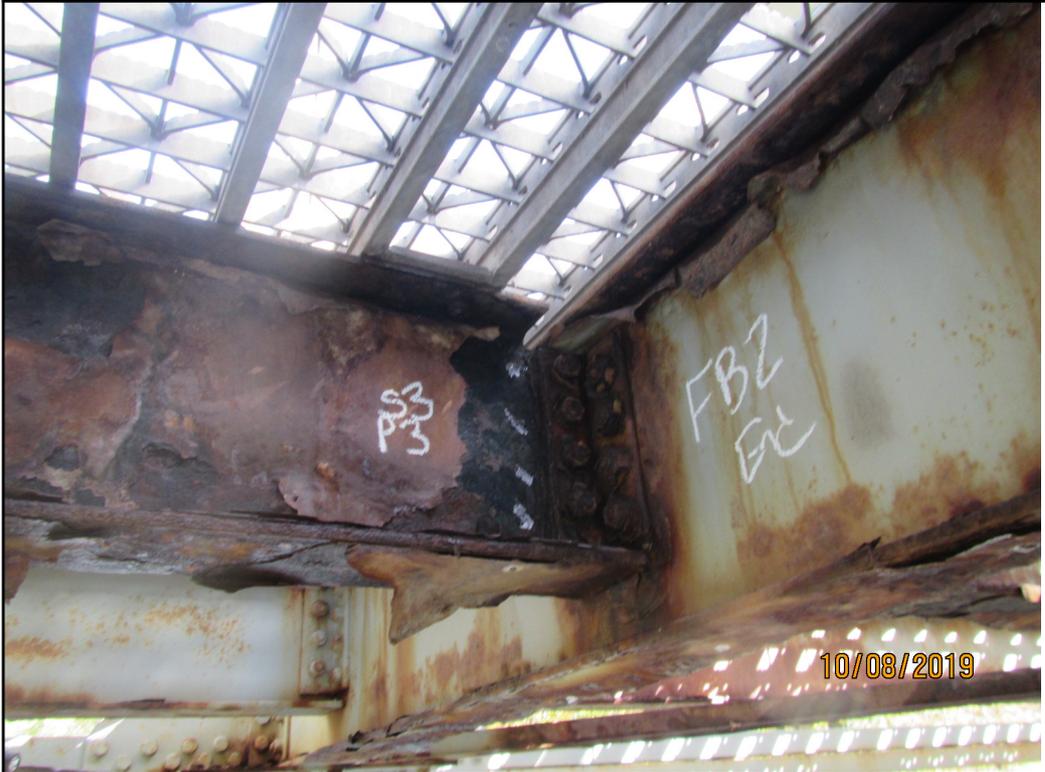
Photo Number: 3 Photo Filename: 3.JPG

**Attachment Description:**  
Panel 3 at Floorbeam FB2  
End face, Stringer S3

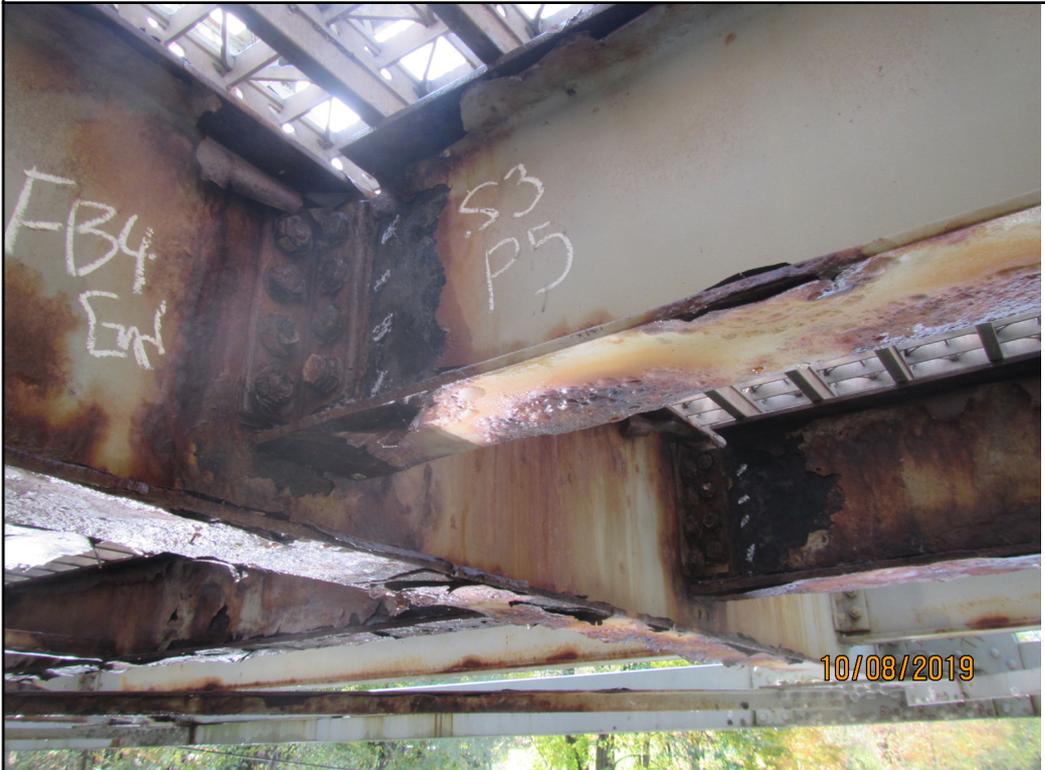
Photo Number: 4 Photo Filename: 4.JPG

**Attachment Description:**  
Panel 5 at Floorbeam FB4  
End face, Stringer S3

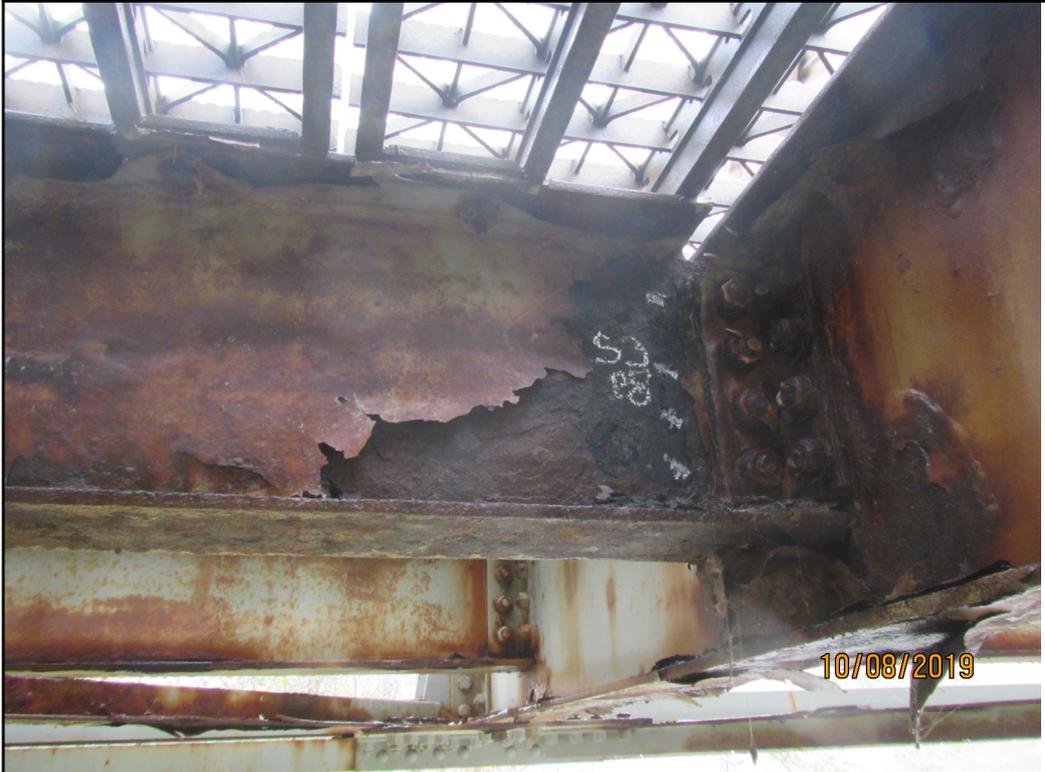
Photo Number: 5 Photo Filename: 5.JPG

**Attachment Description:**  
Panel 8 at Floorbeam FB7  
end face, Stringer S3

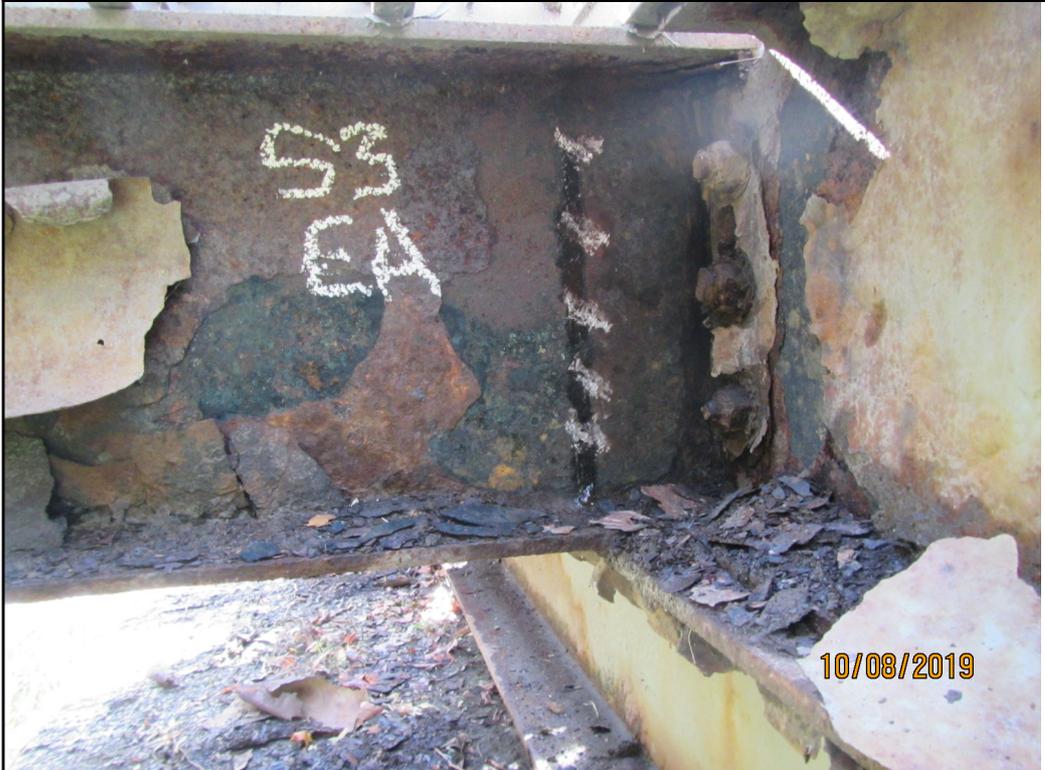
Photo Number: 6 Photo Filename: 6.JPG

**Attachment Description:**  
Panel 8 at End Abutment,  
Stringer S3

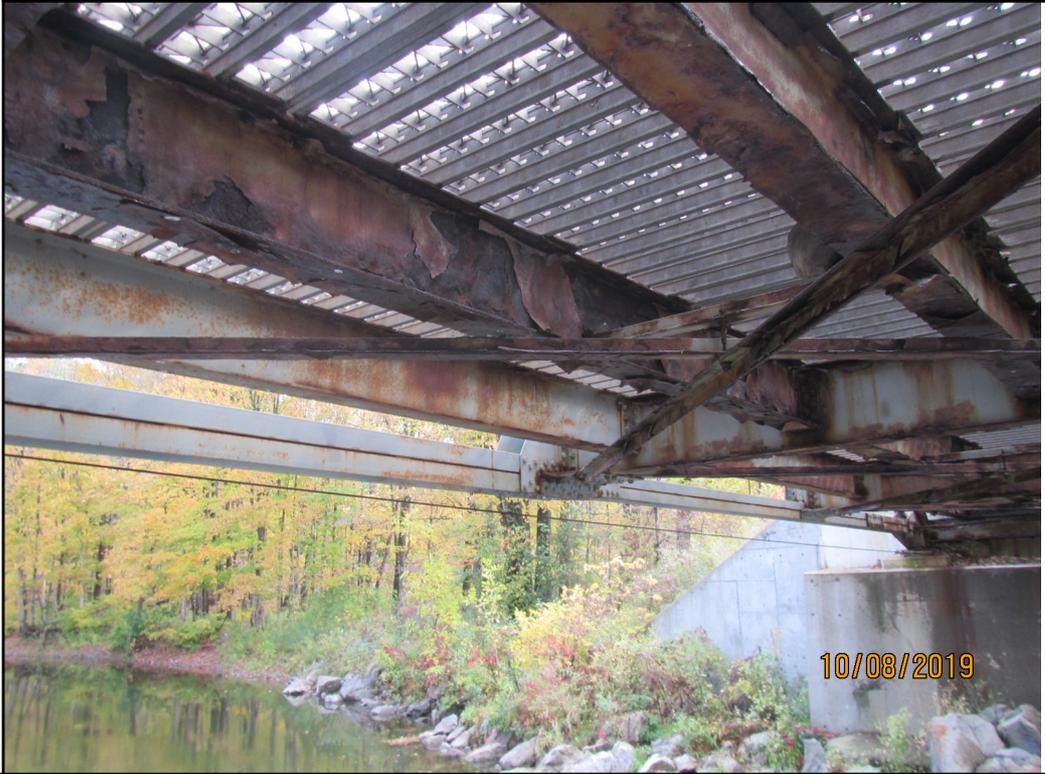
Photo Number: 7 Photo Filename: 7.JPG

CS4: The interior stringers has completely failed for the full length.

CS3: The fascia stringers have the start of paint failure.

**Attachment Description:**  
Panel 3 looking at Begin  
Right – showing paint

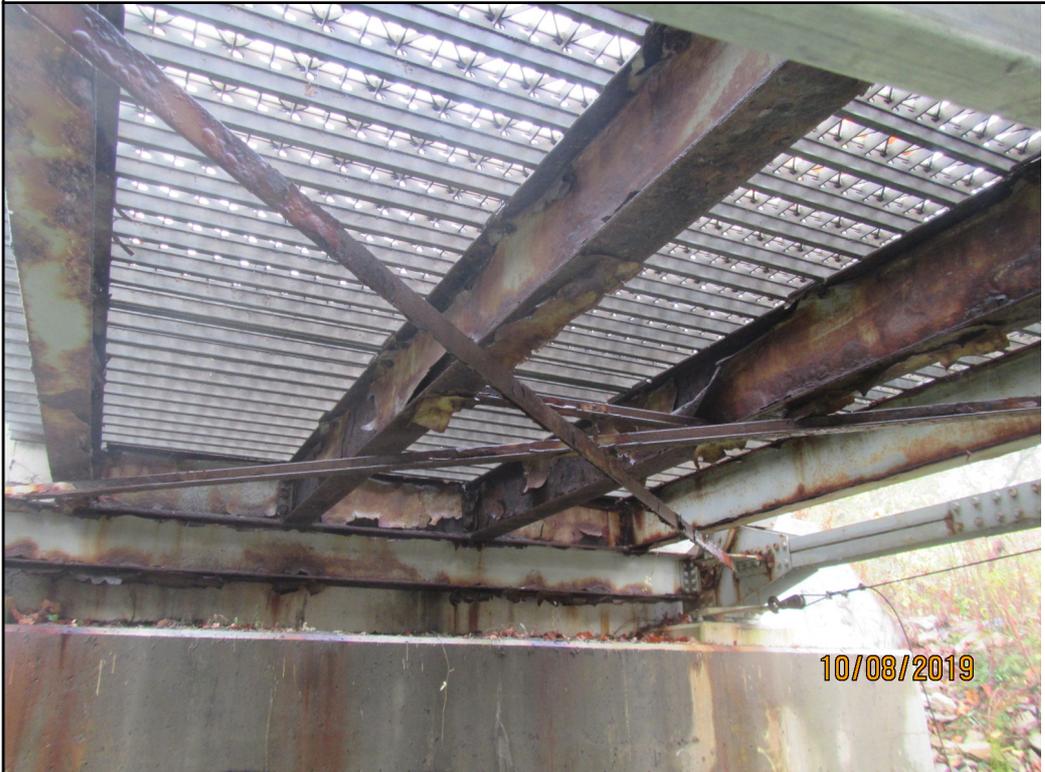
Photo Number: 8 Photo Filename: 8.JPG

**Attachment Description:**  
Panel 8 looking at End  
Abutment -showing paint

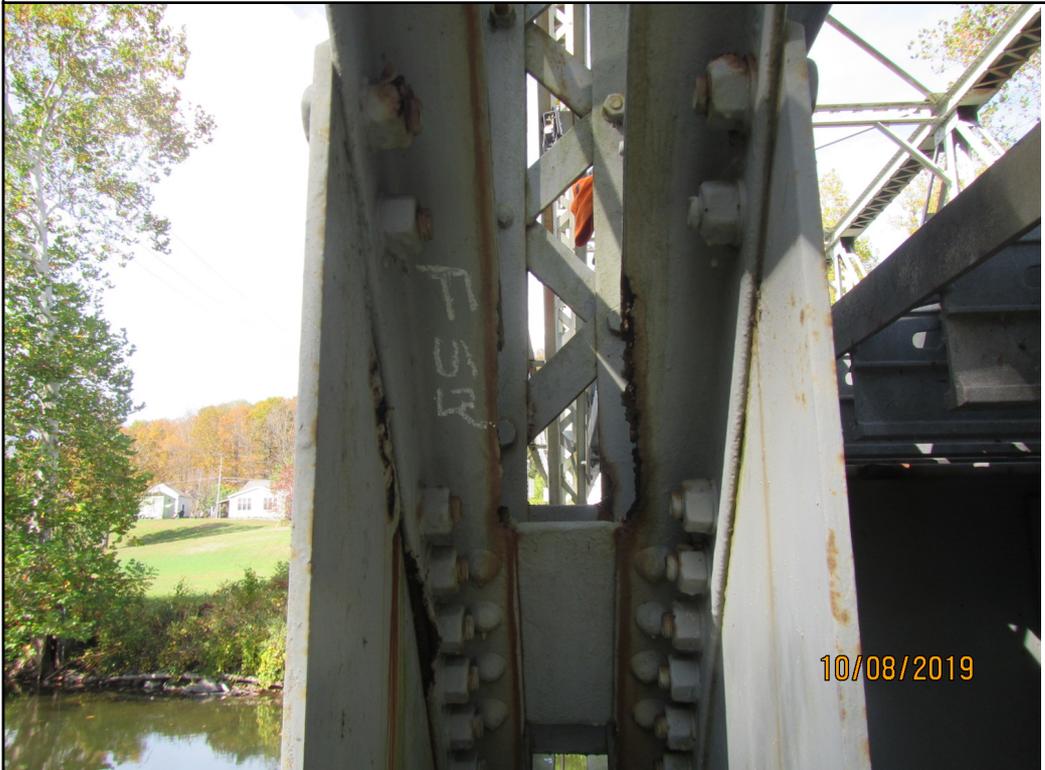
Photo Number: 18 Photo Filename: 18.JPG

**Attachment Description:**  
Left Truss, U1L2 looking at  
End

U1L2 at L2 – Inner legs have impacted rust and 45% loss over a 5 in long area near the panel point. Overall loss to the member is 30% **(Photo 18)**

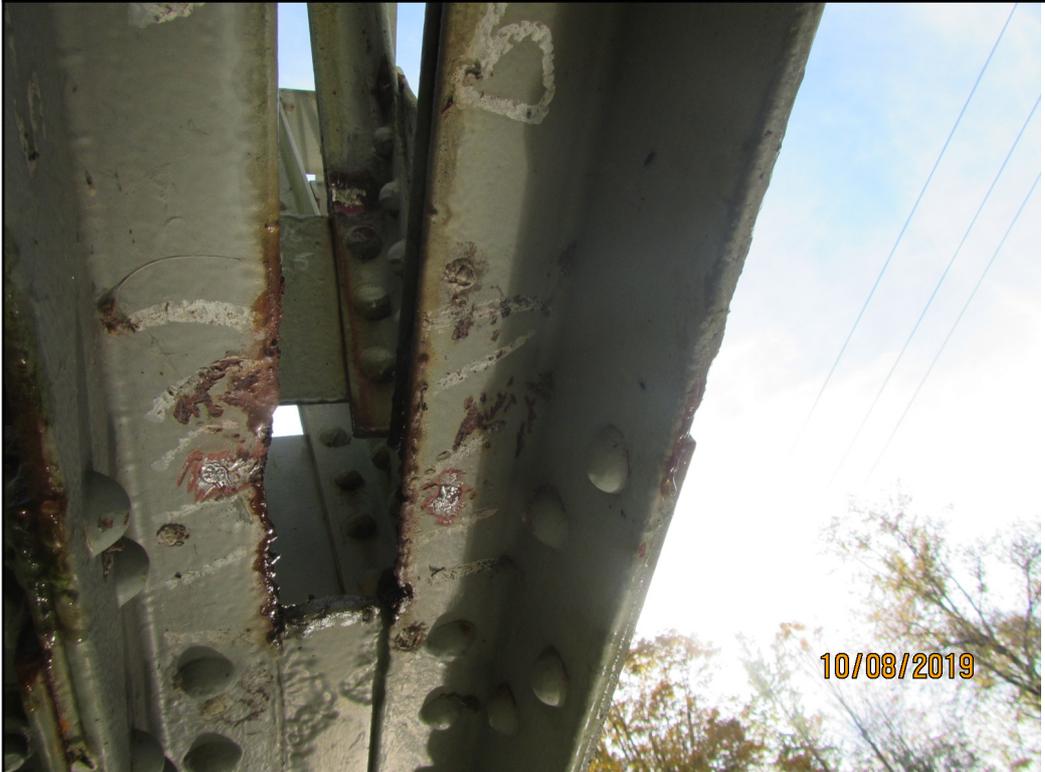
Photo Number: 21 Photo Filename: 21.JPG

**Attachment Description:**  
Left Truss, L5L6 at L5  
looking at Begin

L5L6 at L5 – Inner legs have impacted rust and 35-40% loss over a 10 in long area near the panel point. Vertical legs have 5- 25% loss. Overall loss is 25%. **(Photo 21)**

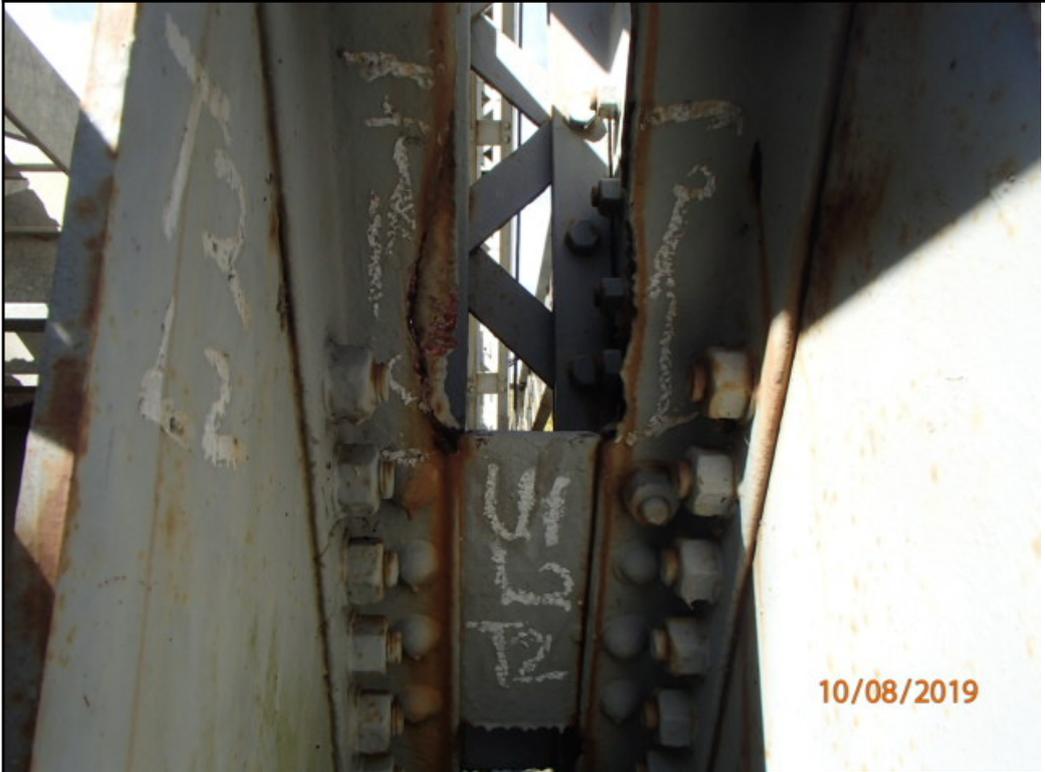
Photo Number: 23 Photo Filename: 23.JPG

**Attachment Description:**  
Right Truss, U1L2 at L2  
looking at End

U1L2 at L2 – Inner legs have impacted rust and 30% loss over a 10 in long area near the panel point. Overall loss is 25%. **(Photo 23)**

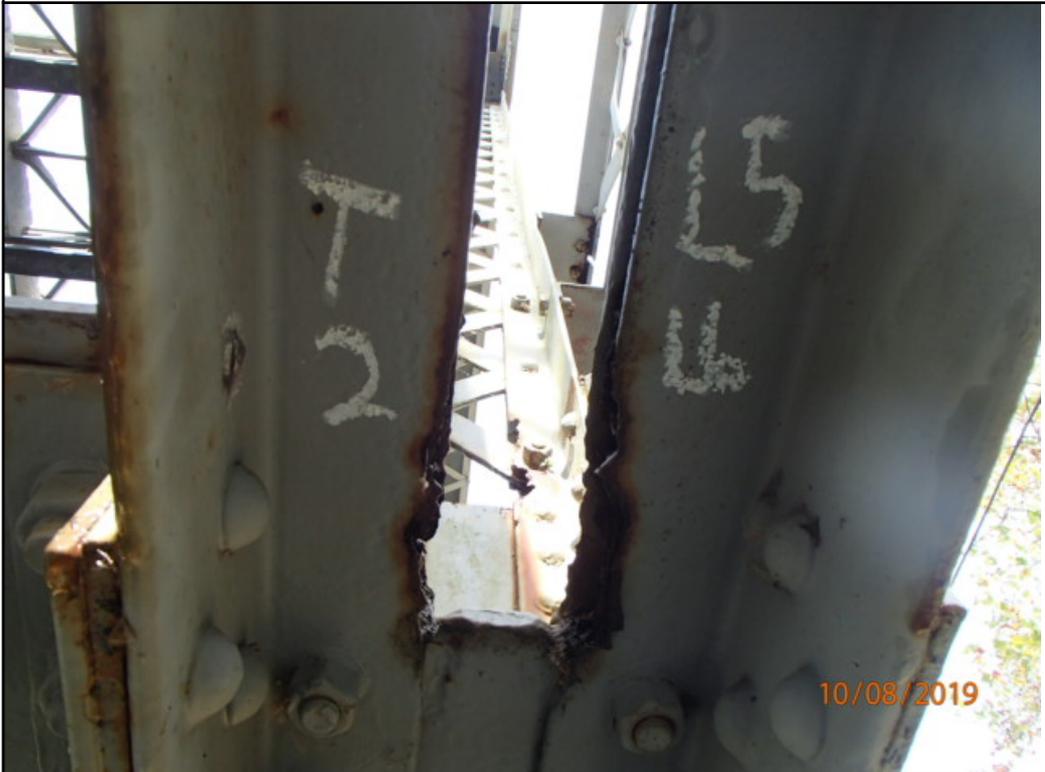
Photo Number: 24 Photo Filename: 24.JPG

**Attachment Description:**  
Right Truss, L5L6 at L6

L5L6 at L6 – Inner legs have impacted rust and 30% loss over a 6 in long area near the panel point. Vertical legs have 5-10% loss. **(Photo 24)**

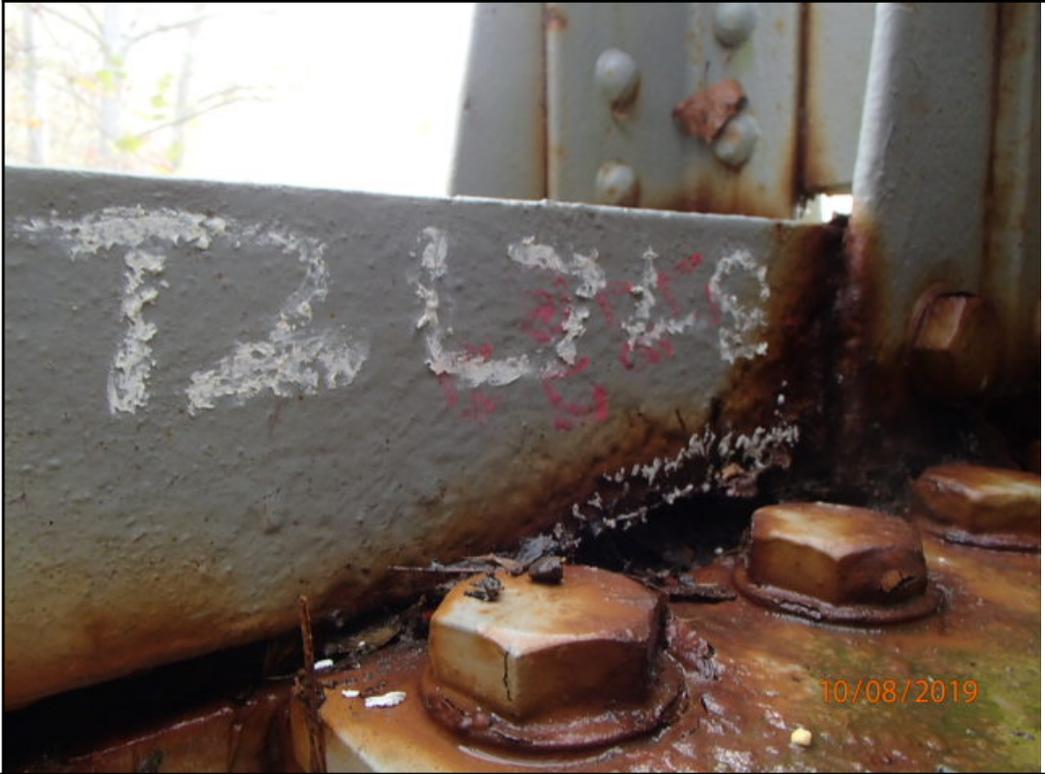
Photo Number: 25

**Attachment Description:**  
Right Truss L7L8 at L7  
looking at Begin Right

L7L8 at L7 – Three 1 in long perforations at the corner of the upper left angle, within 6 in of the gusset plate. Overall loss is no more than 10%. The upper portion of the truss is generally in good condition. **(Photo 25)**

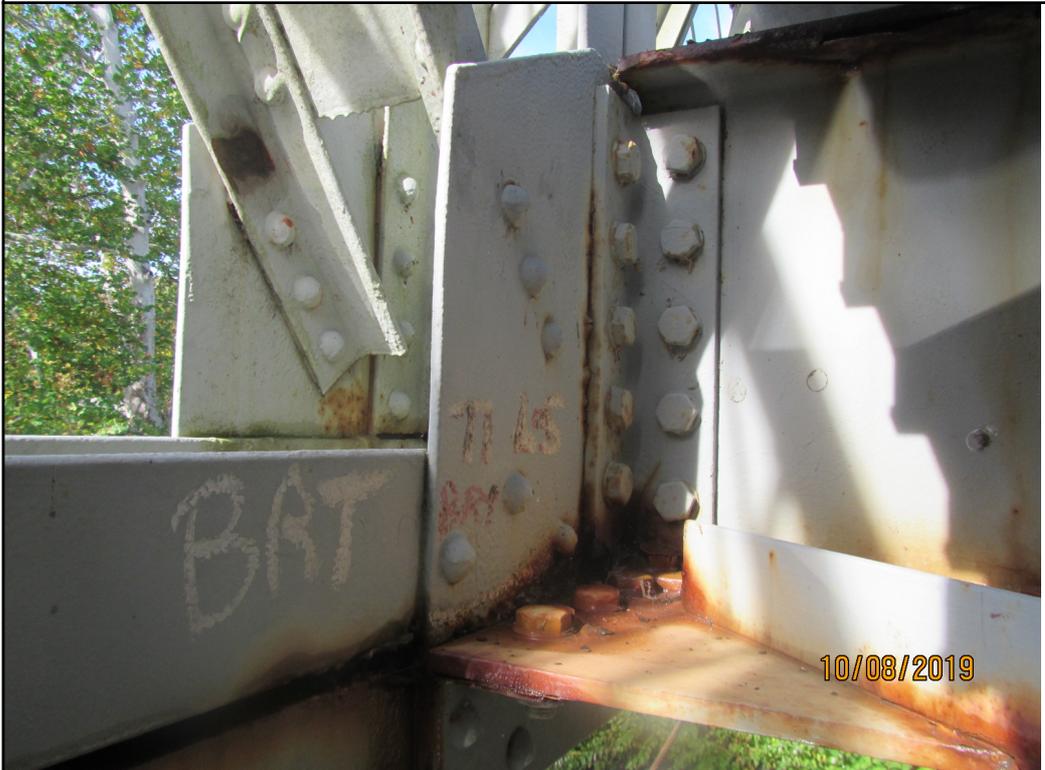
Photo Number: 28 Photo Filename: 28.JPG

Left Truss (T1) at L5: Begin Right Plate – 60% SL (2018 - 65% SL); (Photo 28)  
 Left Truss (T1) at L5: End Right Plate – 50% SL (2018 – 50% SL);

**Attachment Description:**  
Left Truss, Begin Right  
Gusset Plate at L5

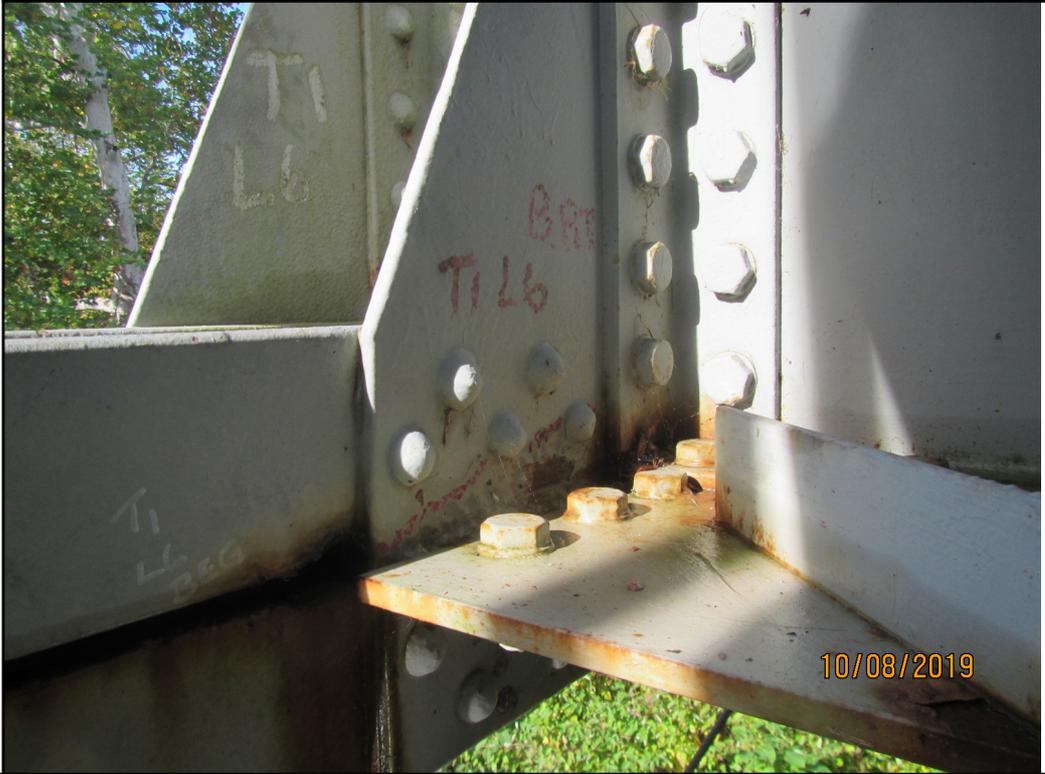
Photo Number: 29 Photo Filename: 29.JPG

Left Truss (T1) at L6: Begin Right Plate – 35% SL (2018 - 35% SL); (Photo 29)  
 Left Truss (T1) at L6: End Right Plate – 50% SL (2018 – 45% SL);

**Attachment Description:**  
Left Truss, Begin Right  
Gusset Plate at L6

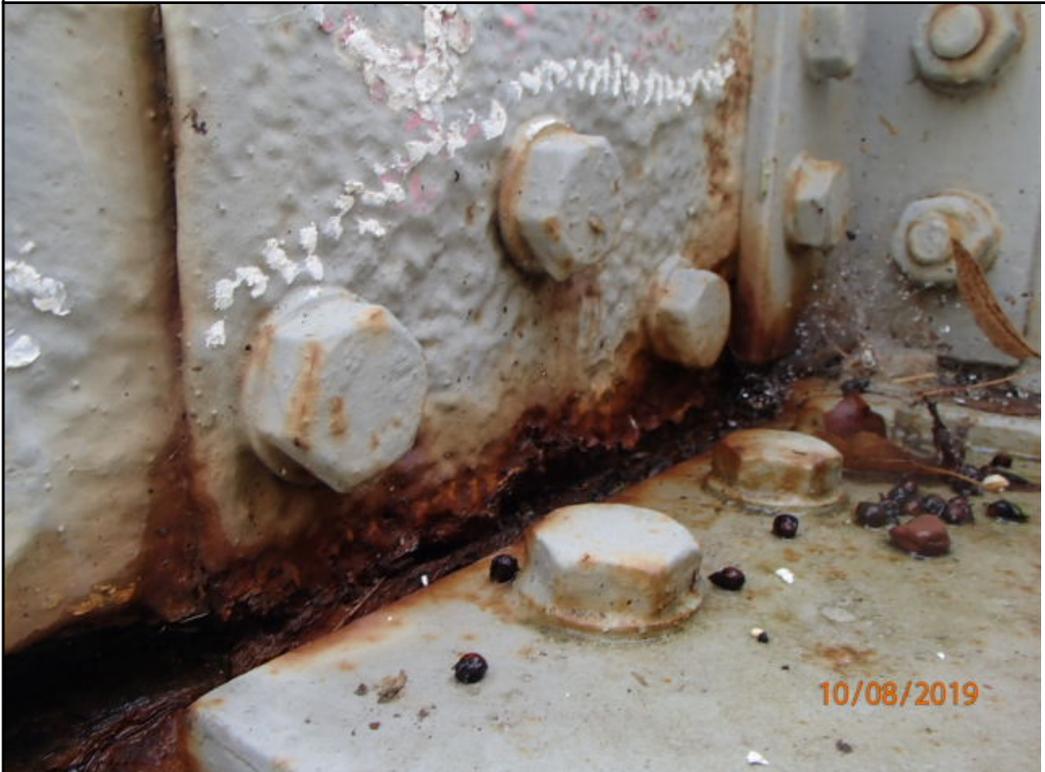
Photo Number: 30 Photo Filename: 30.JPG

**Attachment Description:**  
Right Truss, End Left  
Gusset Plate at L3 with  
perforation

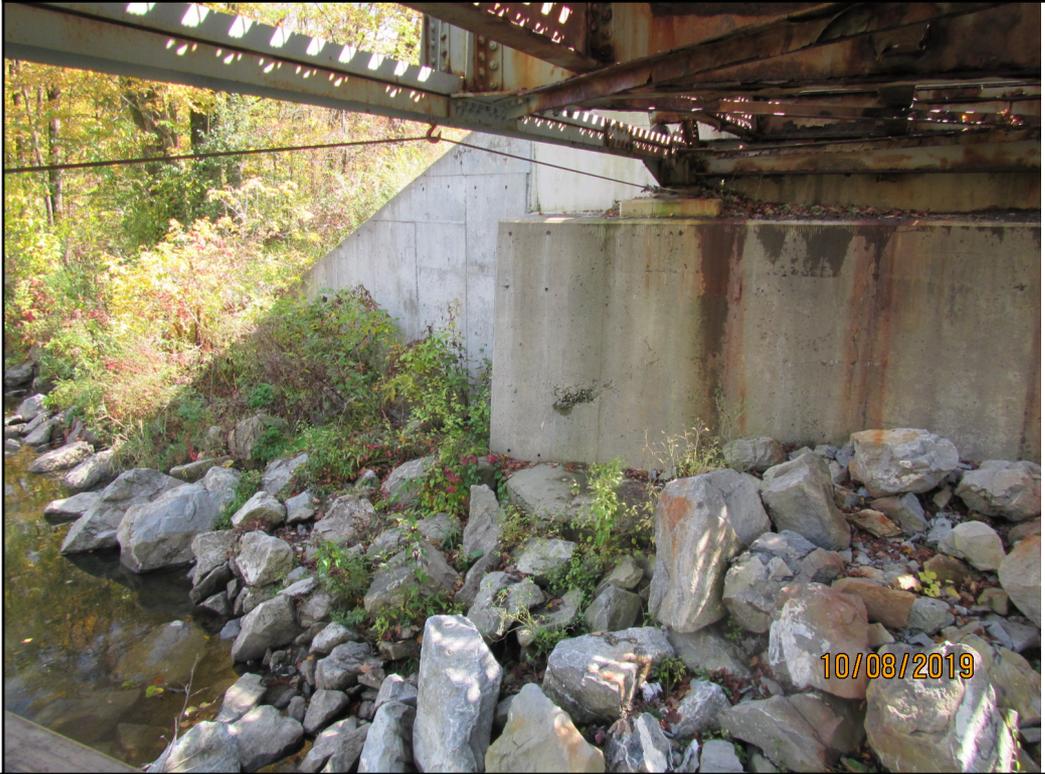
Photo Number: 33 Photo Filename: 33.JPG

CS3: The Begin footing is exposed on the Right side for an 8 ft length up to 14 in high. The concrete is in good condition but is rates CS3 due to the exposure.

**Attachment Description:**  
Begin Abutment footing  
Right side.

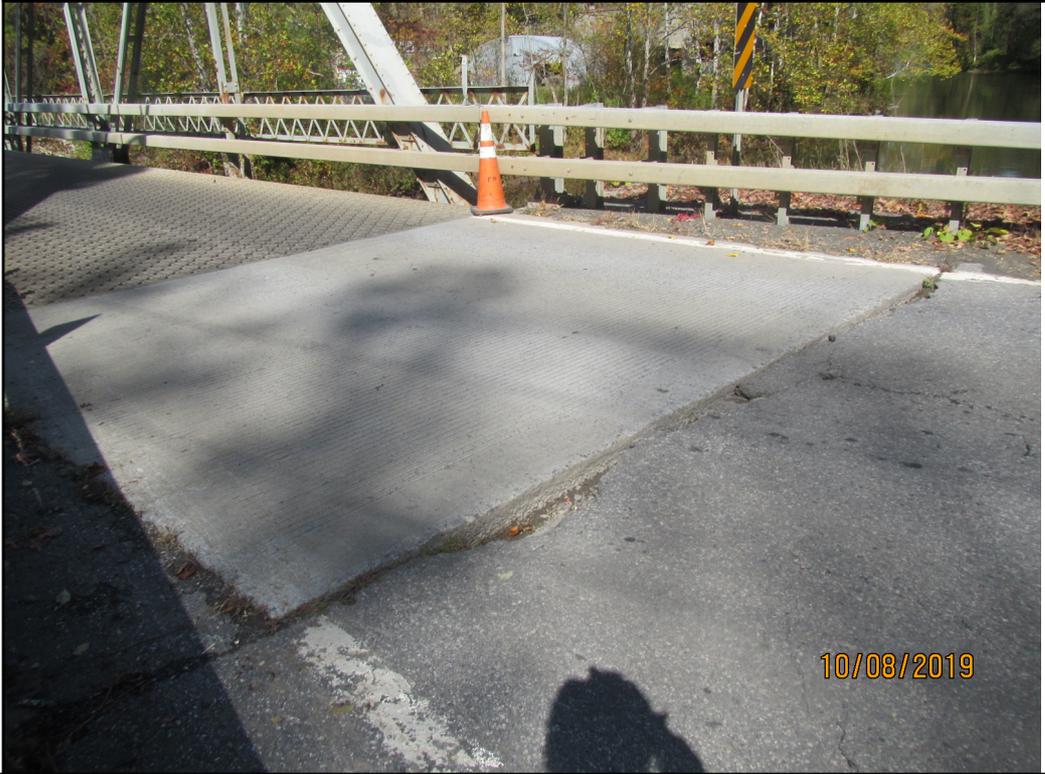
Photo Number: 37 Photo Filename: 37.JPG

The Begin approach asphalt pavement is spalled at the concrete approach slab. The spall is for  $\frac{3}{4}$  of the approach width x 6 in long x up to 4 in deep. The worse of pothole is in the wheel paths causing a rough ride for traffic.

**Attachment Description:**  
Begin Approach

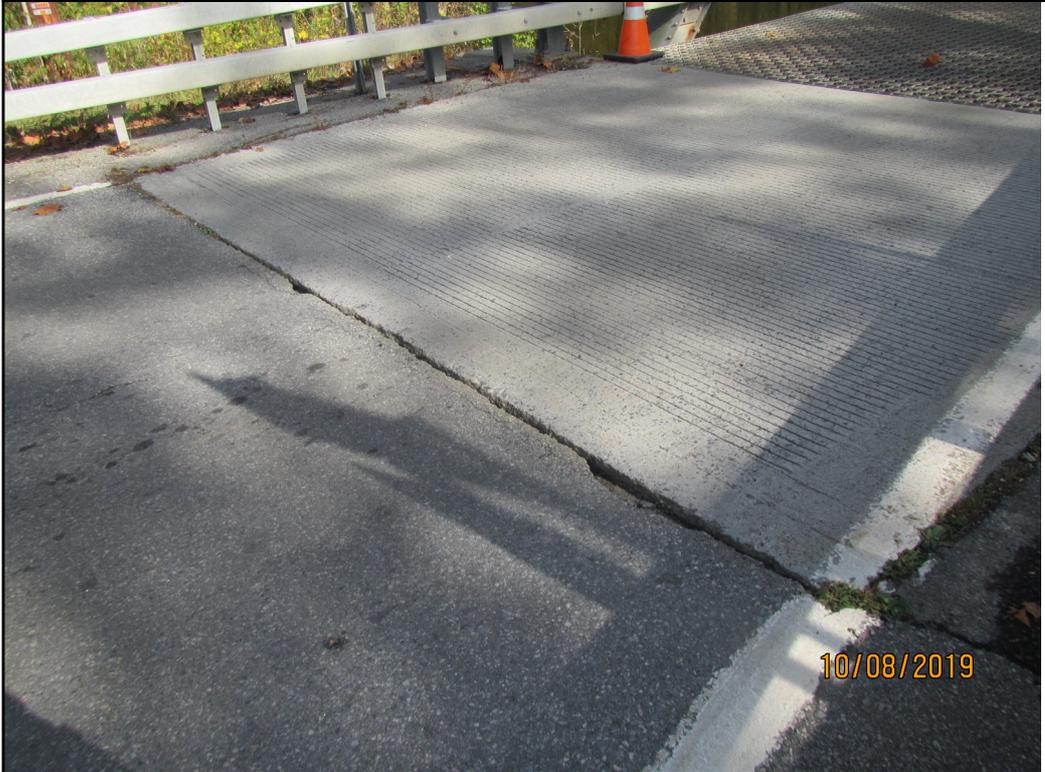
Photo Number: 38 Photo Filename: 38.JPG

The End approach asphalt pavement is also spalled at the concrete approach slab. The spall is up to 2 in deep for the full width of the road x up to 4 in long. In addition the asphalt is approximately 1 in lower than the concrete slab.

**Attachment Description:**  
End Approach

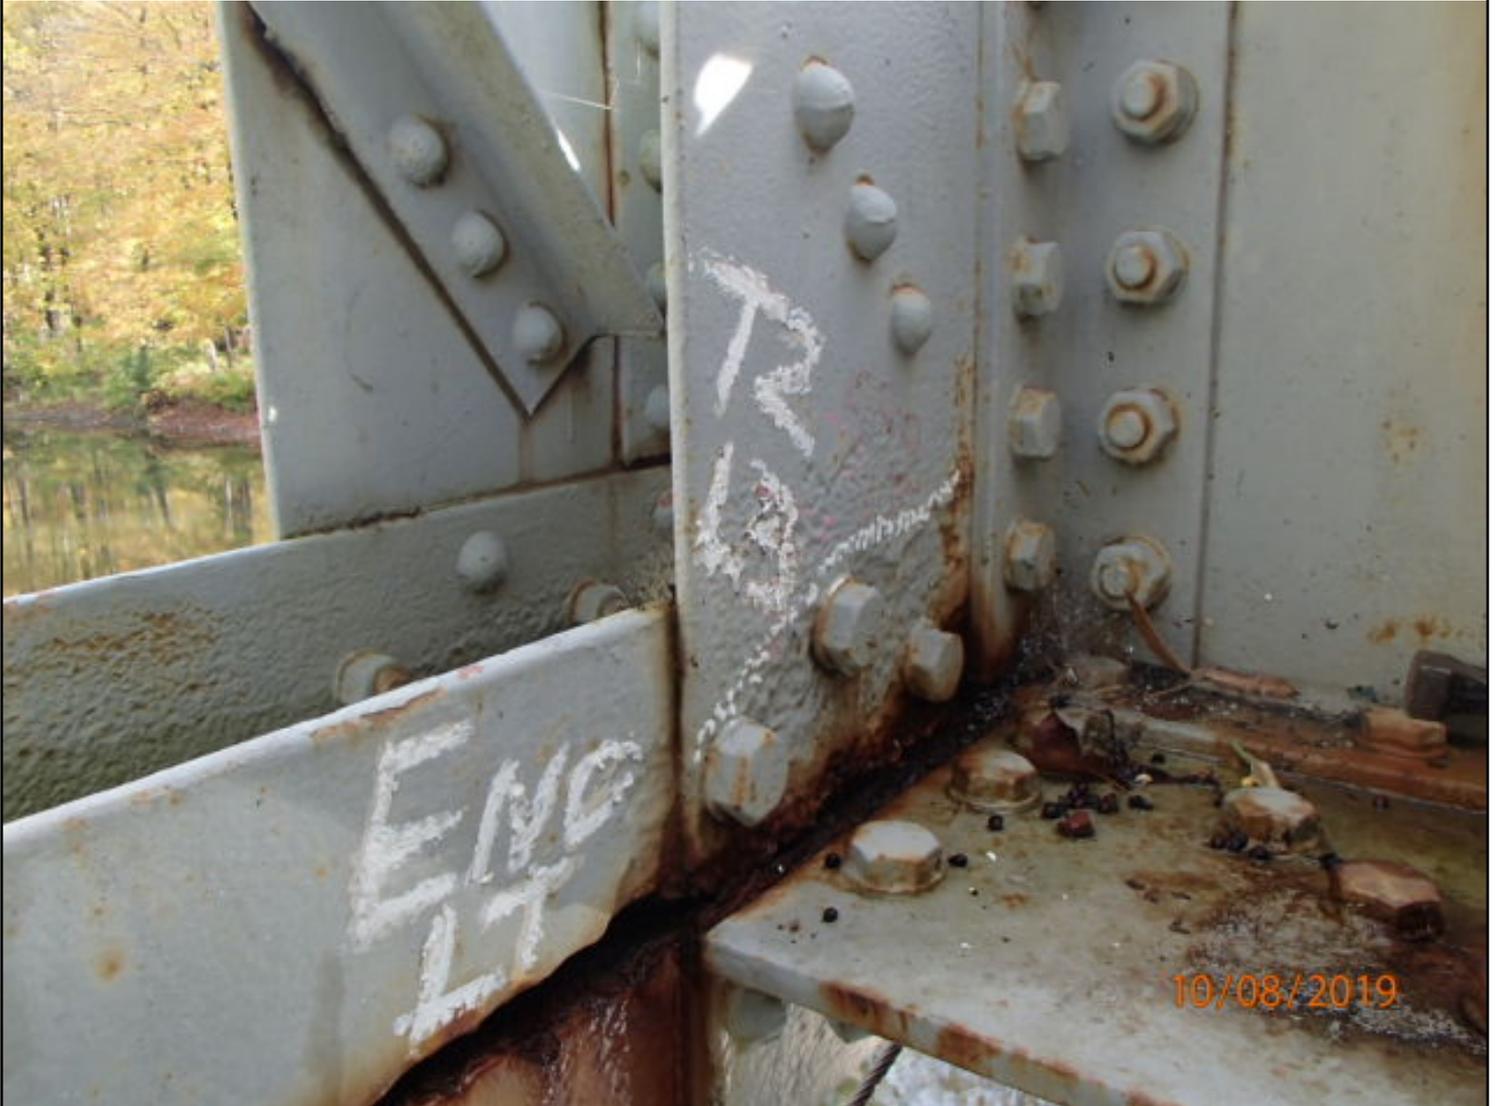
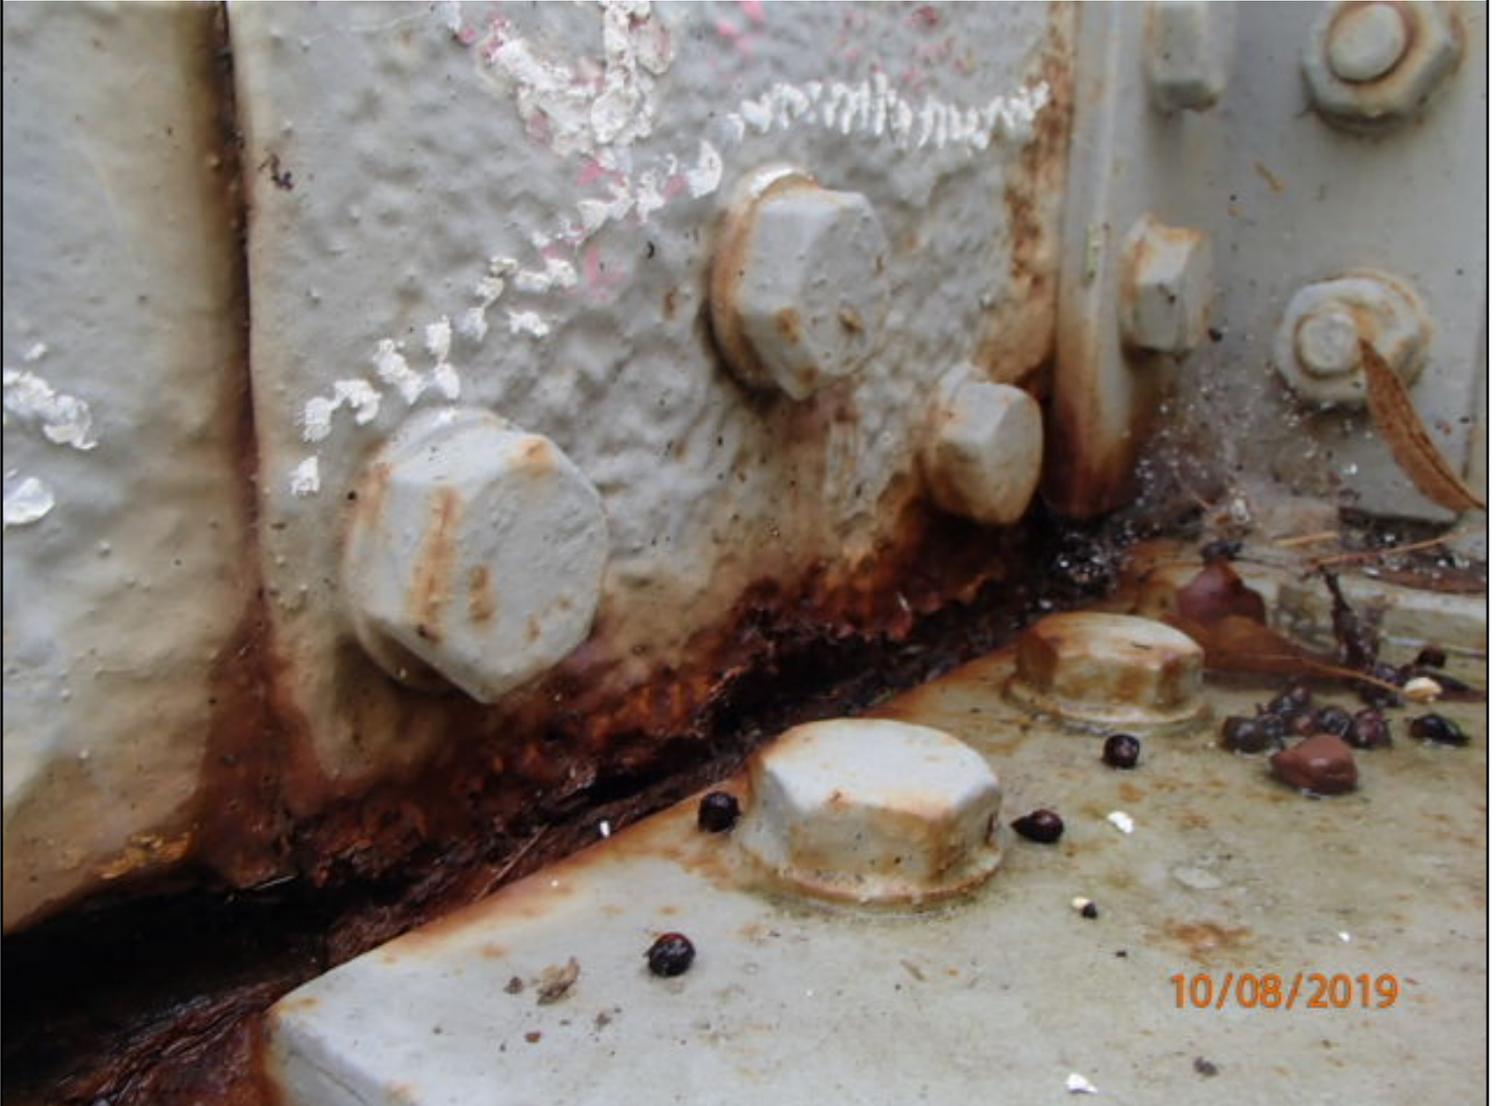
Right Truss (T2) at L3: Begin Left Plate – Previously repaired;  
 Right Truss (T2) at L3: End Left Plate – 75% SL with a perforation over 7 in long x 1 in high (2018 - 75% SL with perforation 6.5 in long); (Photos 2 and 3)

**Attachment Description: Right Truss, End Left Gusset Plate at L3 with perforation**

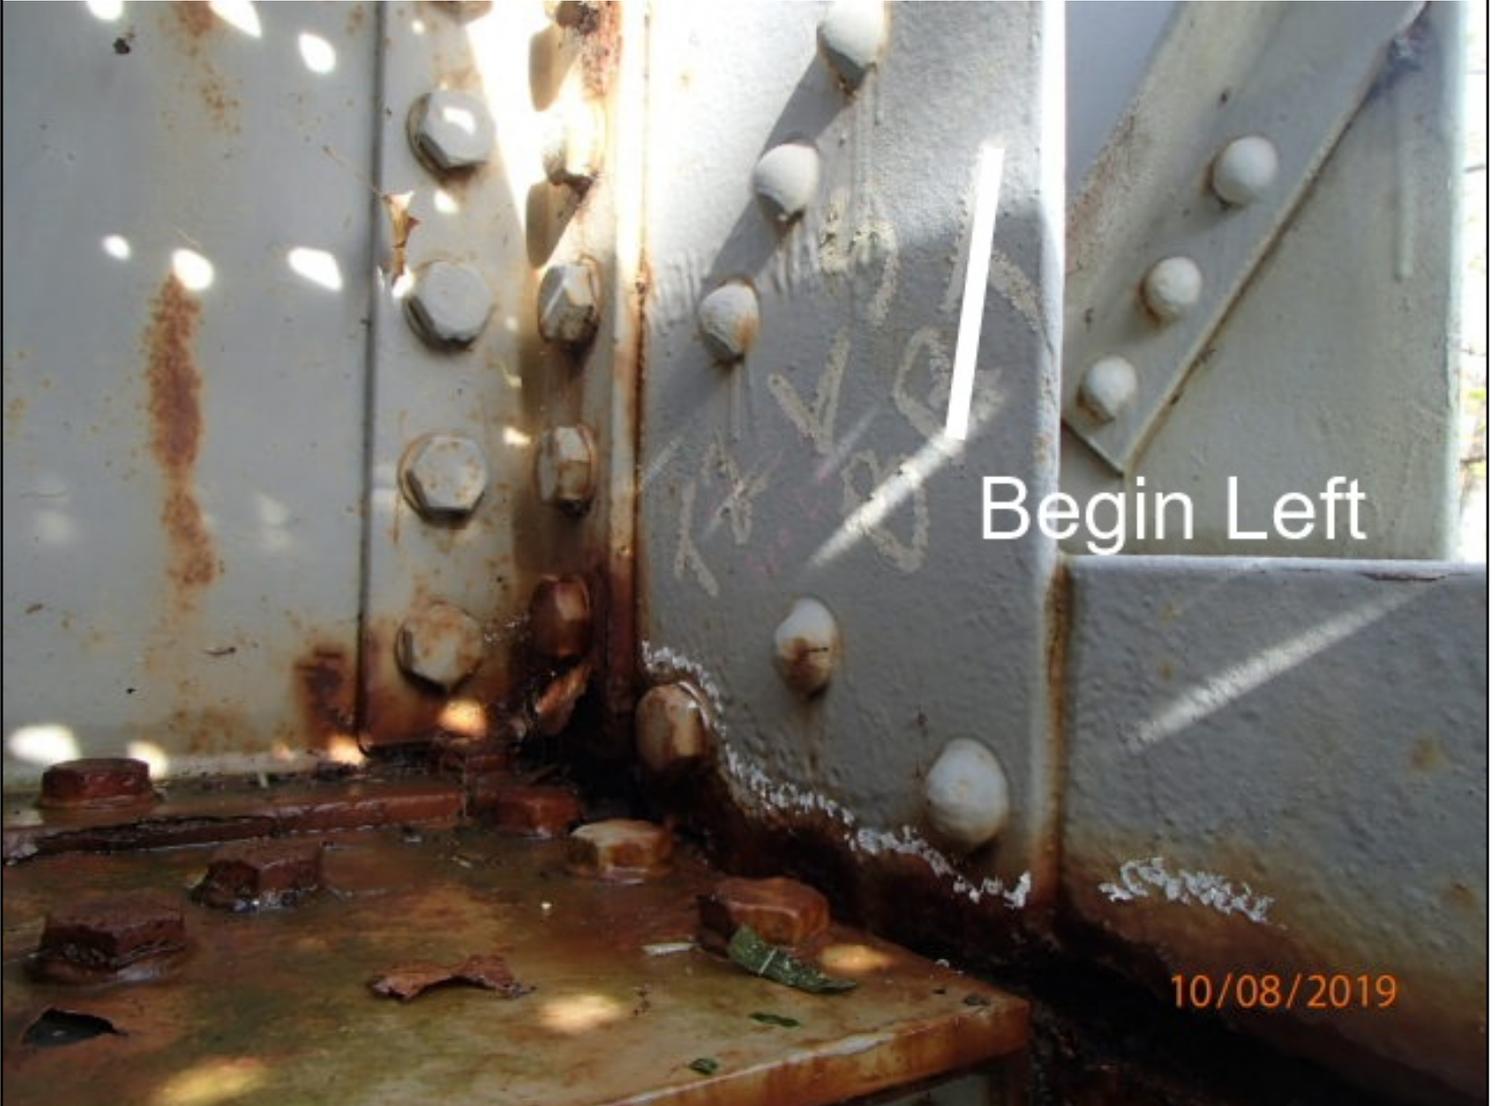
Photo Number: 5

Right Truss (T2) at L5: Begin Left Plate - 70% SL with 4 perforations 1 in long x 1 in high (2018 – no change); (Photo 5)  
 Right Truss (T2) at L5: End Left Plate – Previously repaired;

***Attachment Description: Right Truss, Begin Left Gusset Plate at L5***
