**New York State Department of Transportation
Yellow Flag 1B19VLW059**

Structure Information

Subject: Left Truss (T1) Vertical and Diagonal Member Section Losses
(Bridge posted for 20 tons)

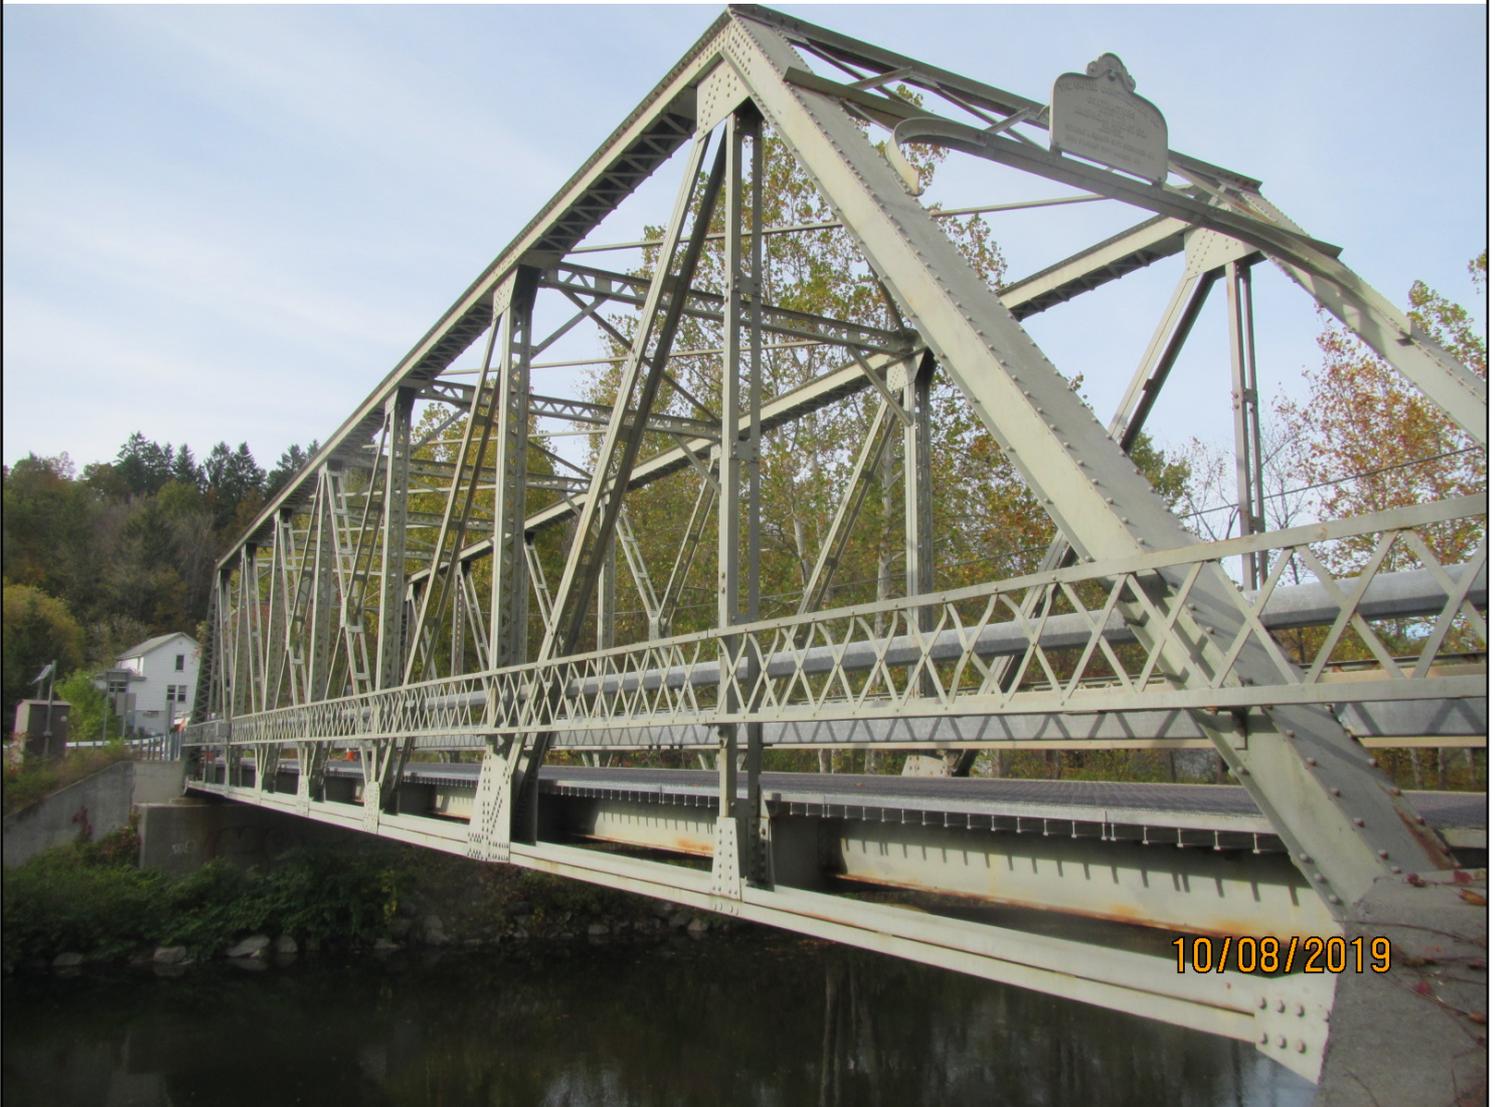
Photo Number: 1

Attachment Description: Left Truss looking at End – General Configuration

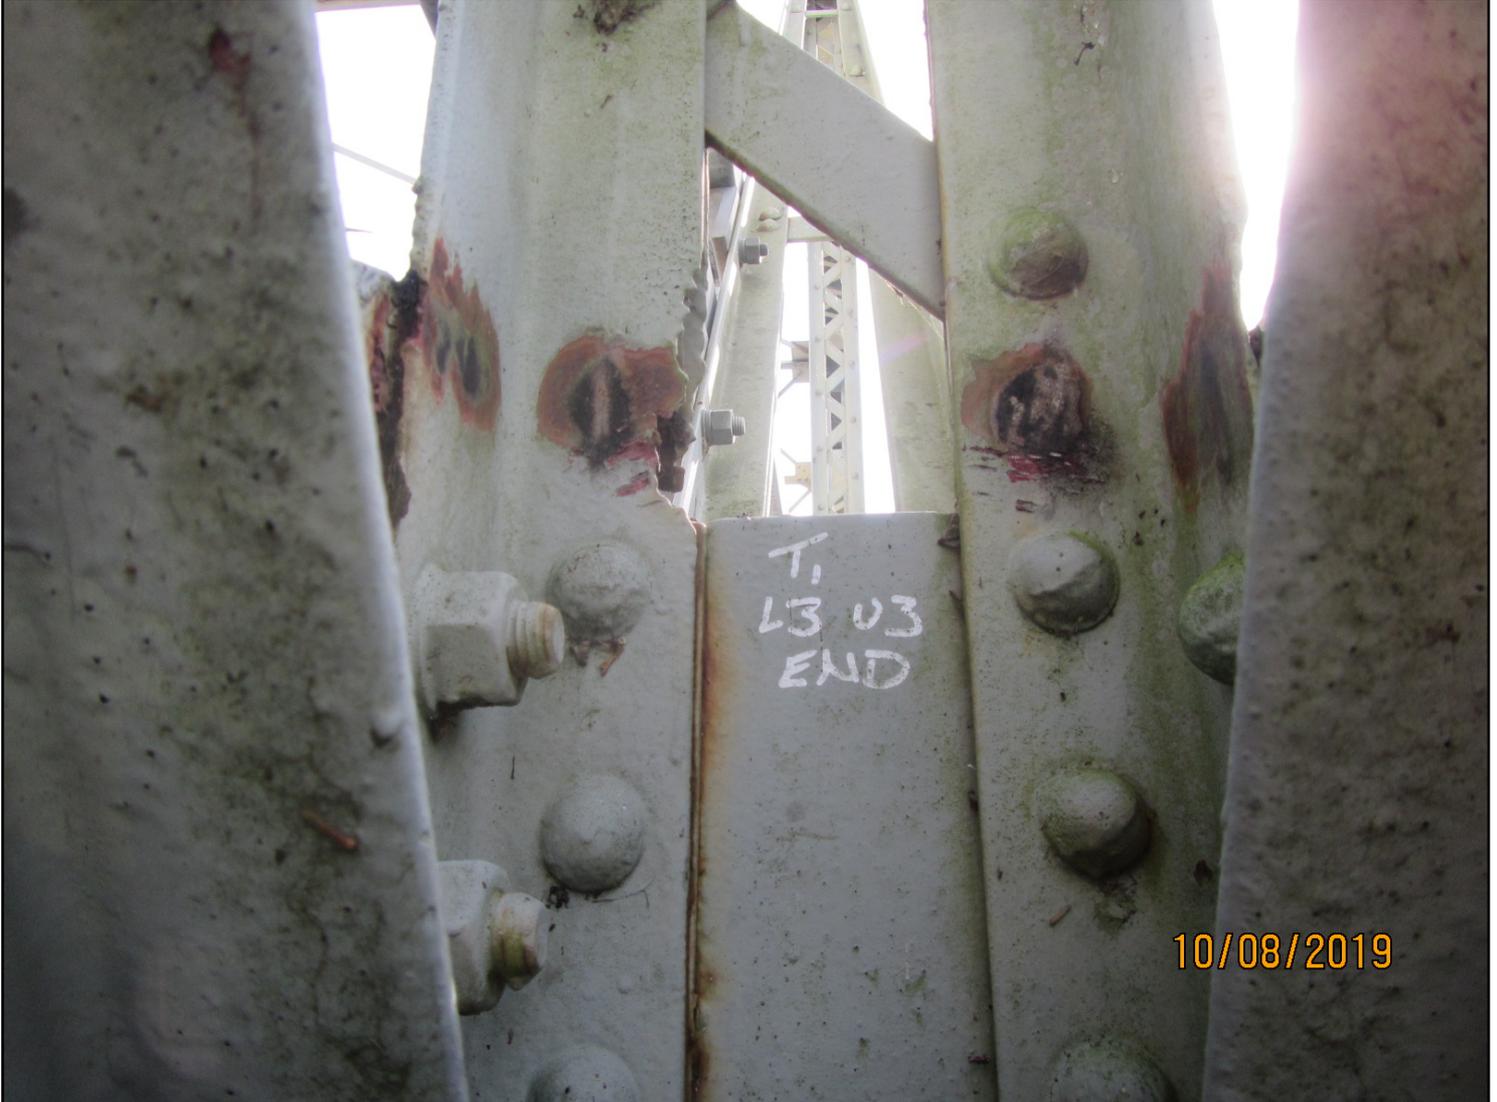
Photo Number: 2

U3L3 at L3 – 45% loss (2018 – 40%); member consists of (4) 4 in x 3 in x 5/16 in angles; (Photo 2)

Attachment Description: Left Truss, U3L3 End face

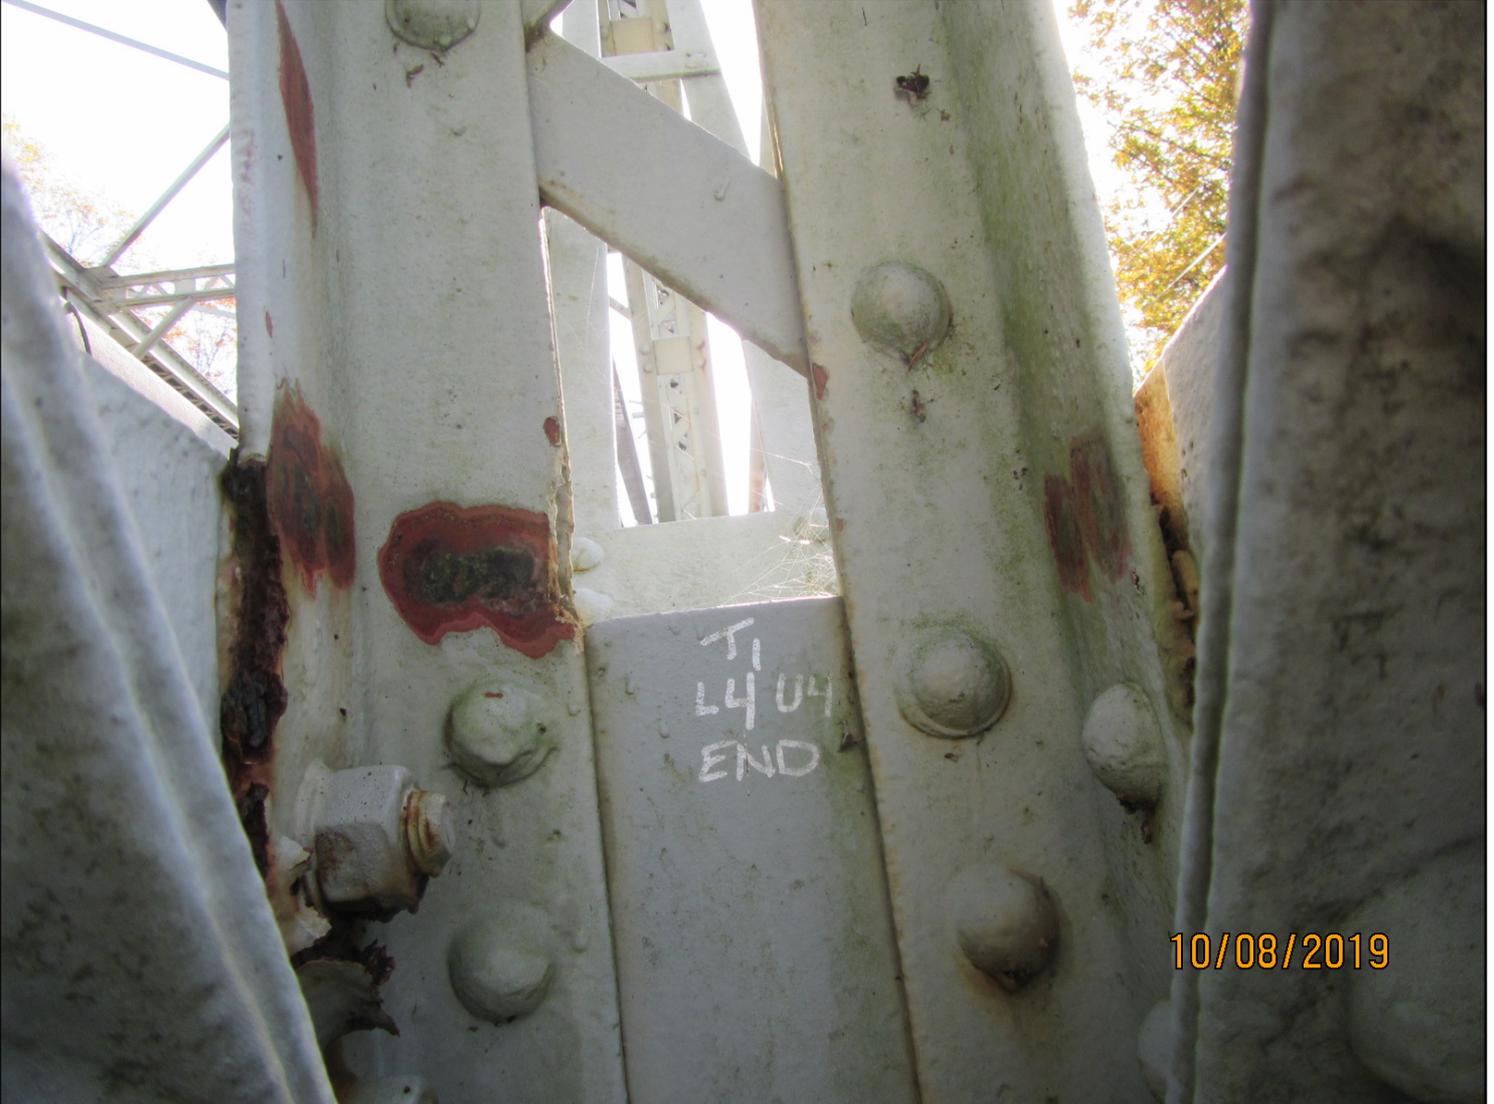
Photo Number: 3

U4L4 at L4 – 30-40% loss (no significant change from 2018) member consists of (4) 3 in x 3-5/8 in x 5/16 in angles; (Photo 3)

Attachment Description: Left Truss, U4L4 End face

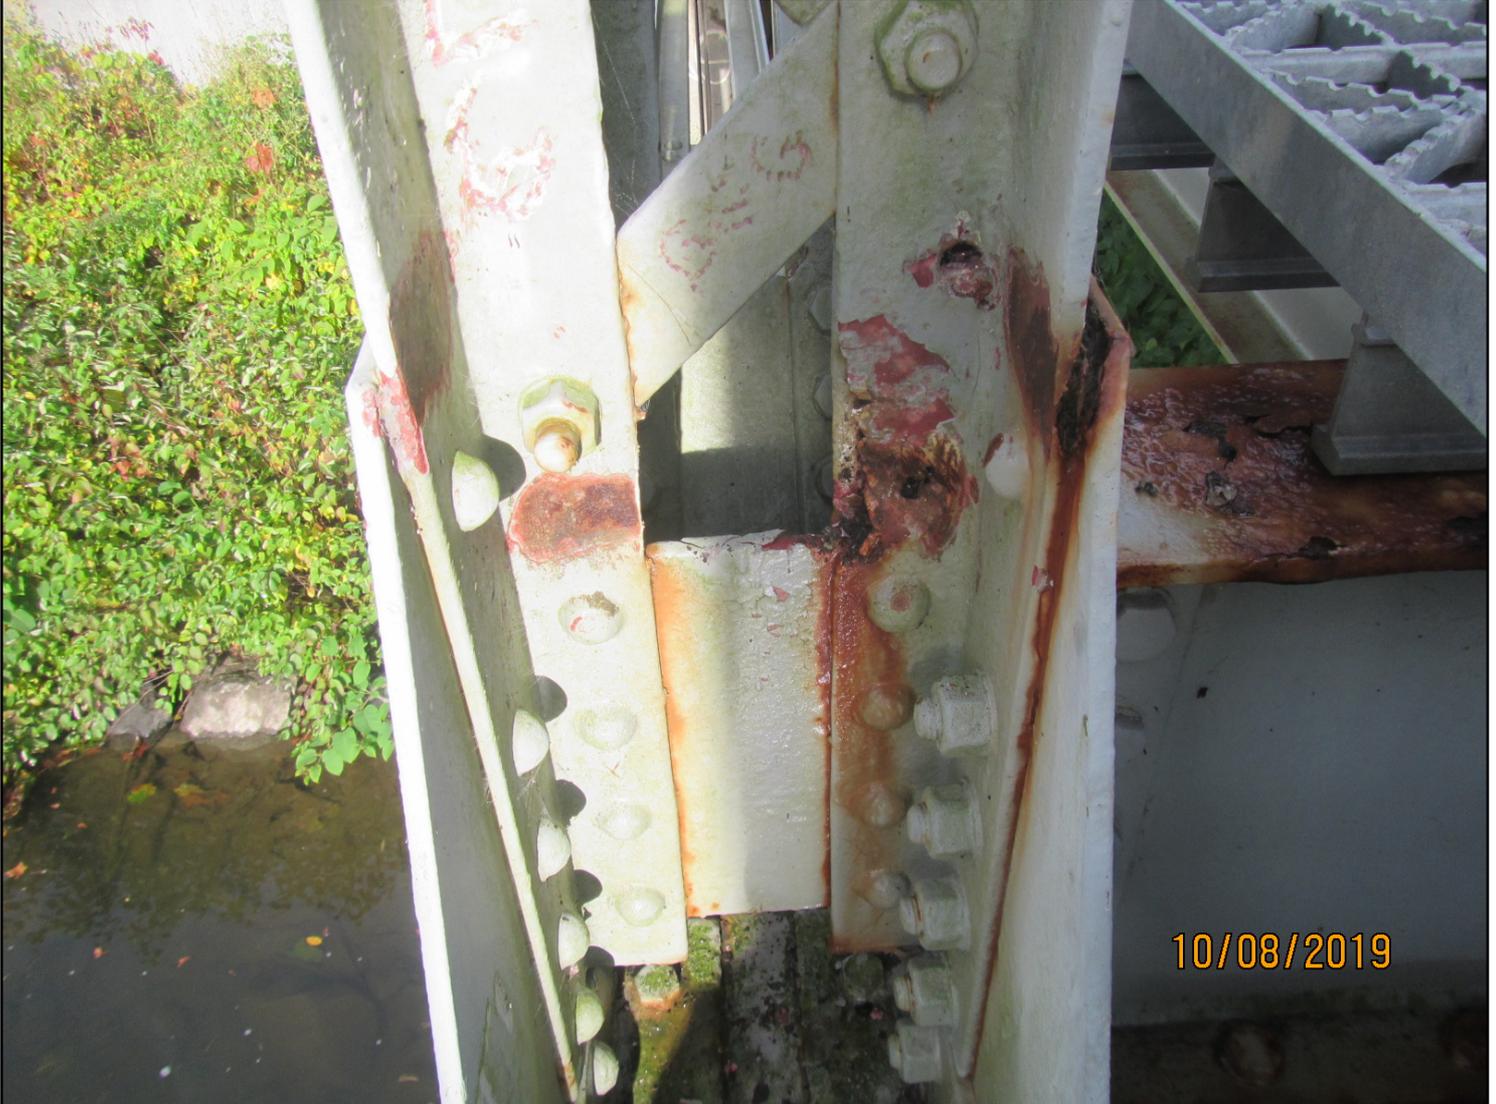
Photo Number: 4

U6L6 at L6 – 30-35% loss (no significant change from 2018) member consists of (4) 4 in x 3 in x 5/16 in angles; (Photo 4)

Attachment Description: Left Truss, U6L6 Begin face
