**New York State Department of Transportation  
Yellow Flag 1B19VLW060**

**BIN: 3306370** *Region: 01 - ALBANY*  
*Feature Carried: BATTEN-DUGAN ROAD* *County: WASHINGTON*  
*Feature Crossed: BATTEN KILL* *Political Unit: Town of JACKSON*  
*Orientation: 8 - NORTHWEST* *Approximate Year Built: 1916*

Subject: Right Truss (T2) Bottom Chord, Vertical, and Diagonal Member Section Losses  
(Bridge posted for 20 tons)

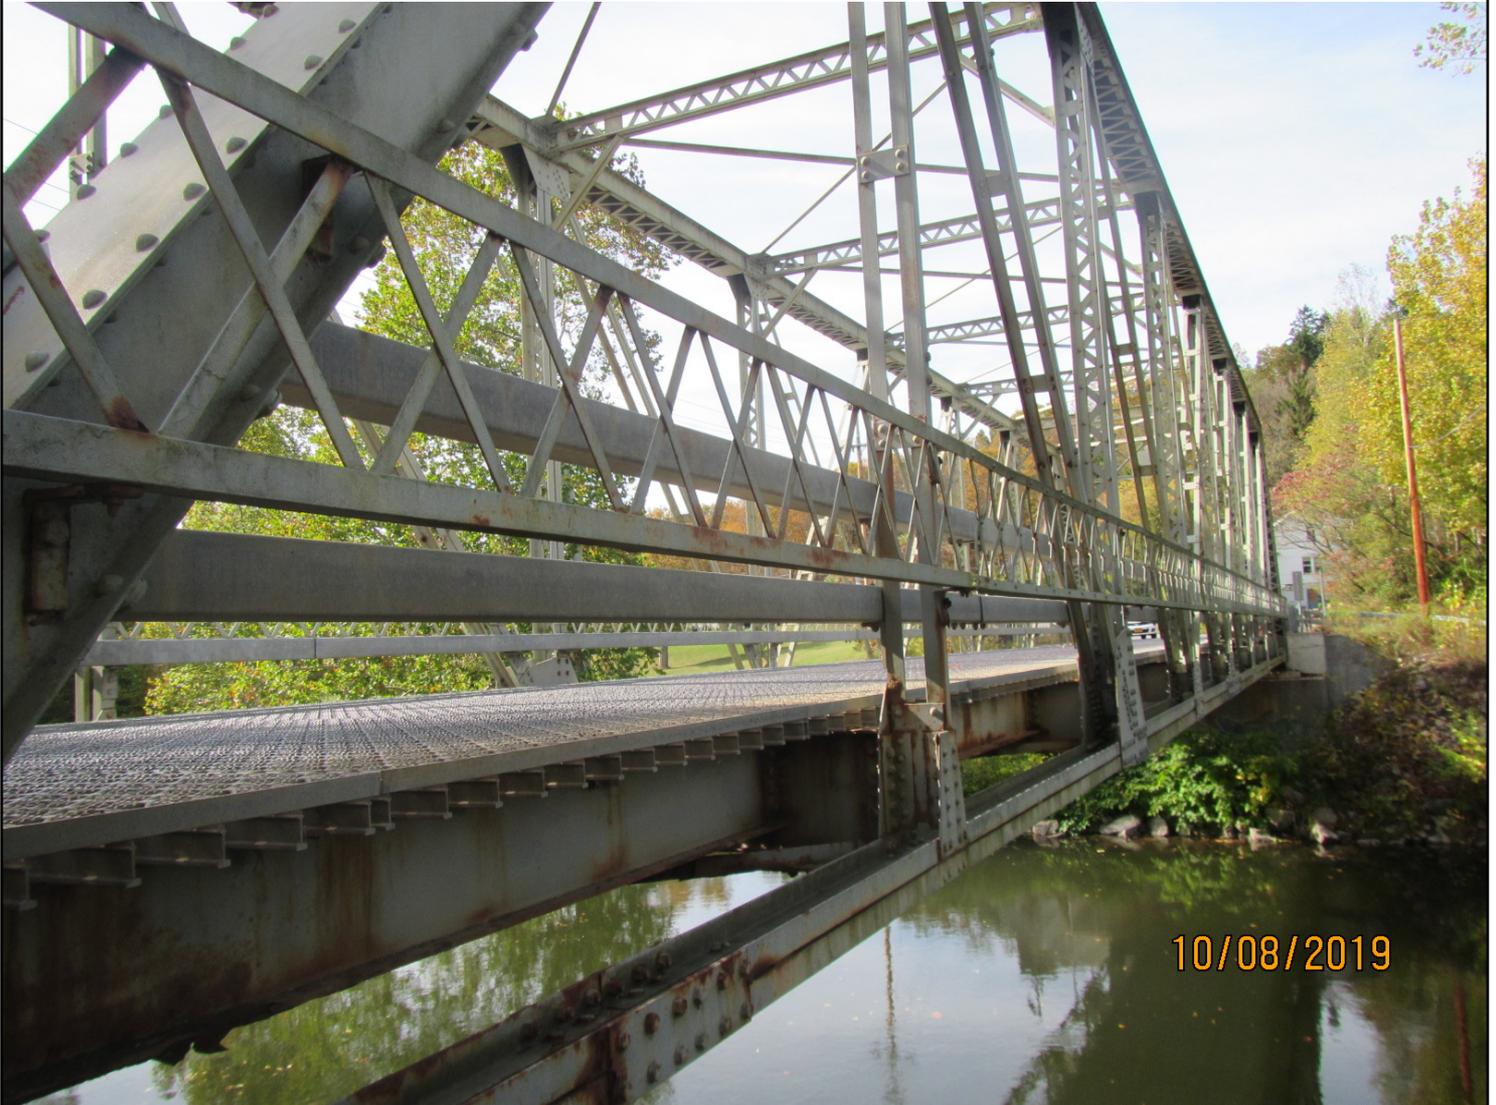
Photo Number: 1

**Attachment Description: Right Truss looking at End – General Configuration**

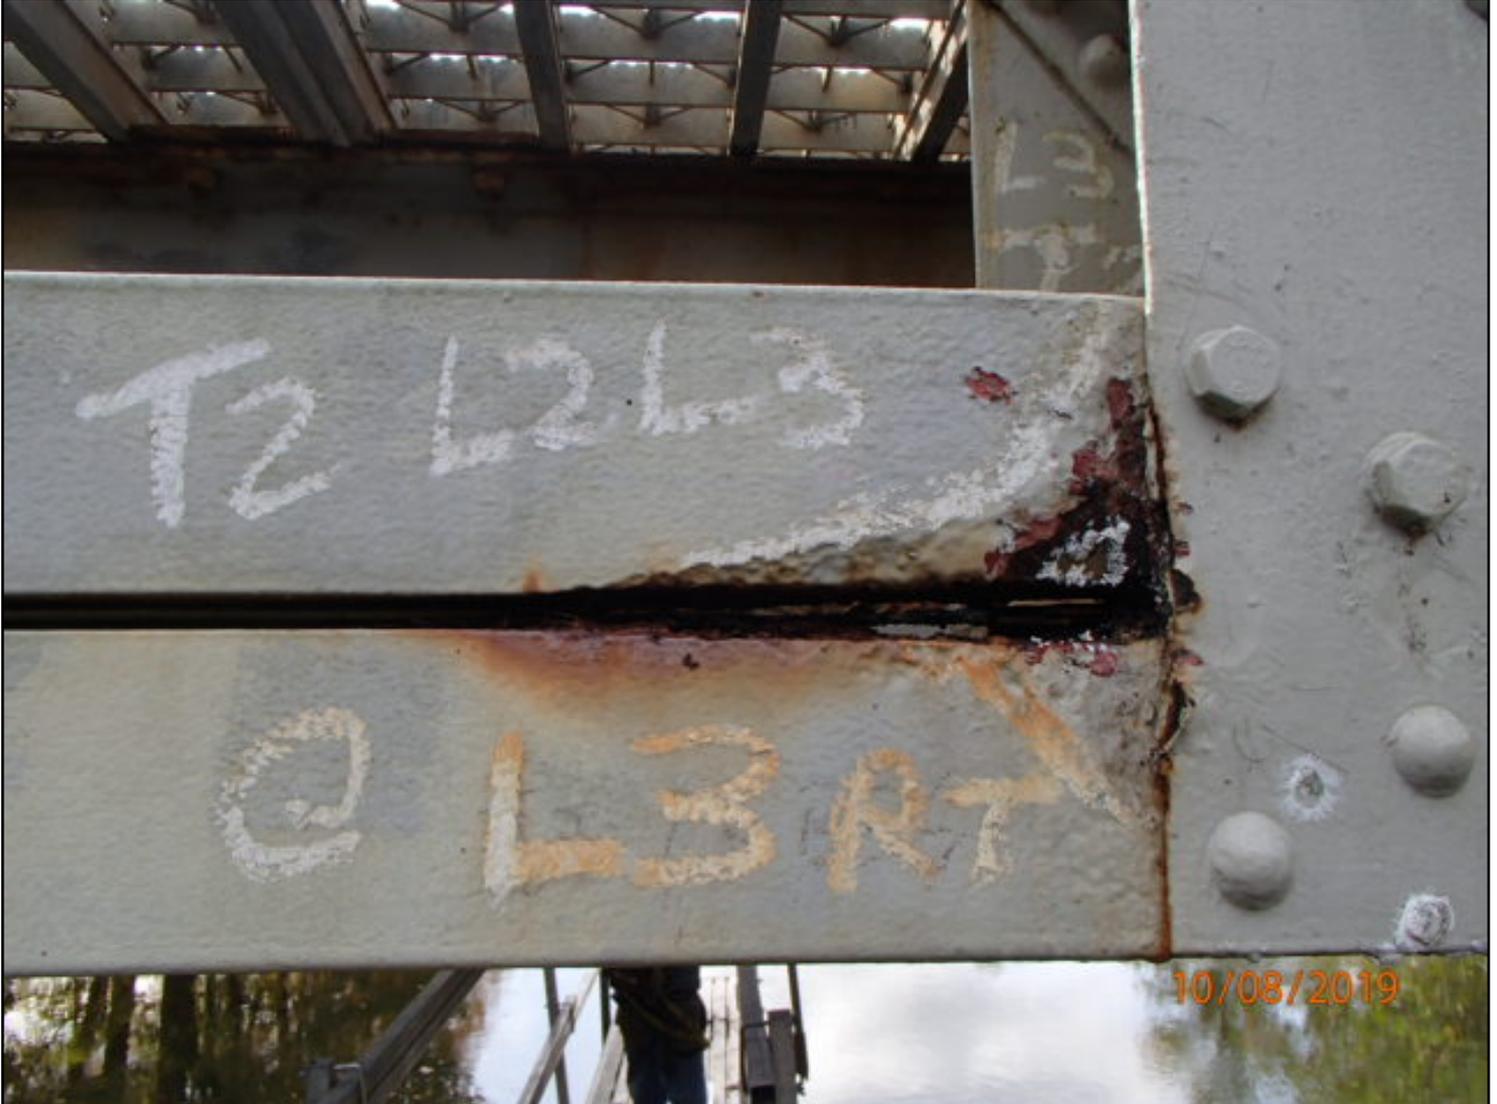
Photo Number: 2

- L2L3 at L3 – 45% loss (2018 – 40%) member consists of (4) 5 in x 3-1/2 in x 7/16 in angles; (Photo 2-3)
- U2L3 at L3 – 30-40% loss (no significant change from 2018) member consists of (4) 2-5/8 in x 2-5/8 in x 5/16 in angles
- U3L3 at L3 – 40-50% loss (no significant change from 2018) member consists of (4) – 4 in x 3 in x 5/16 in angles; (Photo 4)
- U4L4 at L4 – 40% loss (no significant change from 2018) member consists of (4) 3 in x 3-5/8 in x 5/16 in angles; (Photo 5)
- U5L5 at L5 – 30-40% loss (no significant change from 2018) member consists of (4) 4 in x 3 in x 5/16 in angles;
- U6L5 at L5 – 40% loss (no significant change from 2018) member consists of (4) 2-5/8 in x 2-5/8 in x 5/16 in angles;
- U6L6 at L6 – 40% loss (2018 – 35%) member consists of (4) 4 in x 3 in x 5/16 in angles; (Photo 6)

***Attachment Description: Right Truss, L2L3 Right face at L3***

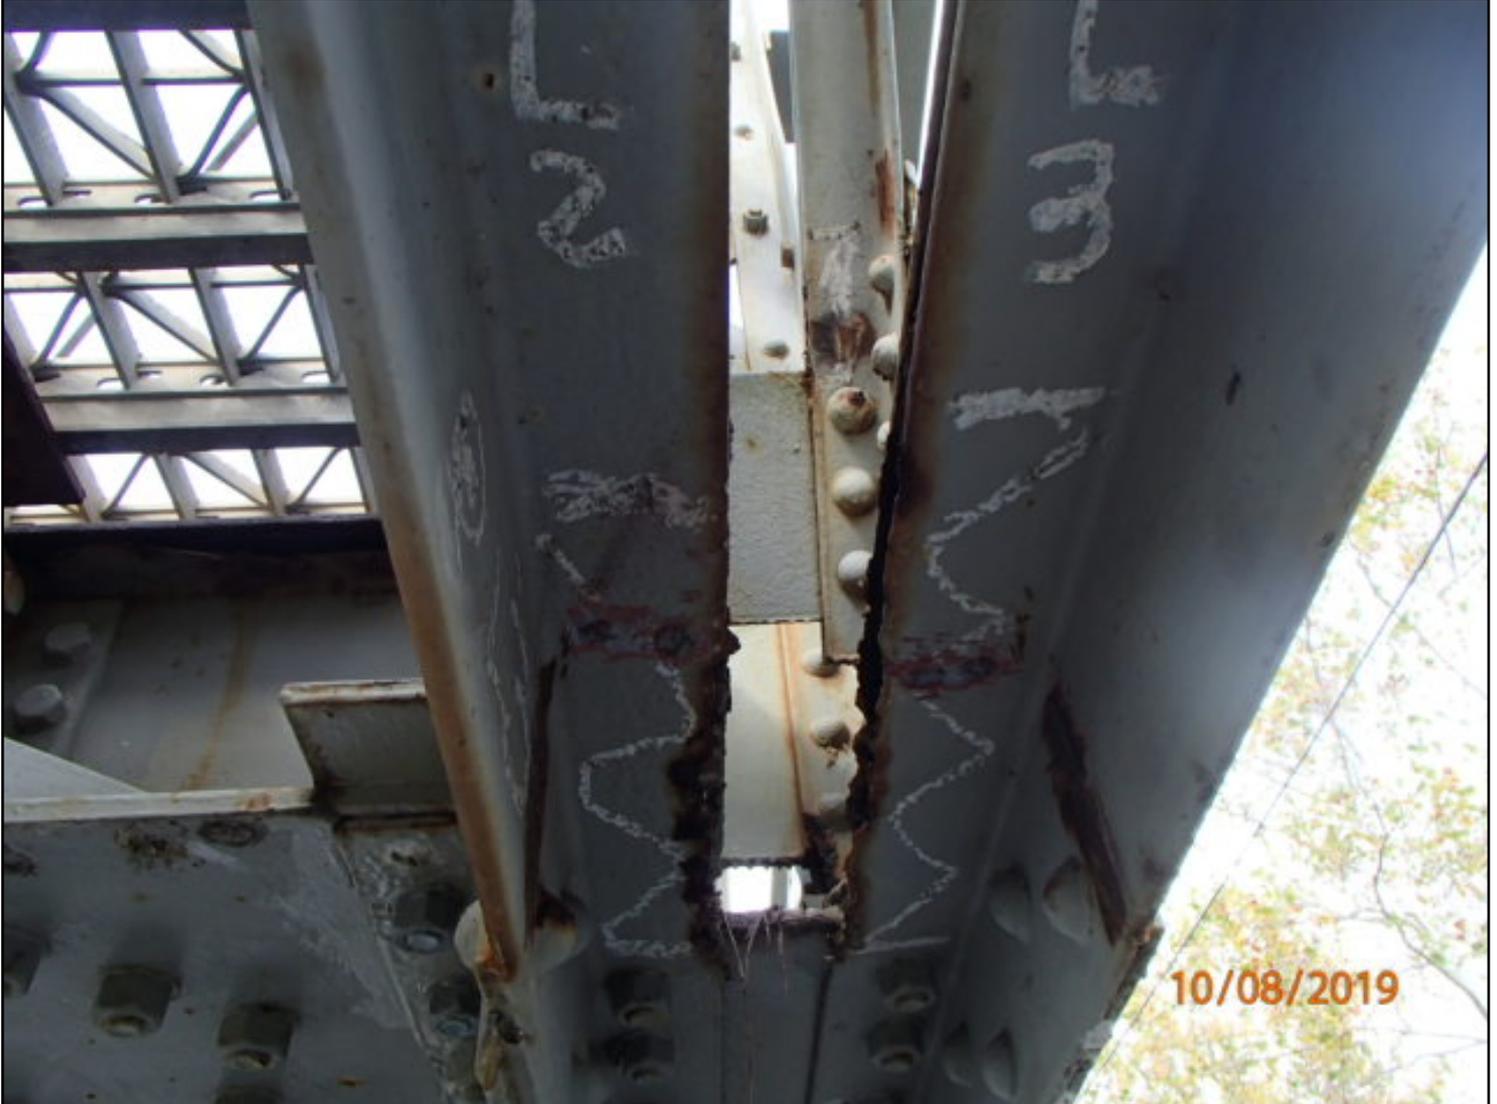
Photo Number: 3

***Attachment Description: Right Truss, L2L3 underside at L3***

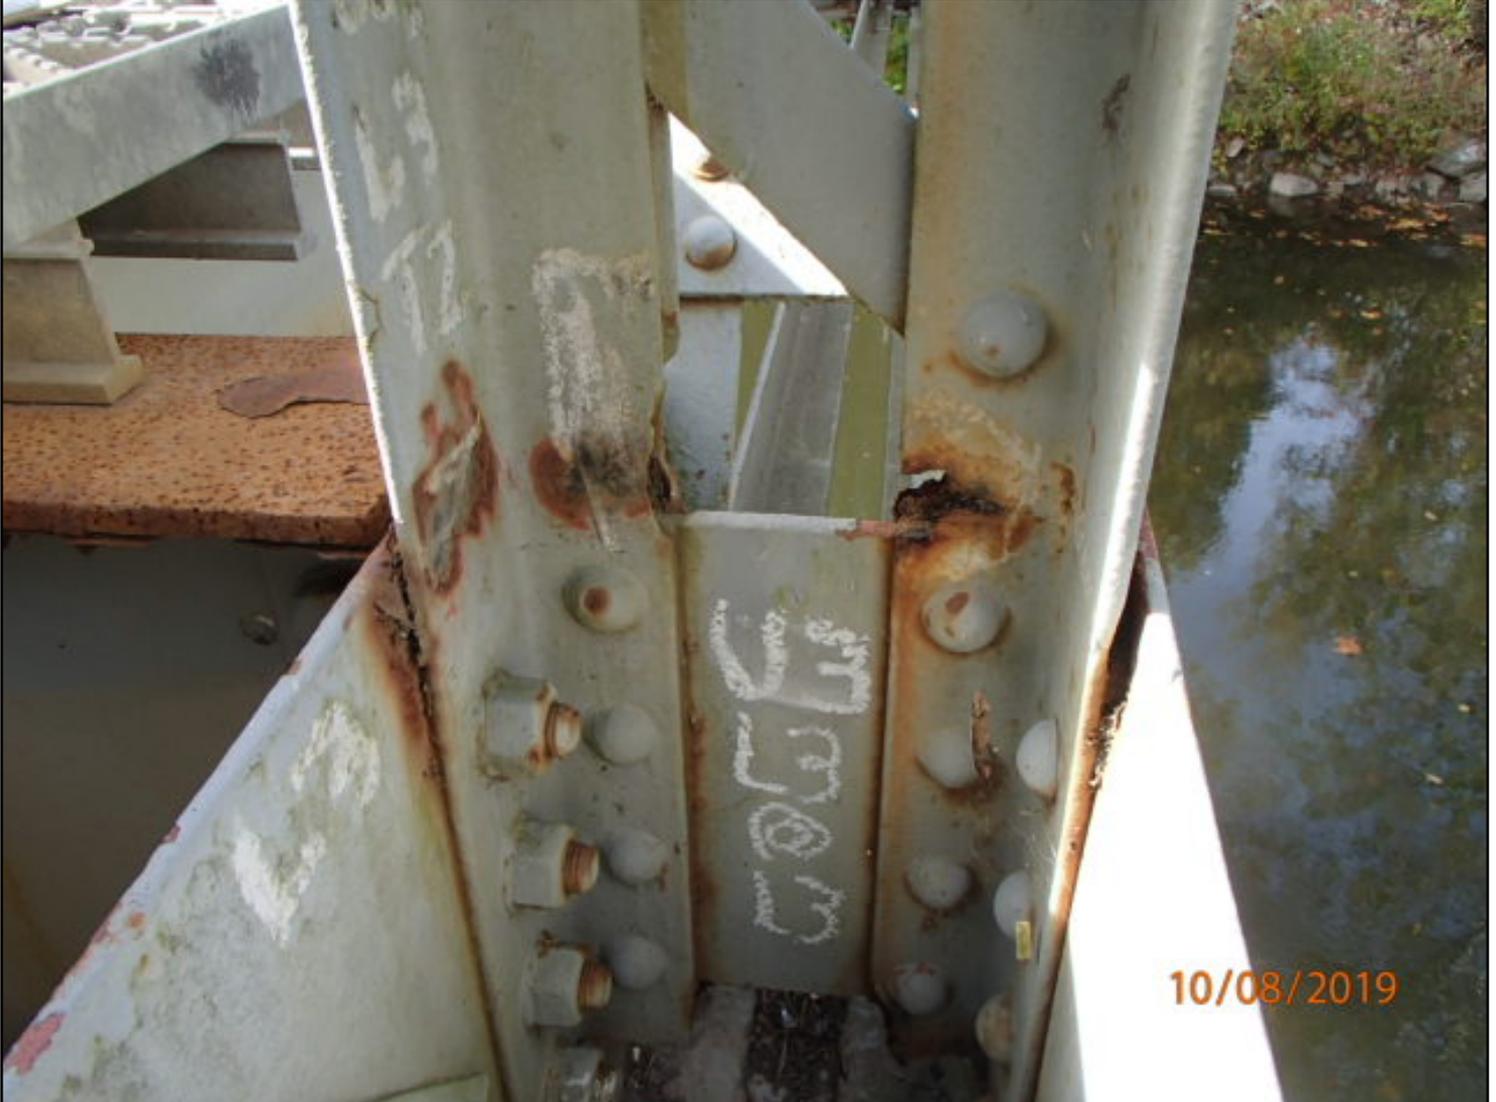
Photo Number: 4

**Attachment Description: Right Truss, U3L3 Begin face**

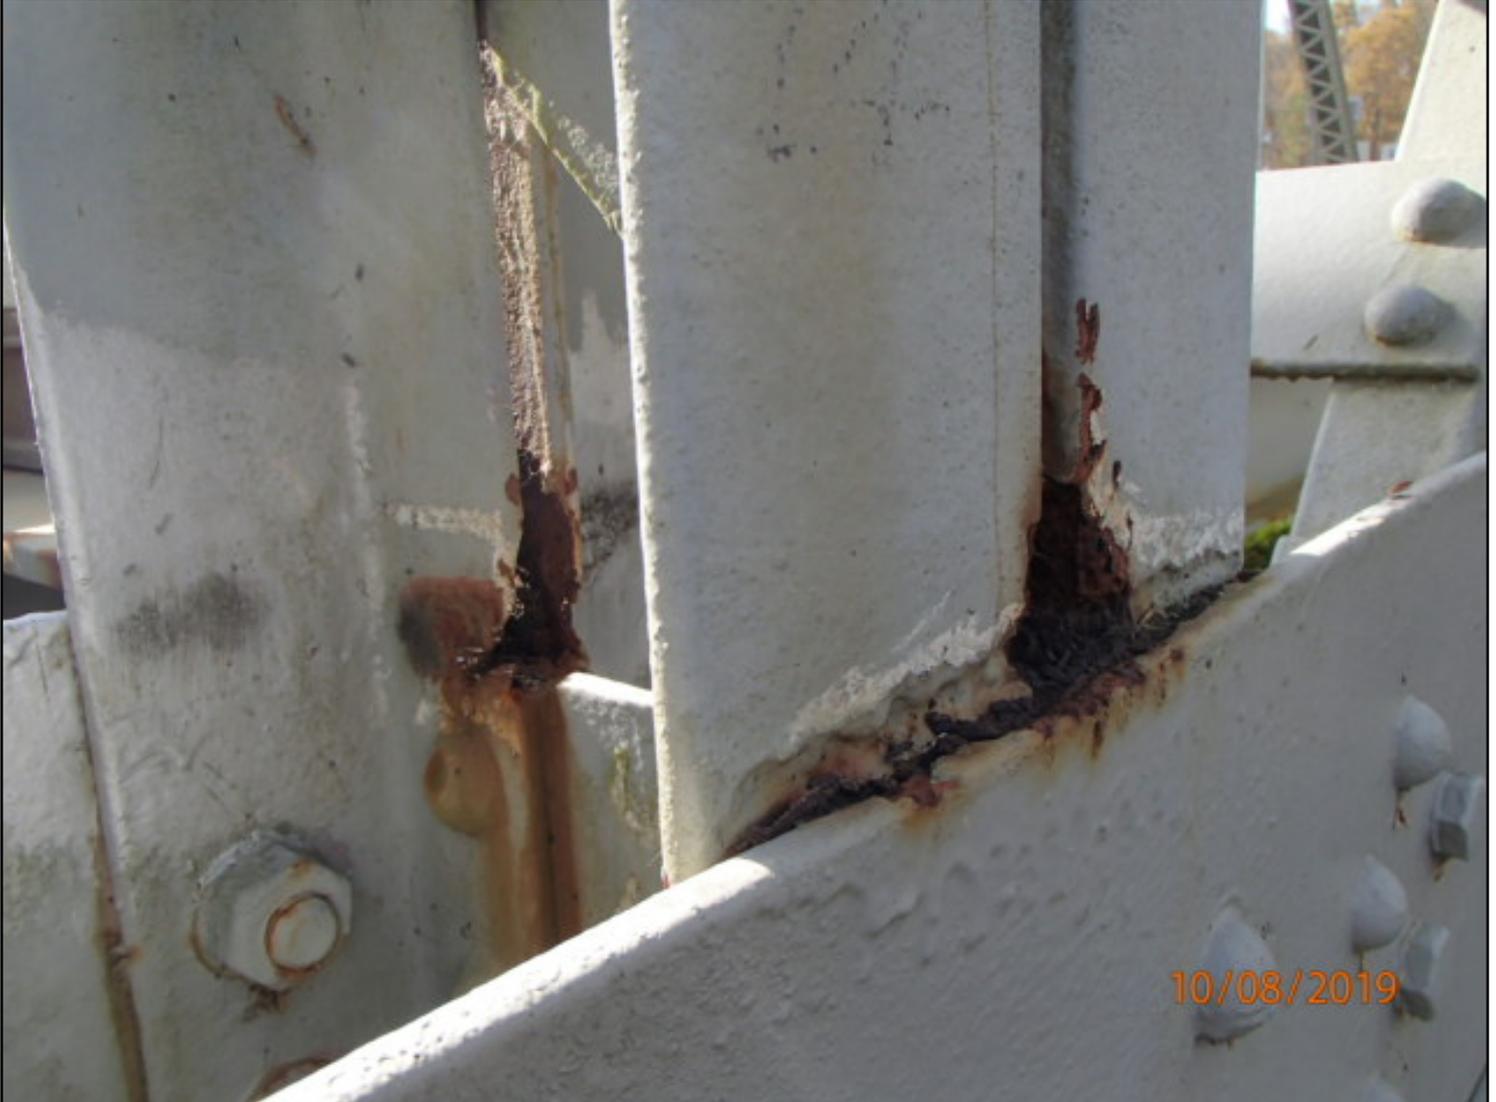
Photo Number: 5

***Attachment Description: Right Truss, U4L4 Begin face***

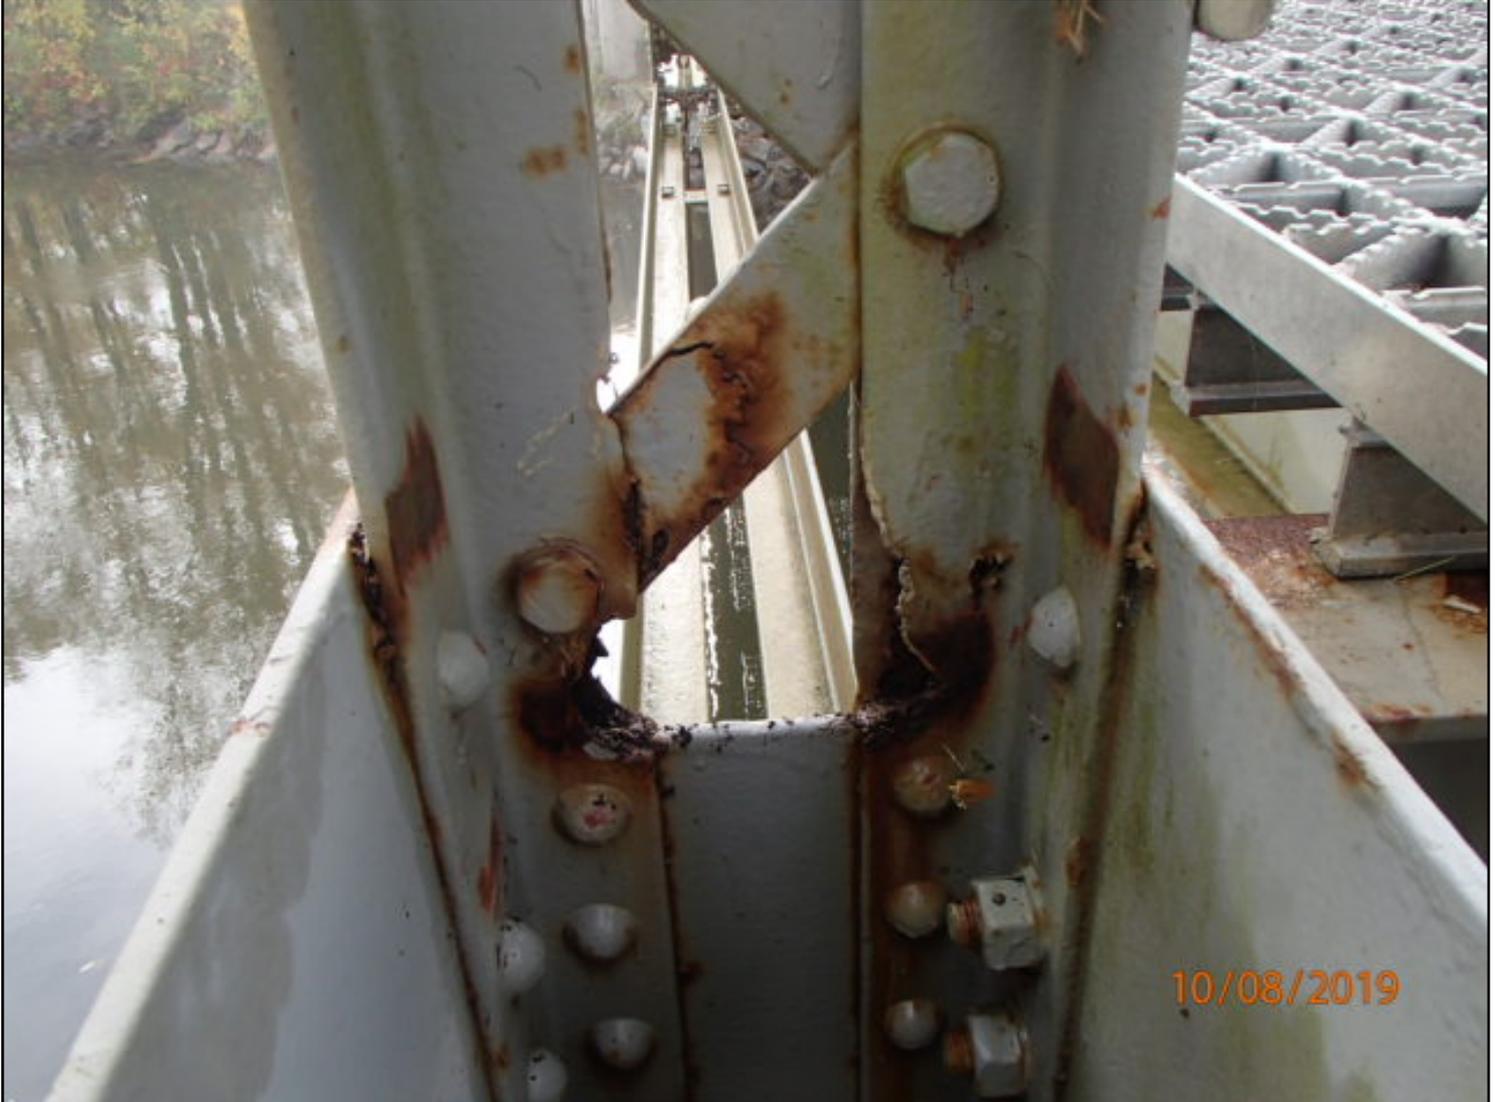
Photo Number: 6

***Attachment Description: Right Truss, U6L6 End face***
