# New York State Department of Transportation General Bridge Inspection Report

*Inspection Date:* October 08, 2019

*BIN:* 3306370

*Feature Carried:* BATTEN-DUGAN ROAD

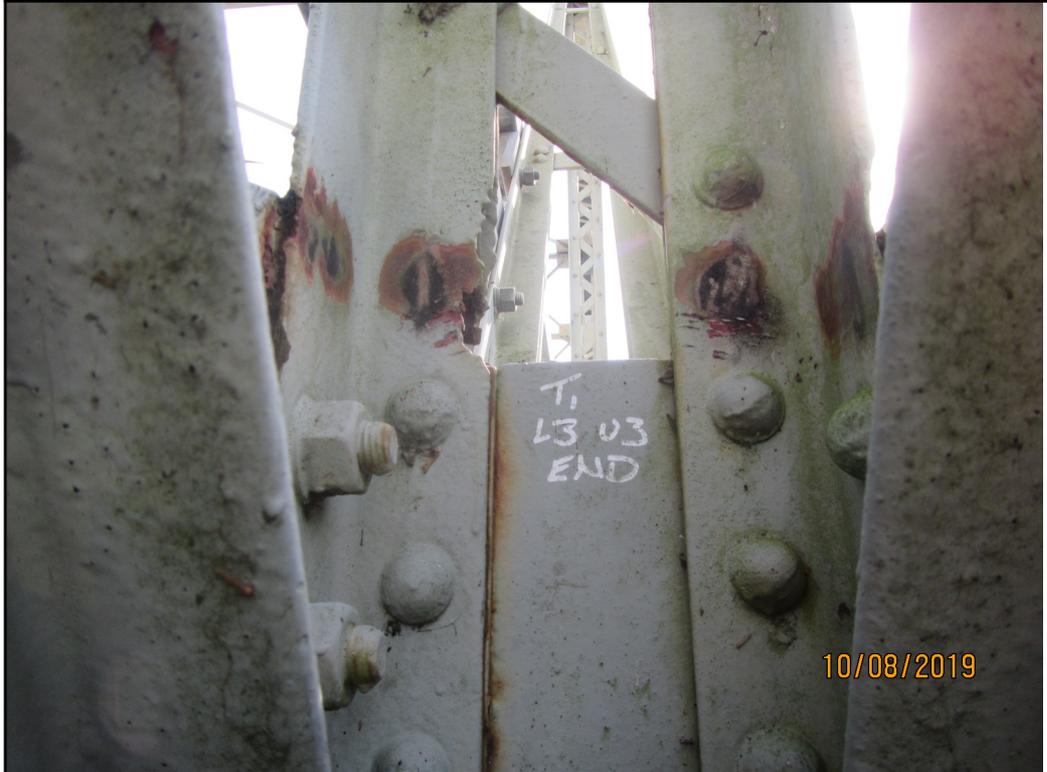
Photo Number: 9 Photo Filename: 9.JPG

**Attachment Description:**  
Left Truss, U3L3 End face

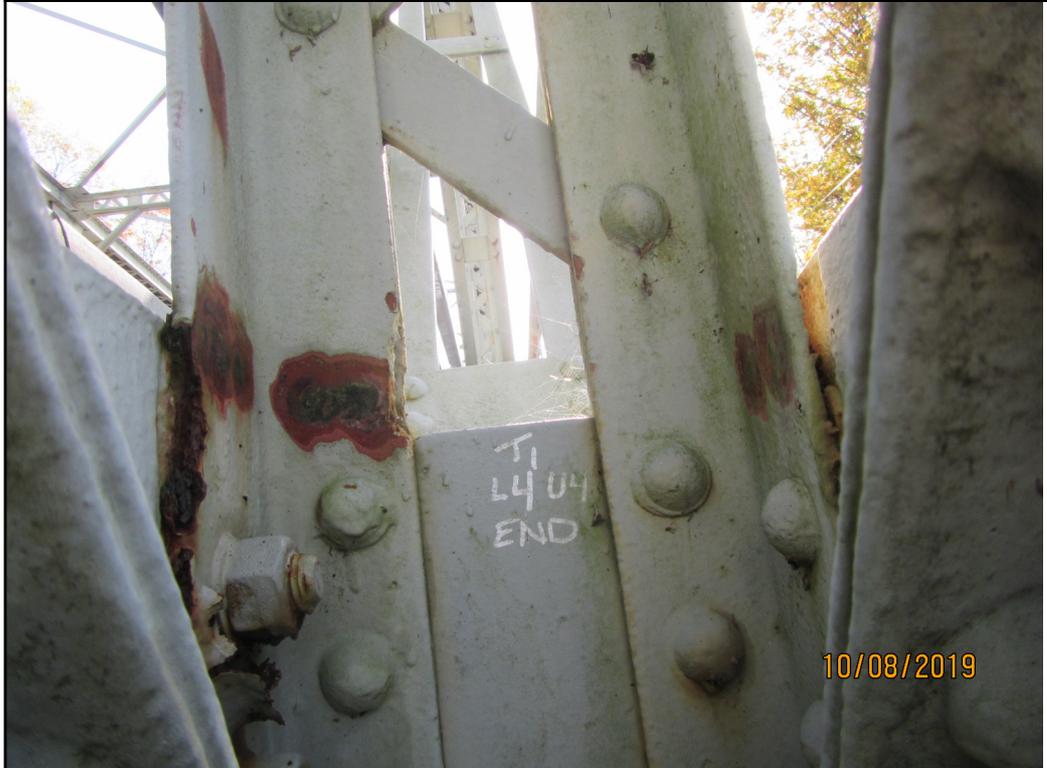
Photo Number: 10 Photo Filename: 10.JPG

**Attachment Description:**  
Left Truss, U4L4 End face

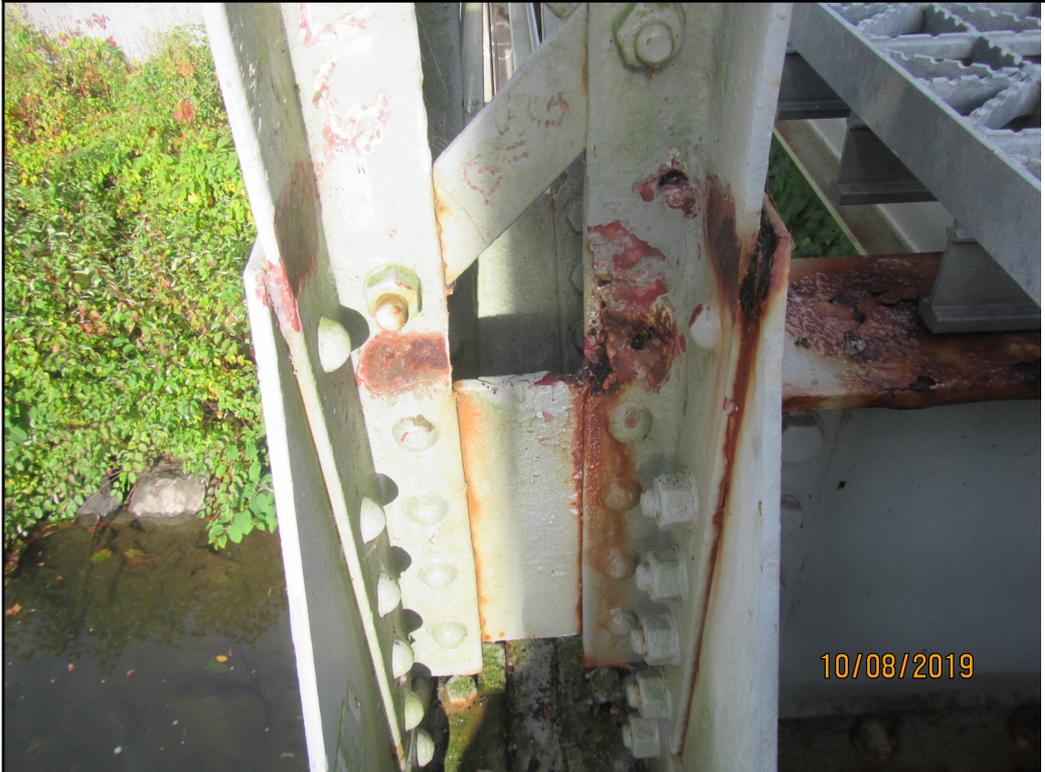
Photo Number: 11 Photo Filename: 11.JPG

**Attachment Description:**  
Left Truss, U6L6 Begin face

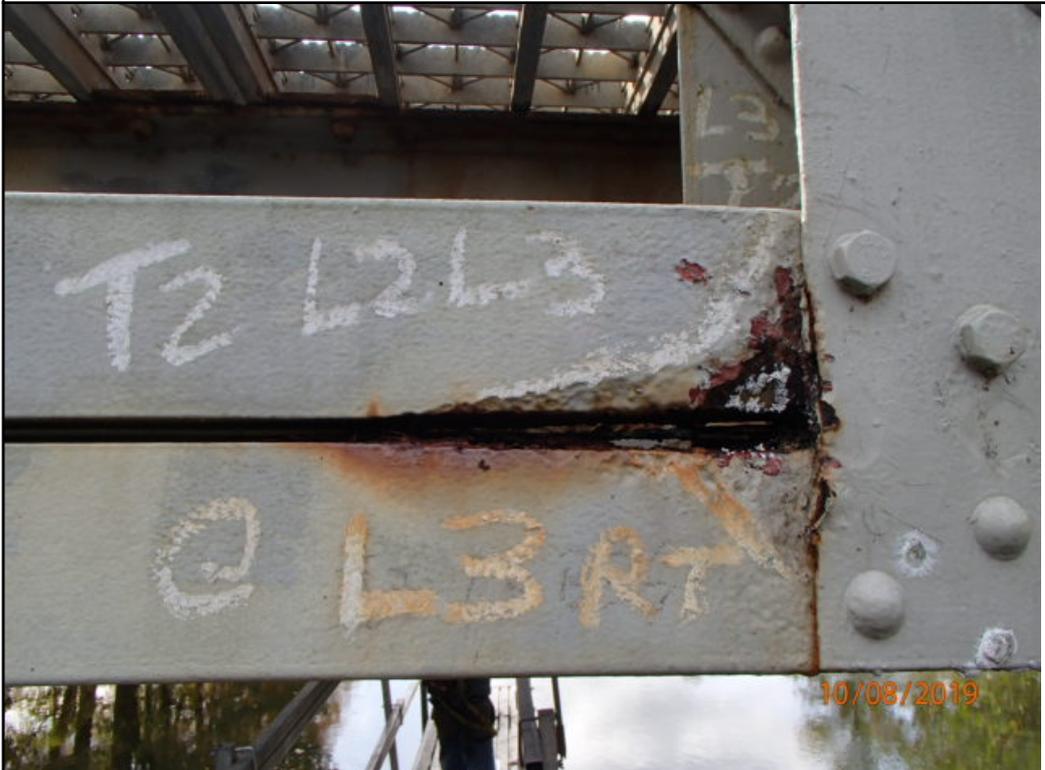
Photo Number: 12 Photo Filename: 12.JPG

**Attachment Description:**  
Right Truss, L2L3 Right  
face at L3

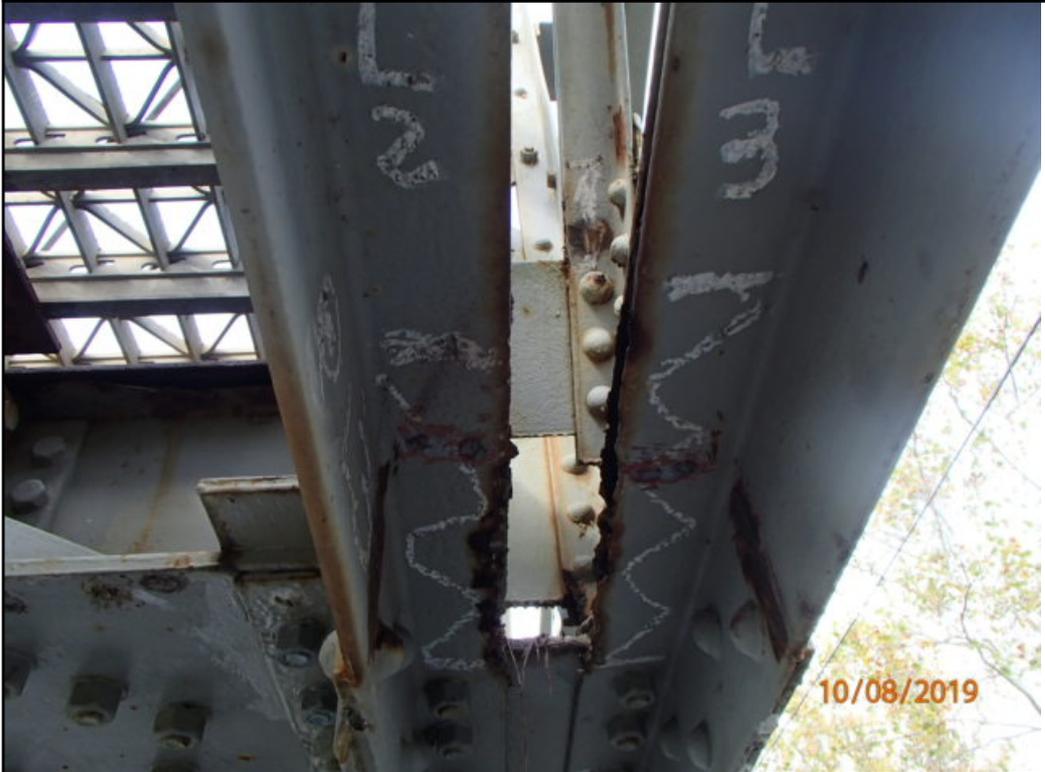
Photo Number: 13 Photo Filename: 13.JPG

**Attachment Description:**  
Right Truss, L2L3 underside  
at L3

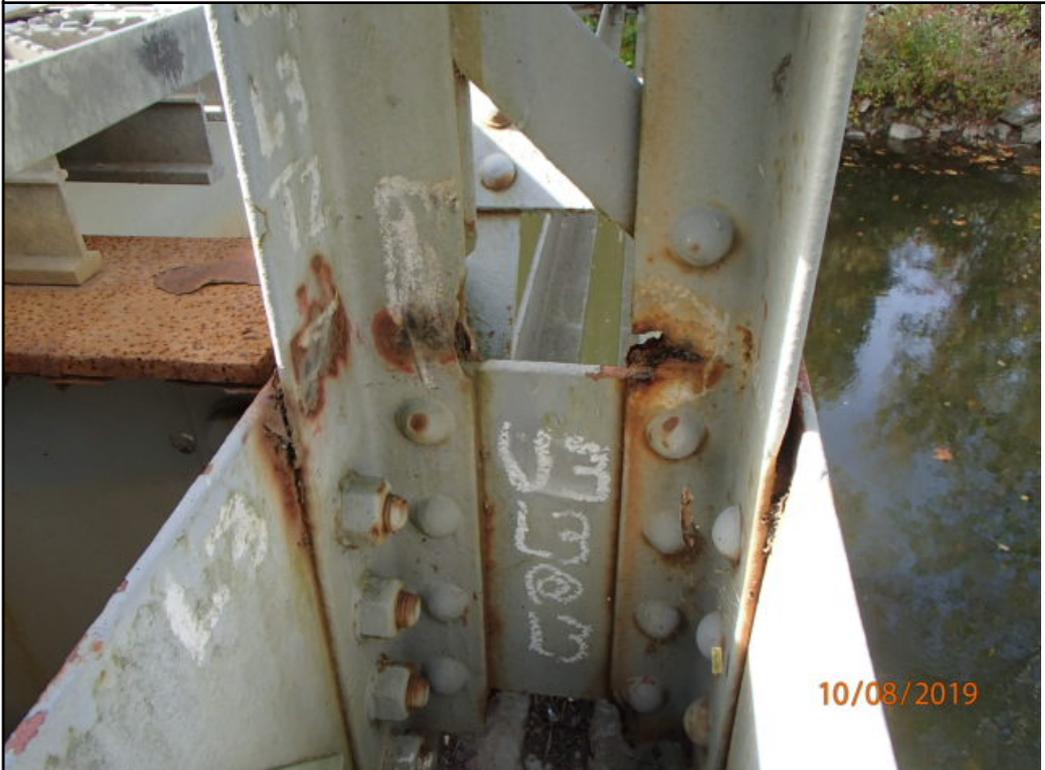
Photo Number: 14 Photo Filename: 14.JPG

**Attachment Description:**  
Right Truss, U3L3 Begin  
face

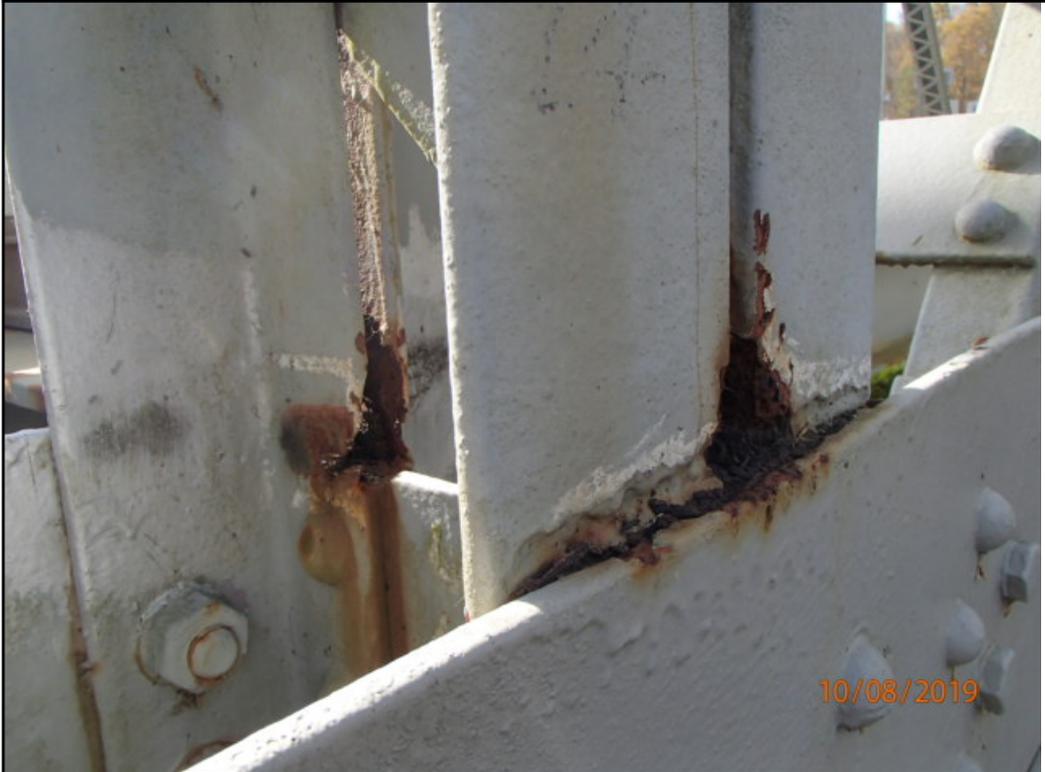
Photo Number: 15 Photo Filename: 15.JPG

**Attachment Description:**  
Right Truss, U4L4 Begin  
face

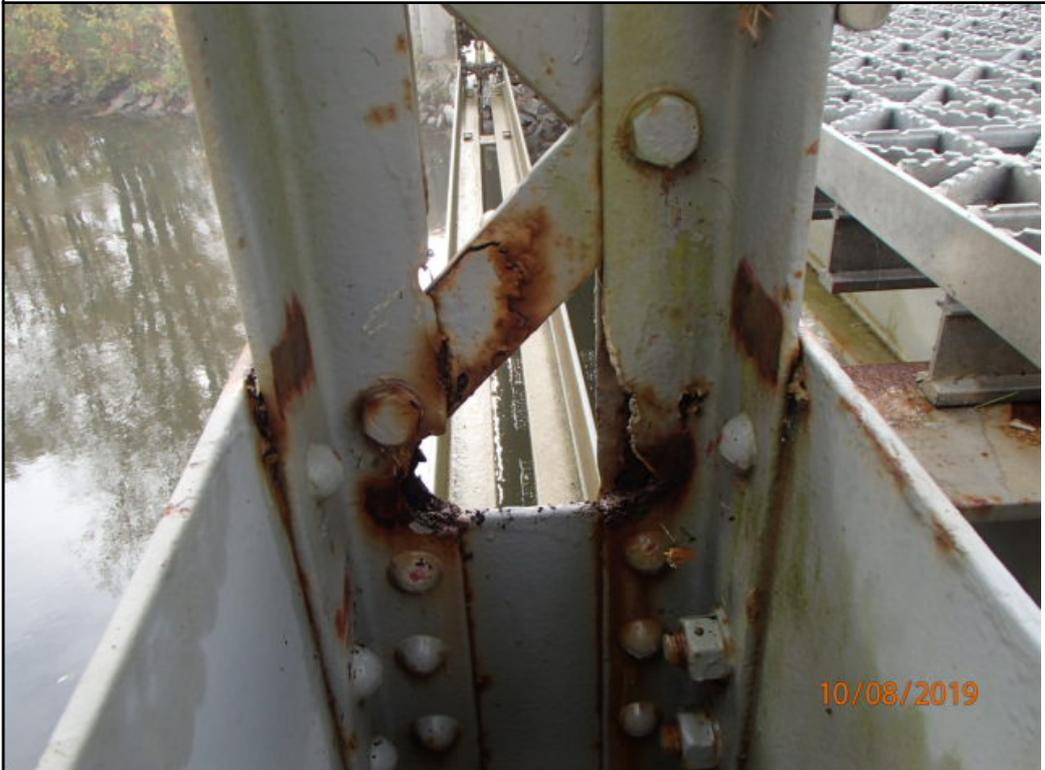
Photo Number: 16 Photo Filename: 16.JPG

**Attachment Description:**  
Right Truss, U6L6 End  
face

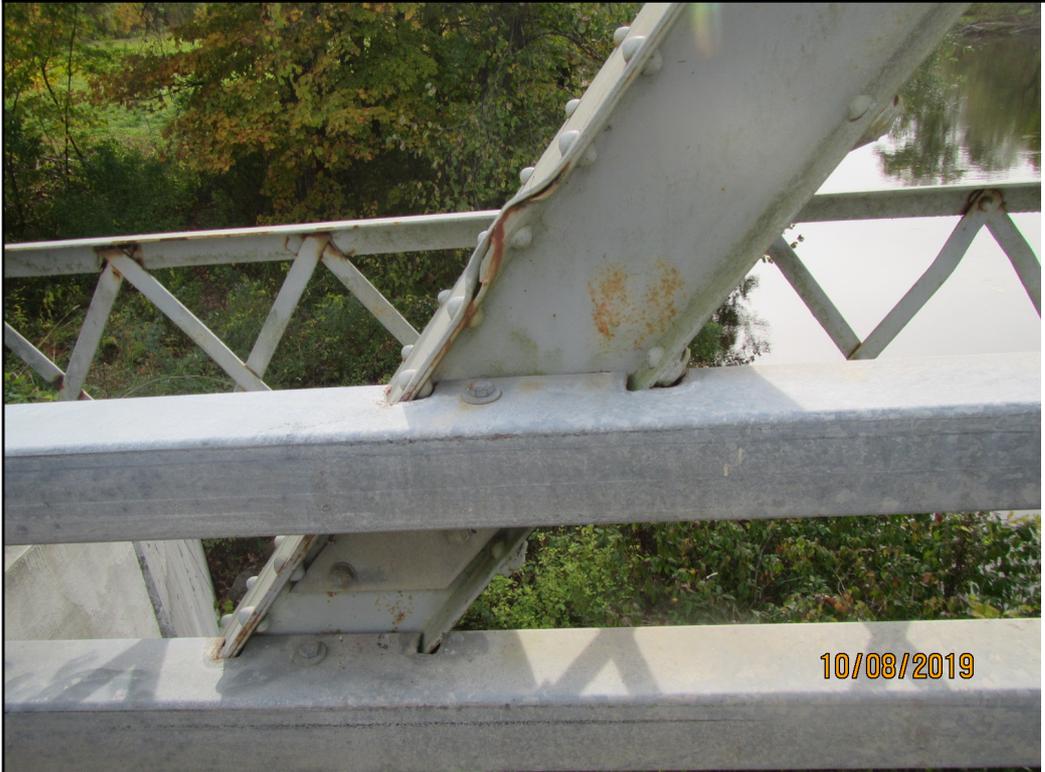
Photo Number: 17 Photo Filename: 17.JPG

**Attachment Description:**  
Left Truss, LOU1 looking  
Left

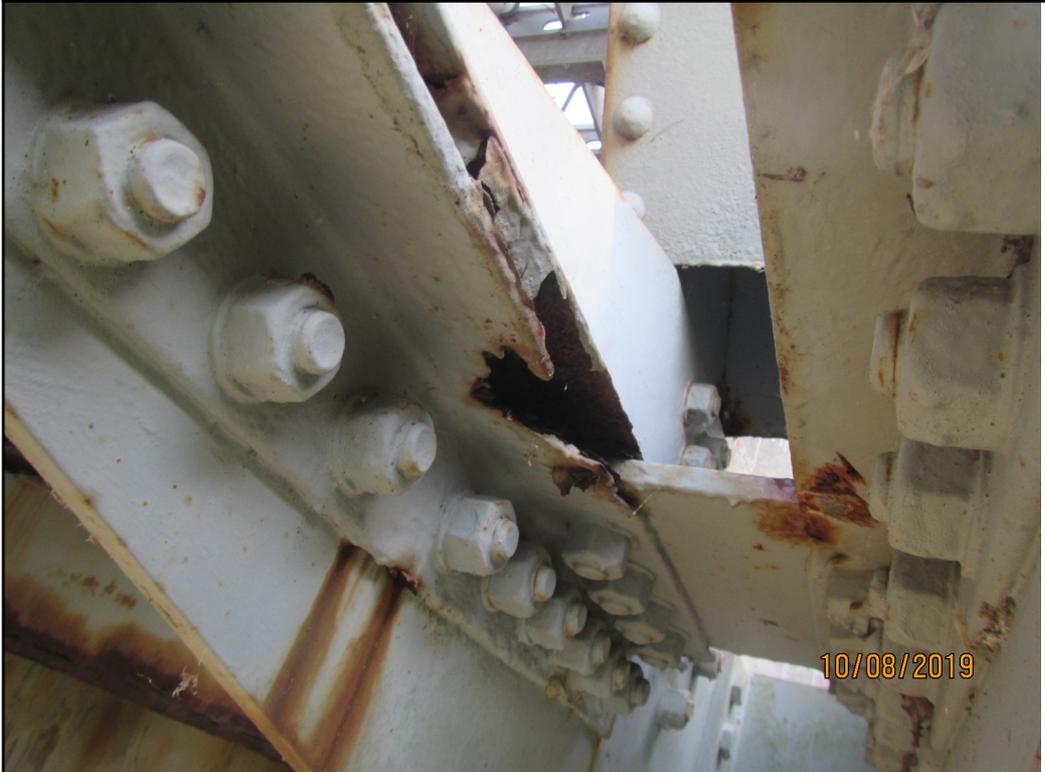
Photo Number: 19 Photo Filename: 19.JPG

**Attachment Description:**  
Left Truss, L1L2 at L1  
looking at Begin

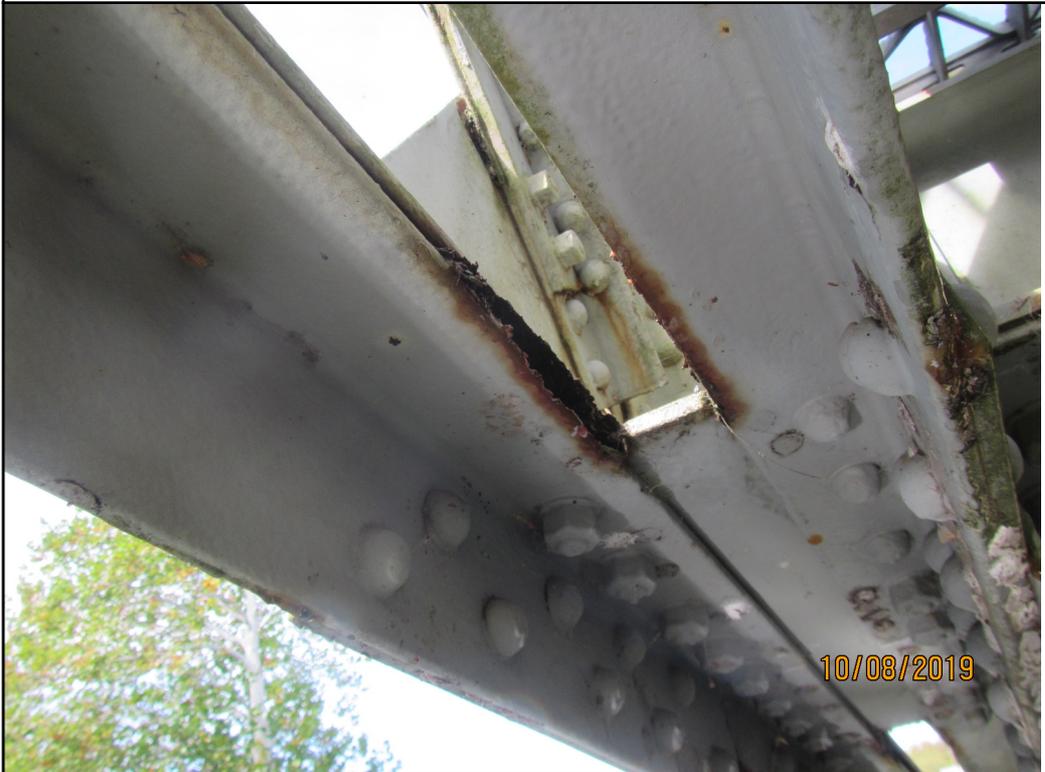
Photo Number: 20 Photo Filename: 20.JPG

**Attachment Description:**  
Left Truss, L3L4 at L4  
looking at End

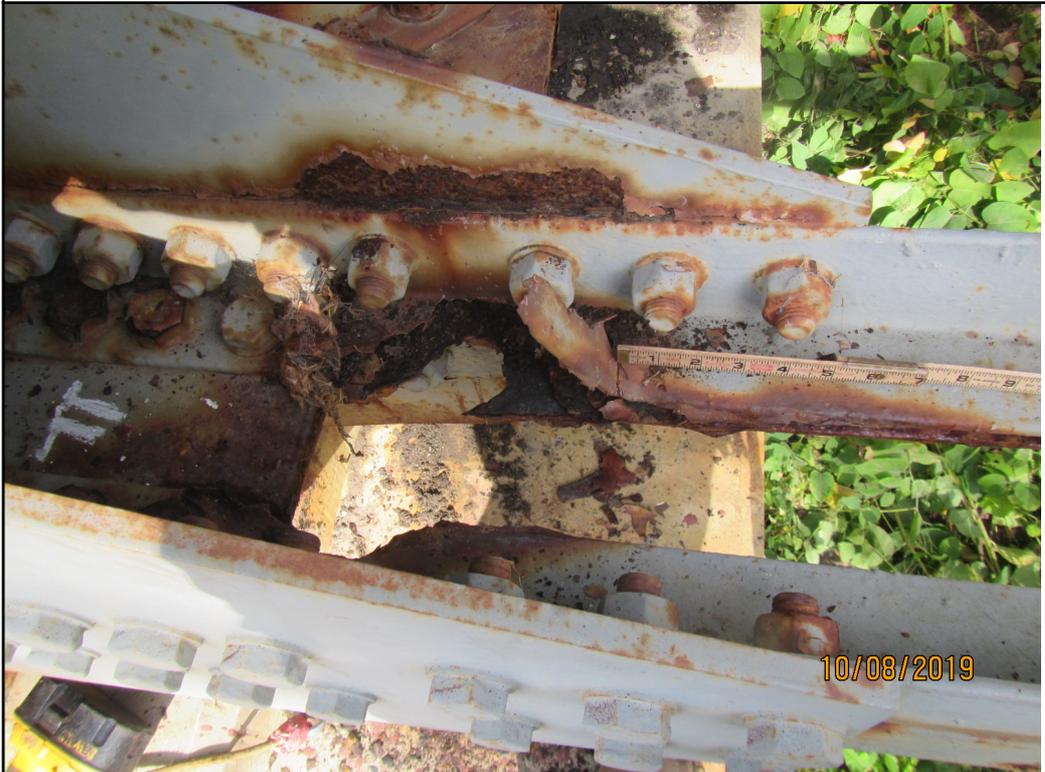
Photo Number: 22 Photo Filename: 22.JPG

**Attachment Description:**  
Left Truss, L7L8 at L8  
looking Right

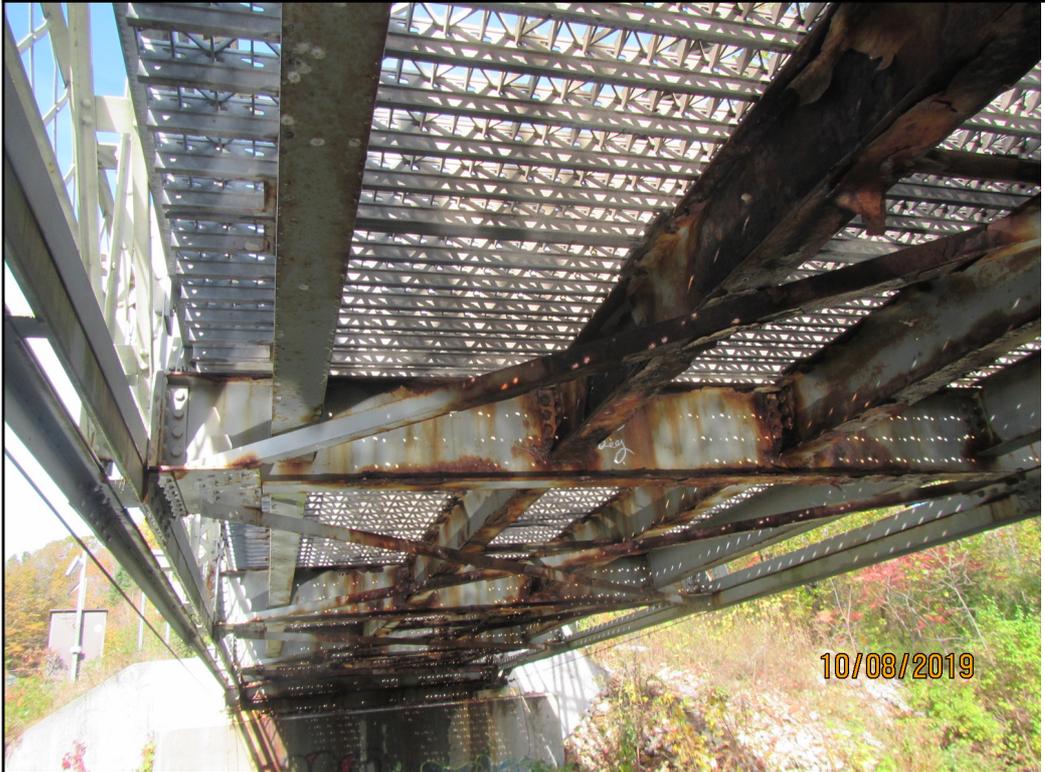
Photo Number: 27 Photo Filename: 27.JPG

<i>Referenced Sketch(es):</i> None						
The lateral cross bracing below deck (under Stringers S2 and S3) has heavy corrosion and approximately 25% section loss to the horizontal and vertical legs. Above deck the sway strut has old pack rust near all the panel points causing the angles to bow. The angles ends also have perforations.						
Span 1: BA850 - Backwall	TQ	CS-1	CS-2	CS-3	CS-4	CS-5
	27	27	0	0	0	0
Common						
<i>Referenced Photo(s):</i> None						
<i>Referenced Sketch(es):</i> None						
Disagree with previous rating.						
Span 1: BA851 - Abutment Pedestal	TQ	CS-1	CS-2	CS-3	CS-4	CS-5
	2	2	0	0	0	0
Common						
<i>Referenced Photo(s):</i> None						
<i>Referenced Sketch(es):</i> None						
Disagree with previous rating.

**Attachment Description:**  
Framing looking at End

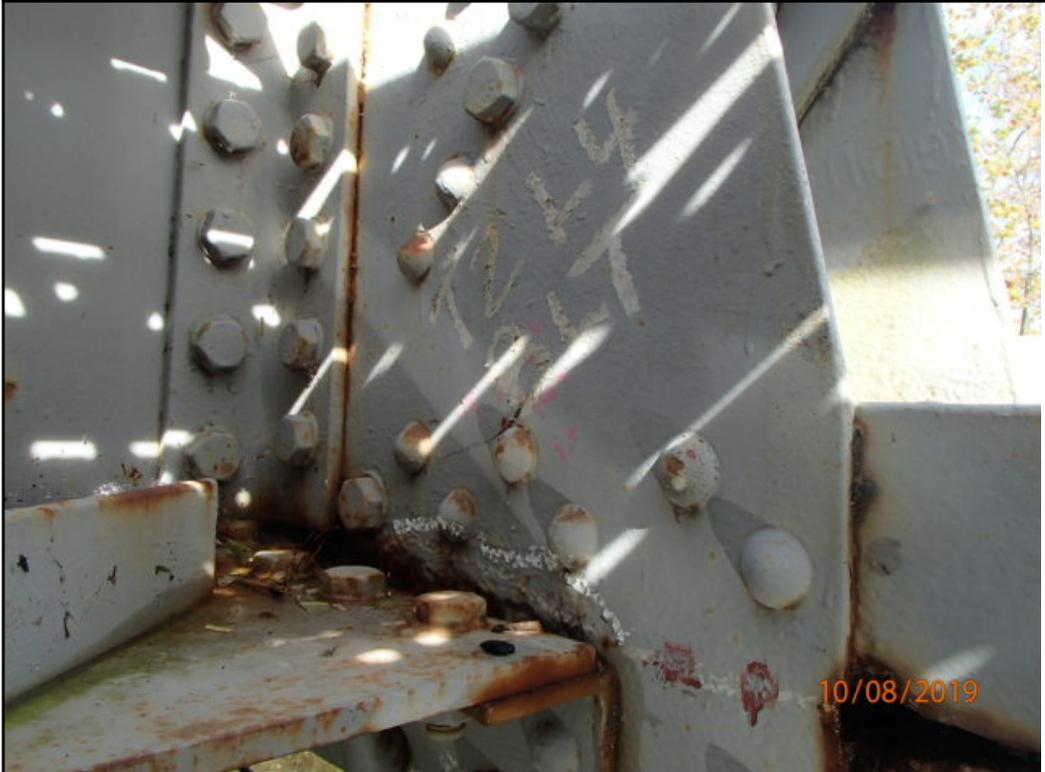
Photo Number: 31 Photo Filename: 31.JPG

**Attachment Description:**  
Right Truss, Begin Left  
Gusset Plate at L4

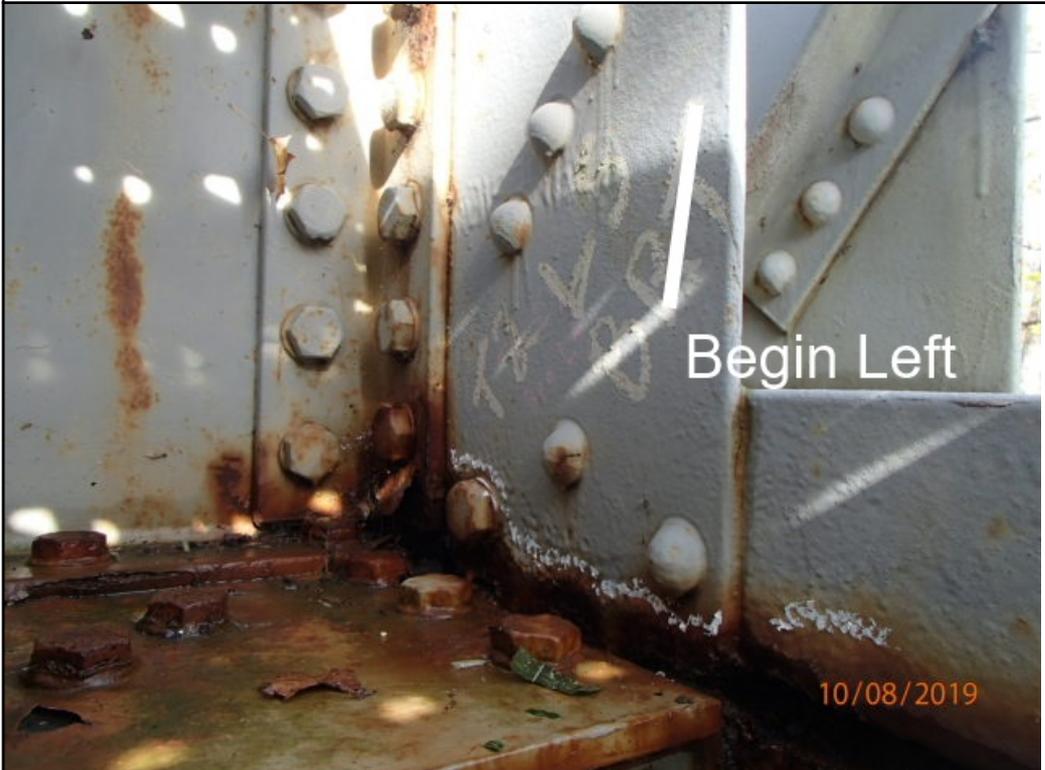
Photo Number: 32 Photo Filename: 32.JPG

**Attachment Description:**  
Right Truss, Begin Left  
Gusset Plate at L5

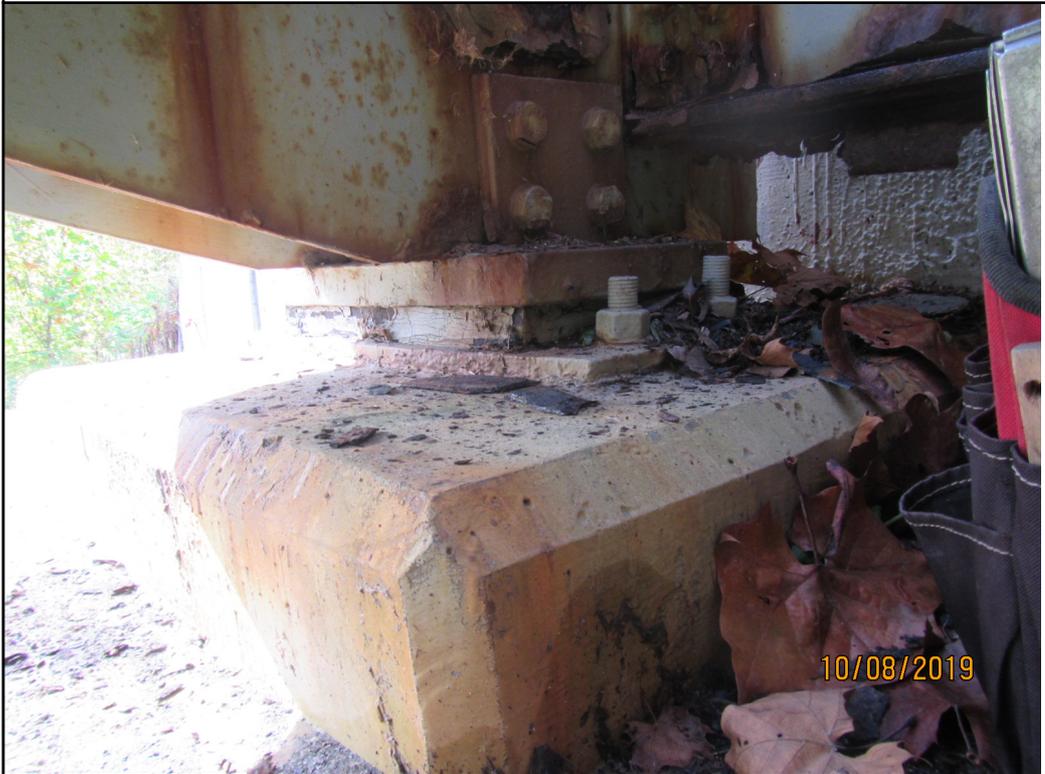
Photo Number: 34 Photo Filename: 34.JPG

**Attachment Description:**  
End Abutment Left Truss  
Bearing

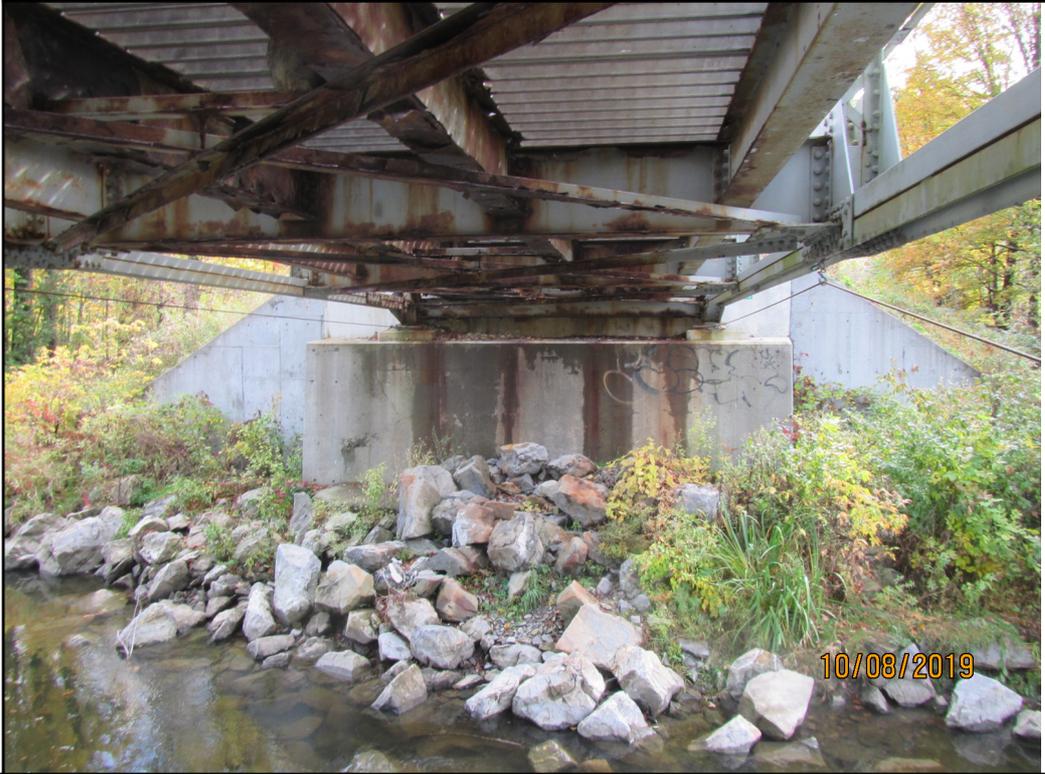
Photo Number: 35 Photo Filename: 35.JPG

**Attachment Description:**  
Begin Abutment

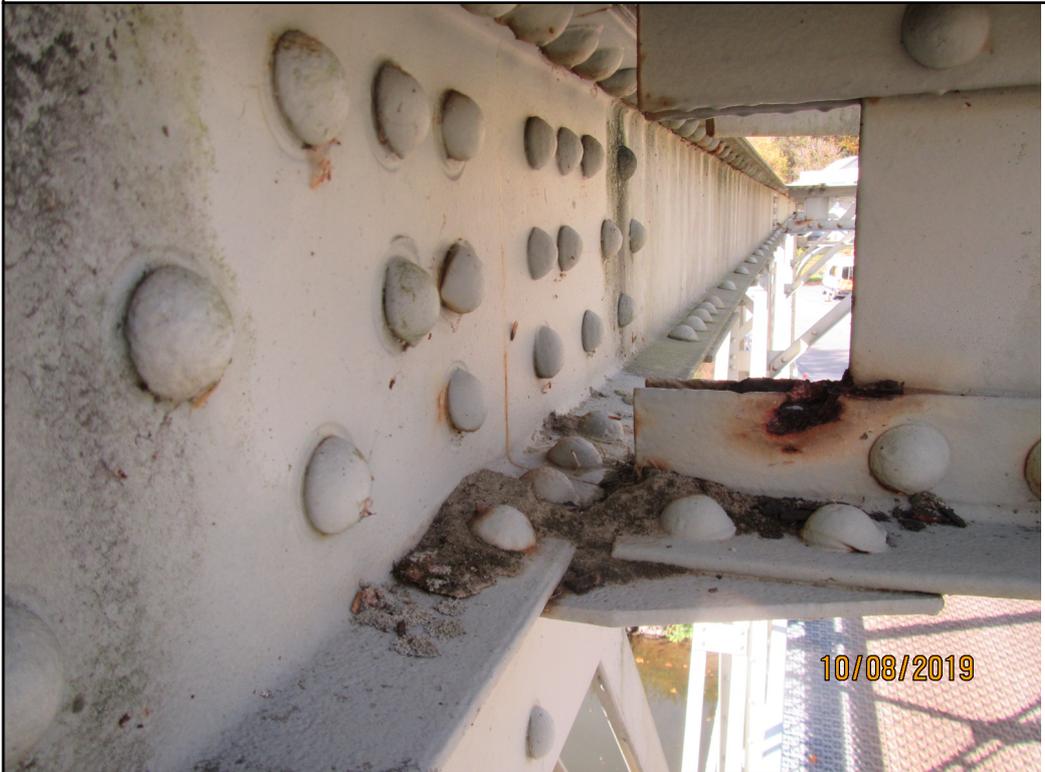
Photo Number: 36 Photo Filename: 36.JPG

CS3/4: The paint has failed or is failing along the horizontal gusset plate and connection for the lateral bracing on the outboard faces of the gusset plates (facing inwards under the bridge). See NBE 162 note.

**Attachment Description:**  
Left truss at U3 looking at  
End (typ)

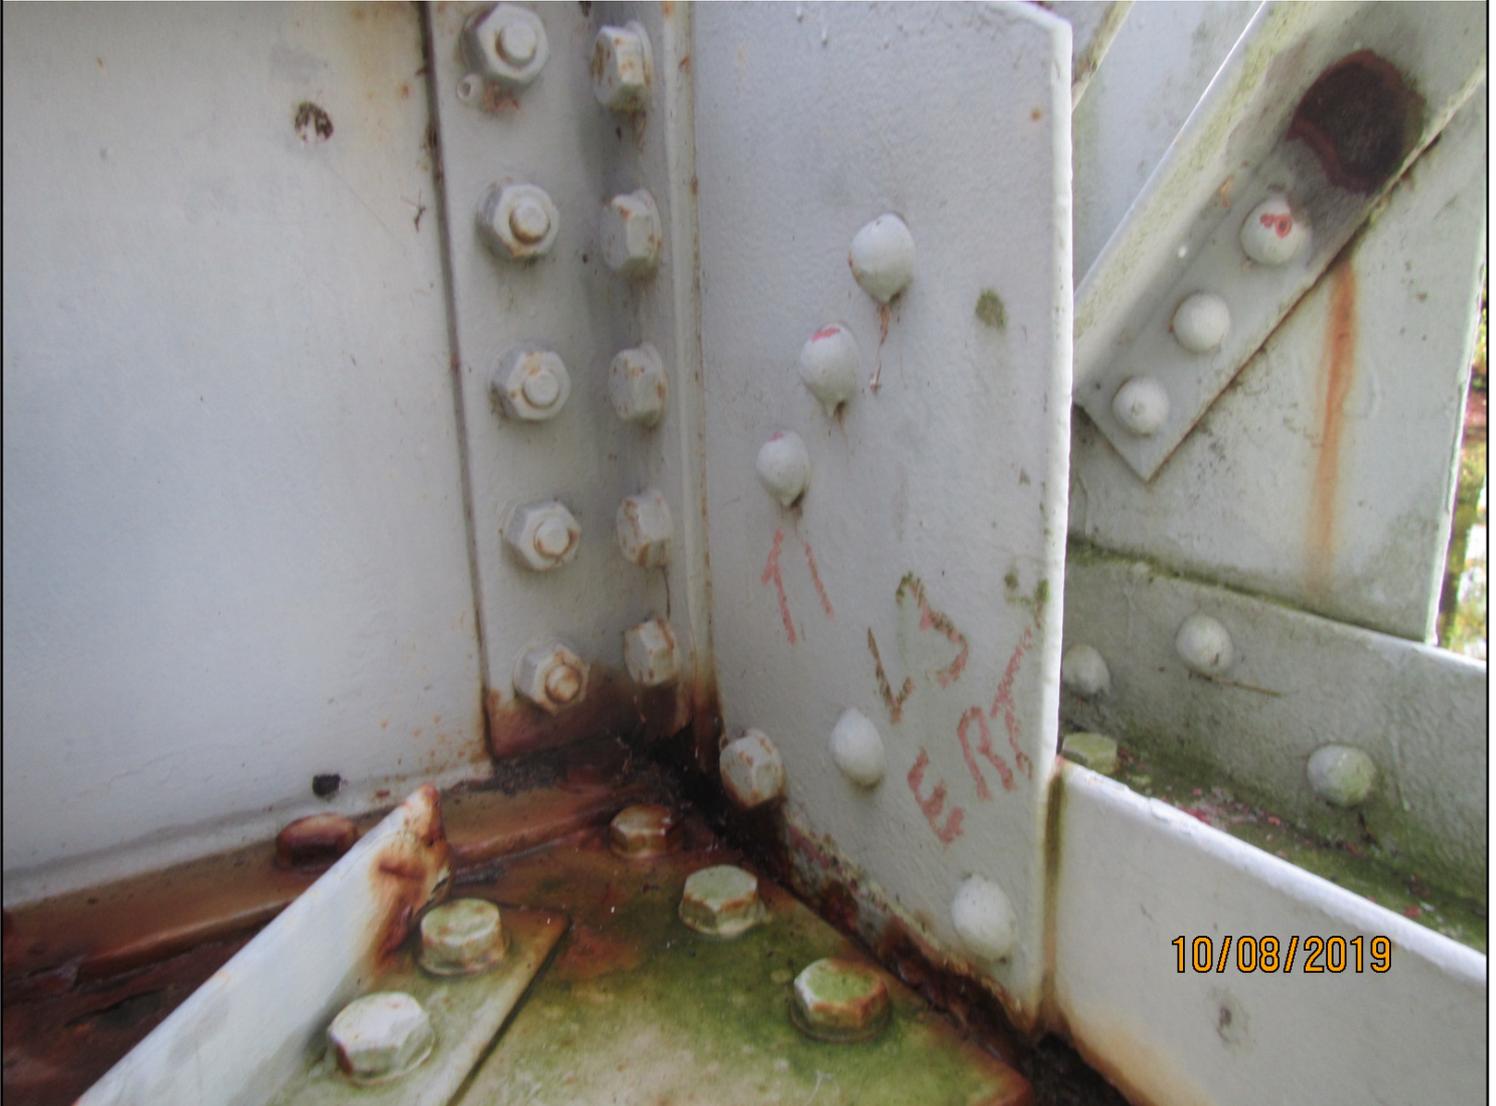
Photo Number: 2

***Attachment Description: Left Truss, End Right Gusset Plate at L3***

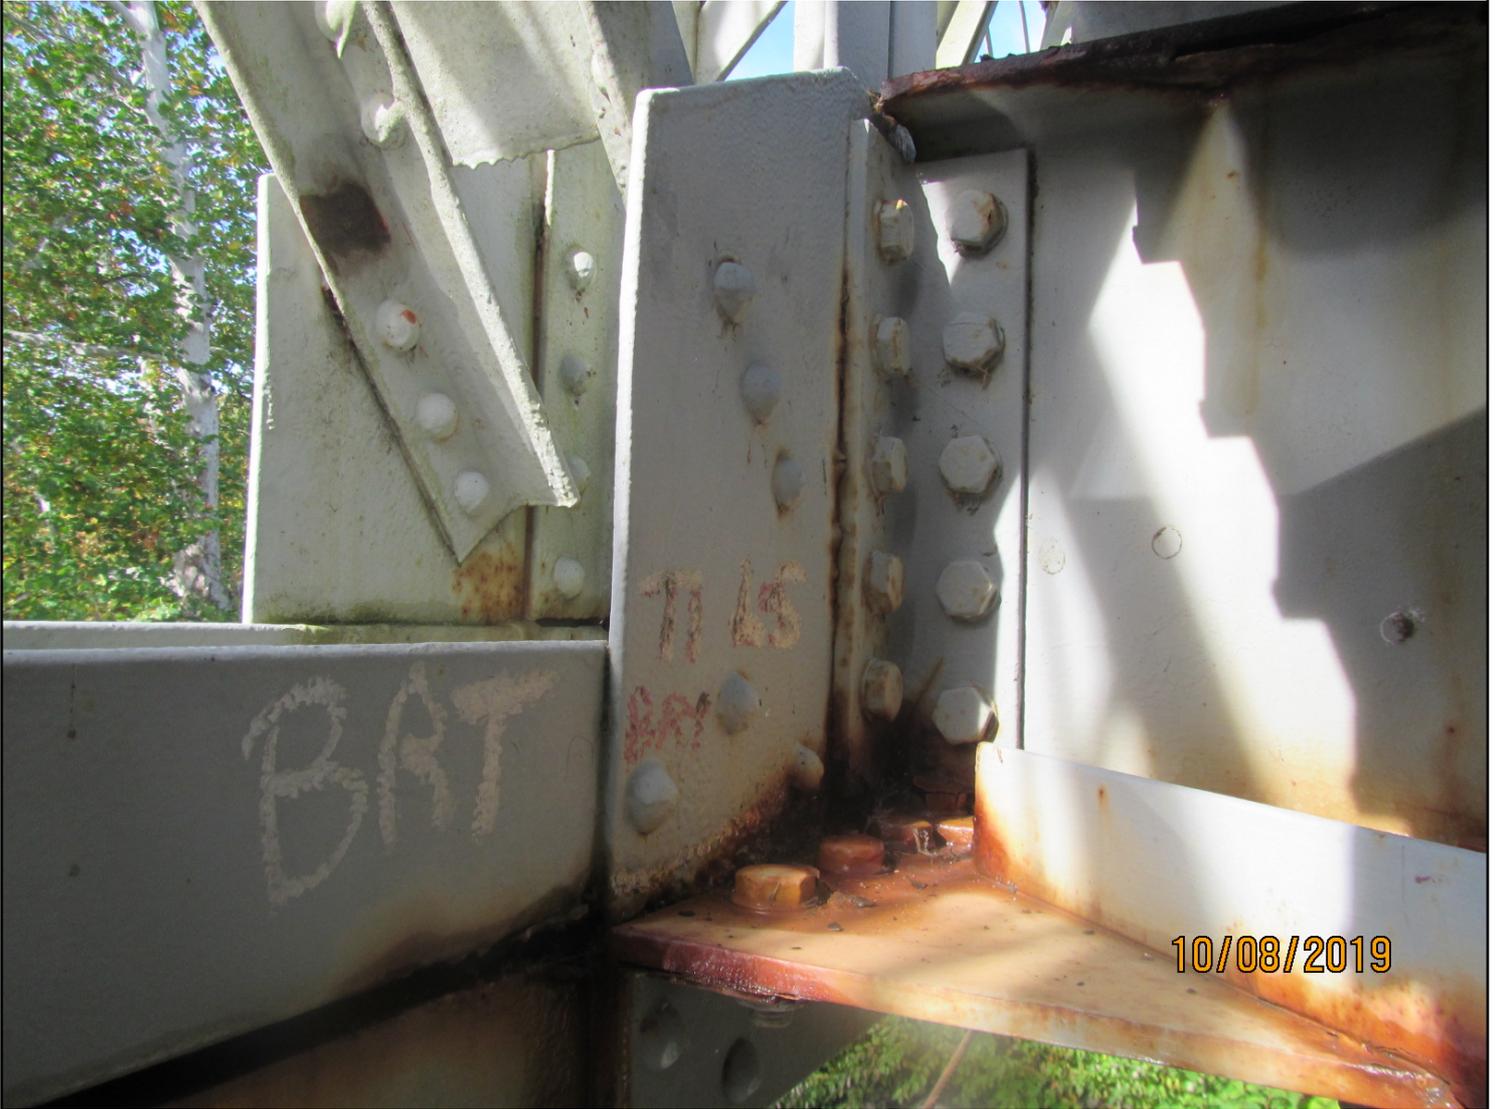
Photo Number: 3

**Attachment Description: Left Truss, Begin Right Gusset Plate at L5**

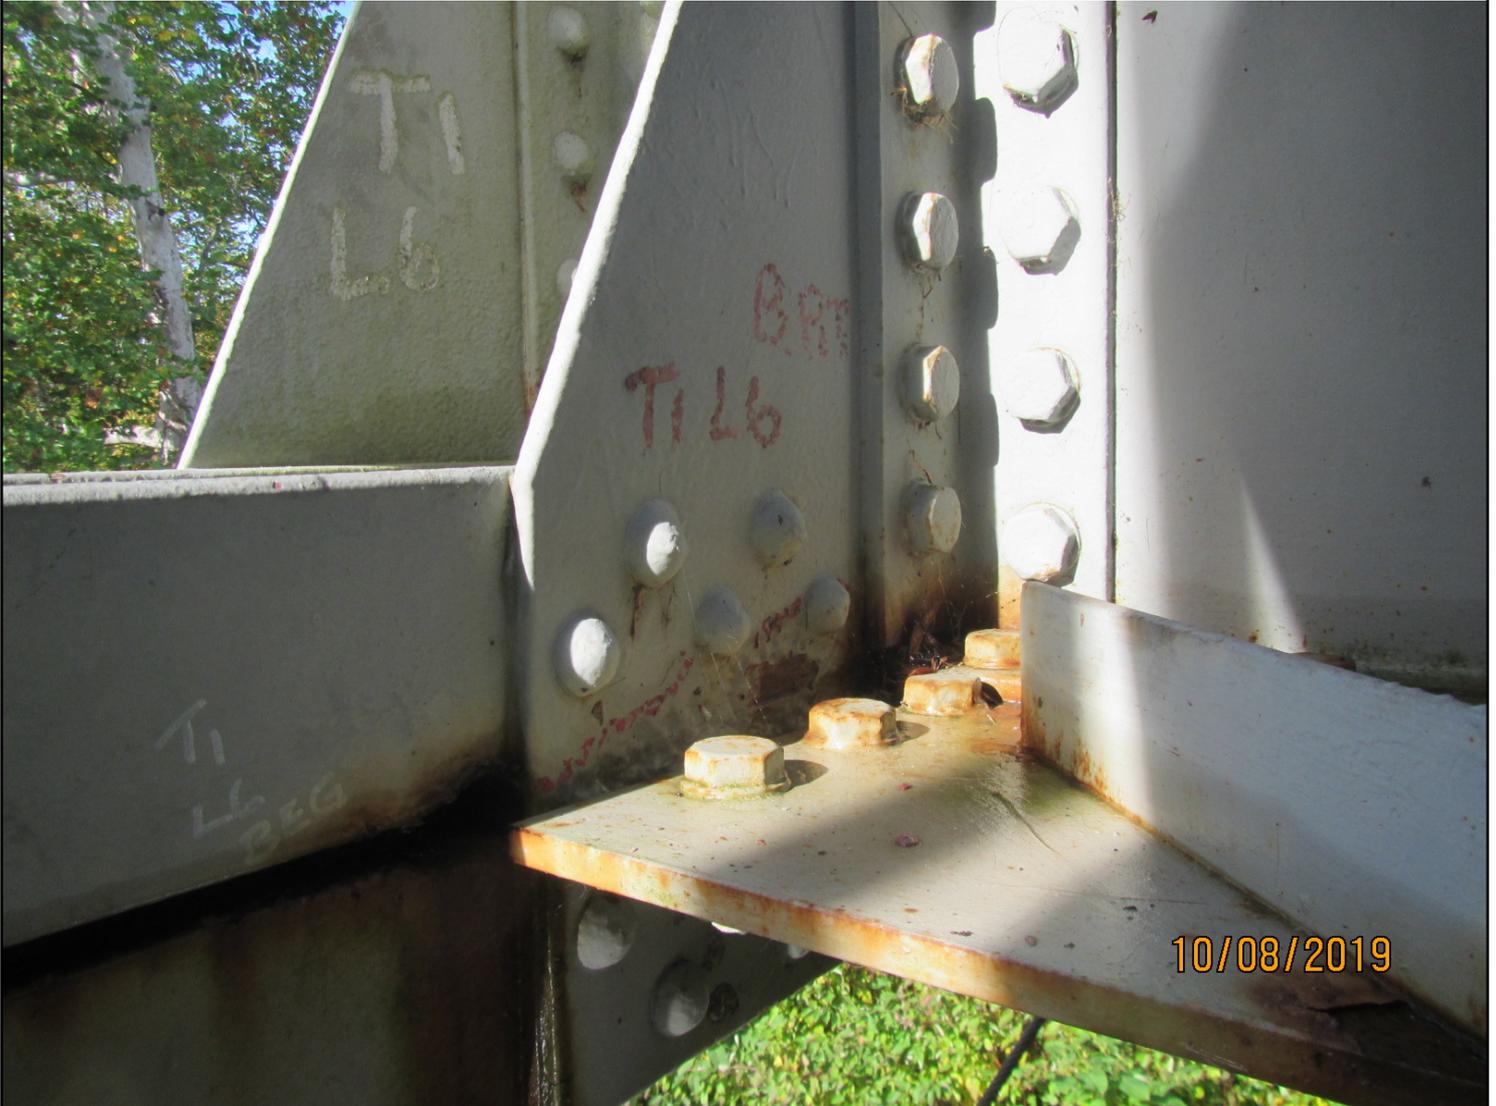
Photo Number: 4

**Attachment Description: Left Truss, Begin Right Gusset Plate at L6**

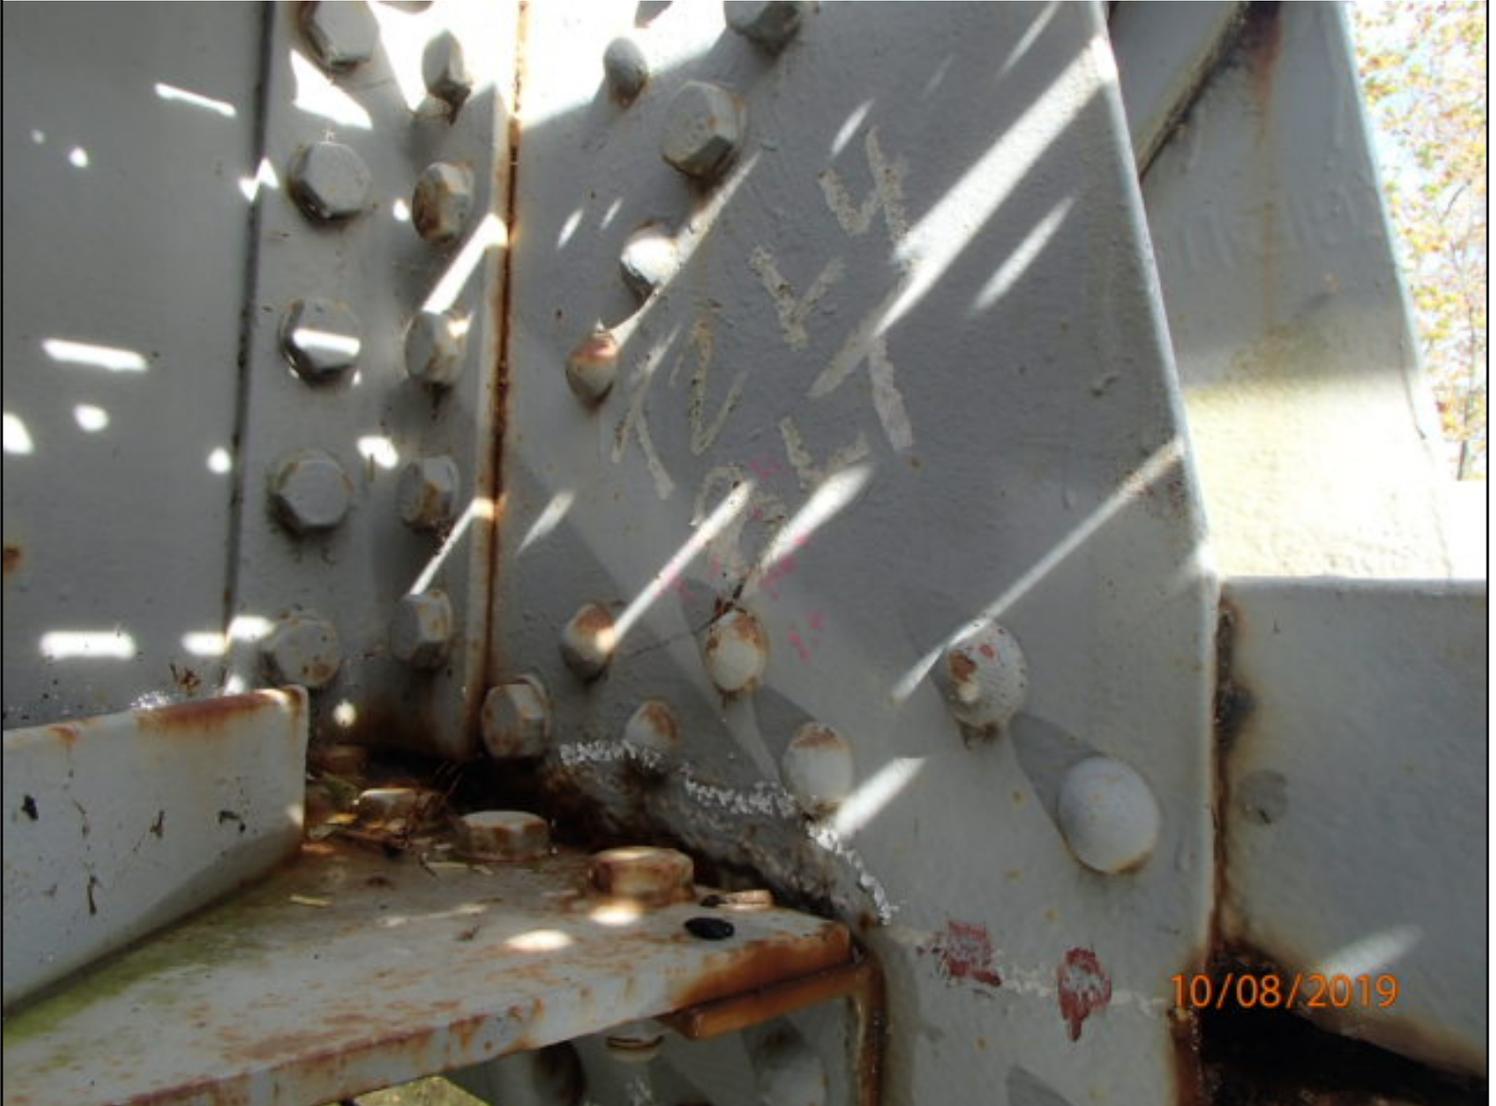
Photo Number: 4

**Attachment Description: Right Truss, Begin Left Gusset Plate at L4**
