# New York State Department of Transportation General Bridge Inspection Report

*Inspection Date:* October 08, 2019

*BIN:* 3306370

*Feature Carried:* BATTEN-DUGAN ROAD

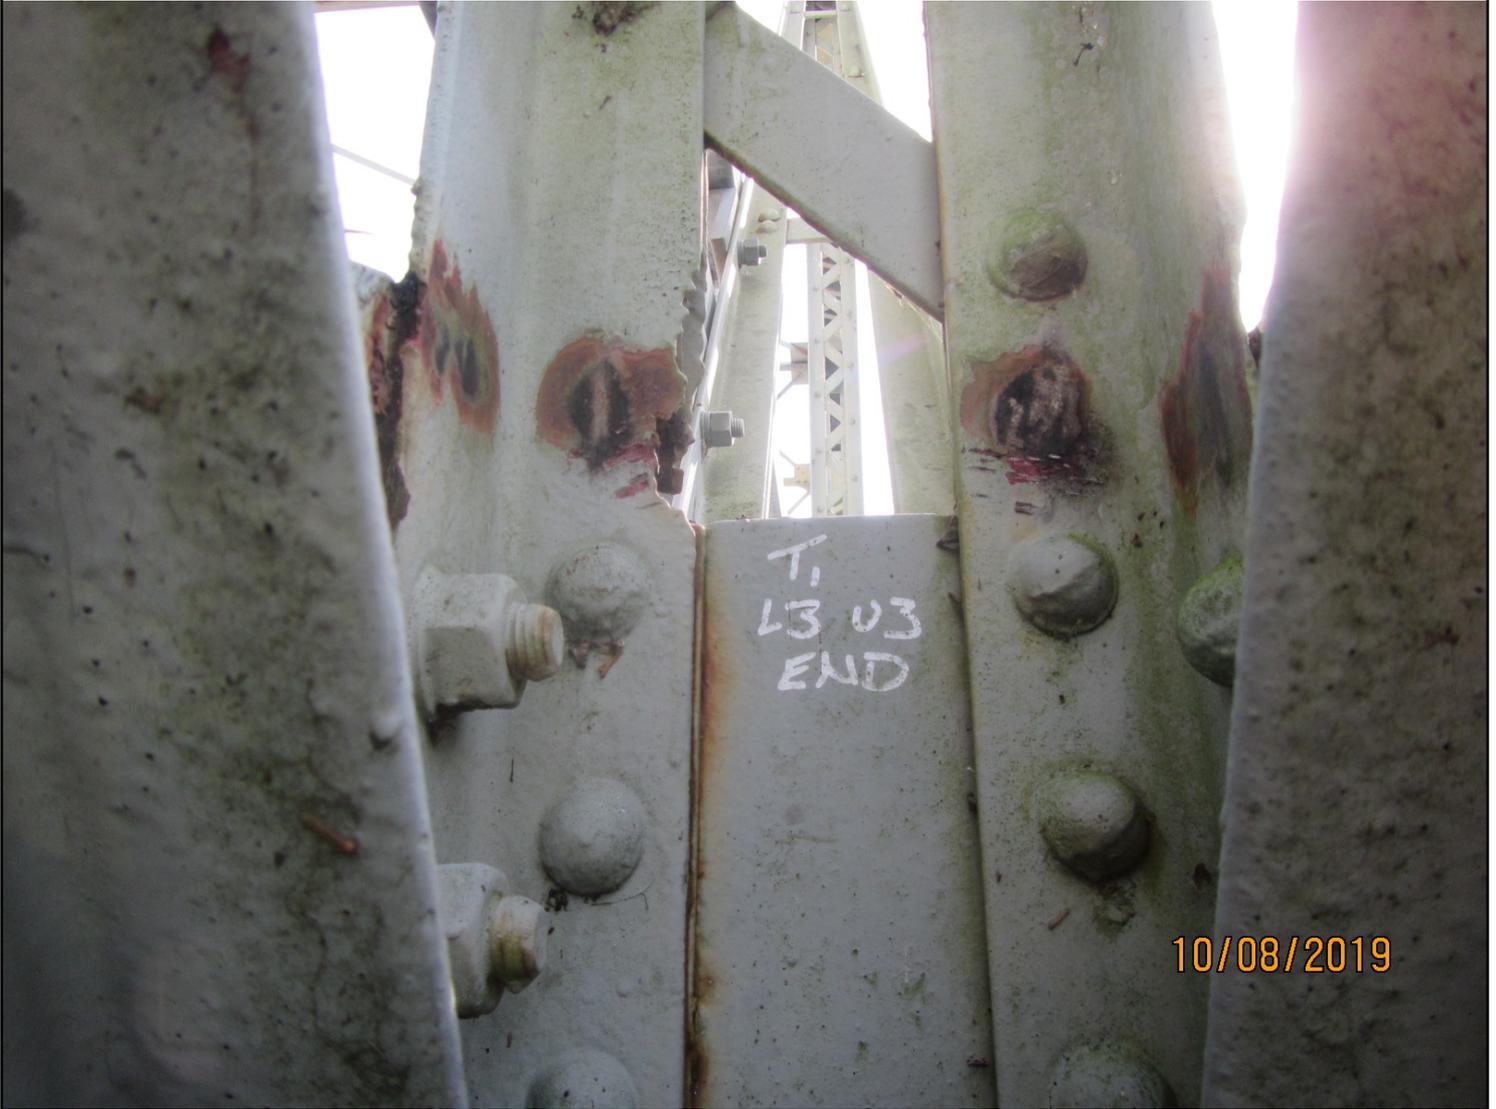
Photo Number: 2

No significant changes during this inspection. This flag is being reissued (supersedes YF 1B18Y0W016) due to the section losses to the angles of the vertical and diagonal member directly above the lower chord. In addition the bridge is single span truss that is non-redundant and fracture critical.

**Attachment Description: Left Truss, U3L3 End face**

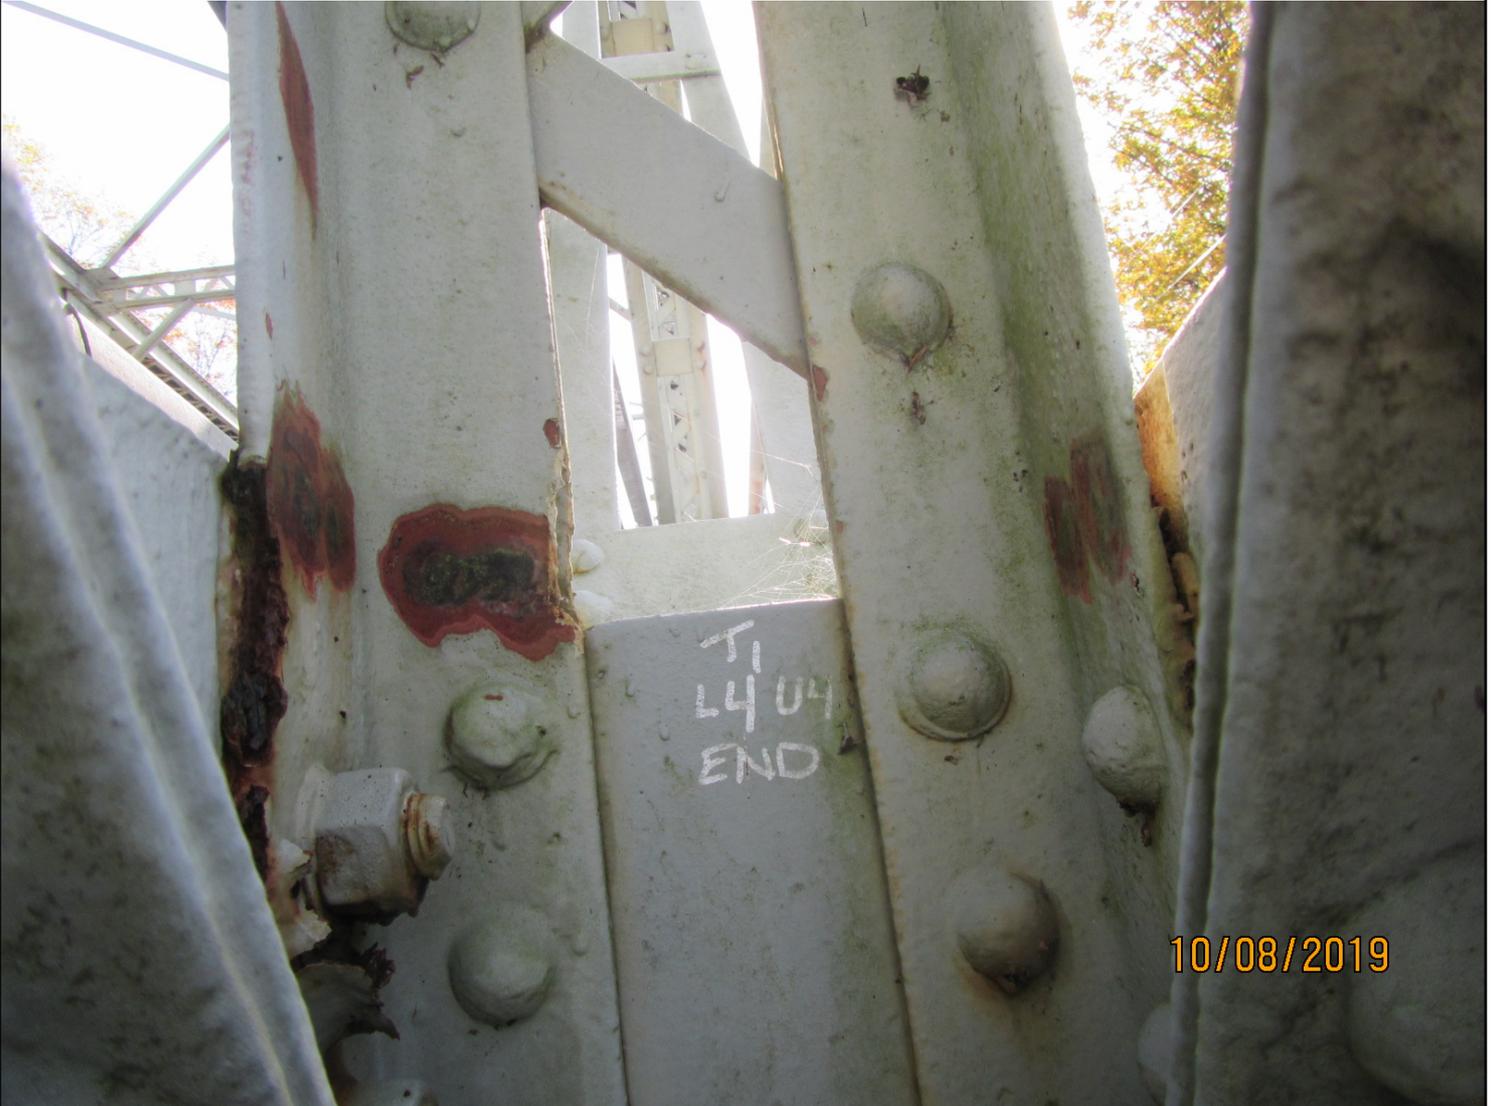
Photo Number: 3

**Attachment Description: Left Truss, U4L4 End face**

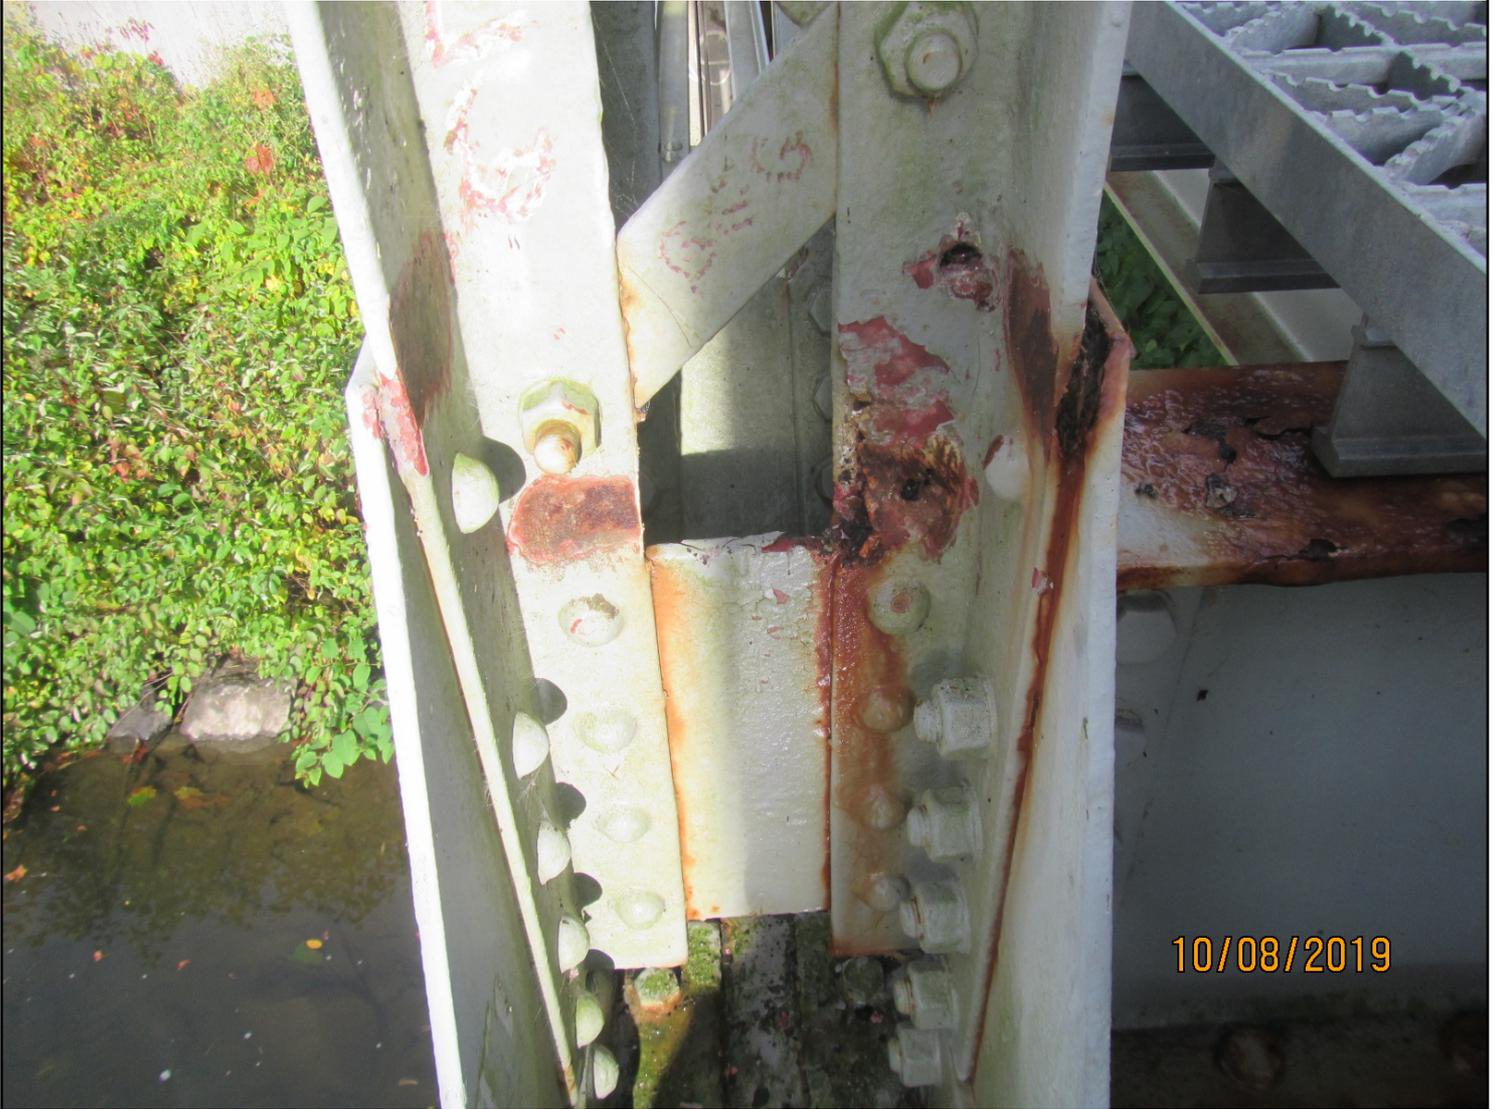
Photo Number: 4

***Attachment Description: Left Truss, U6L6 Begin face***

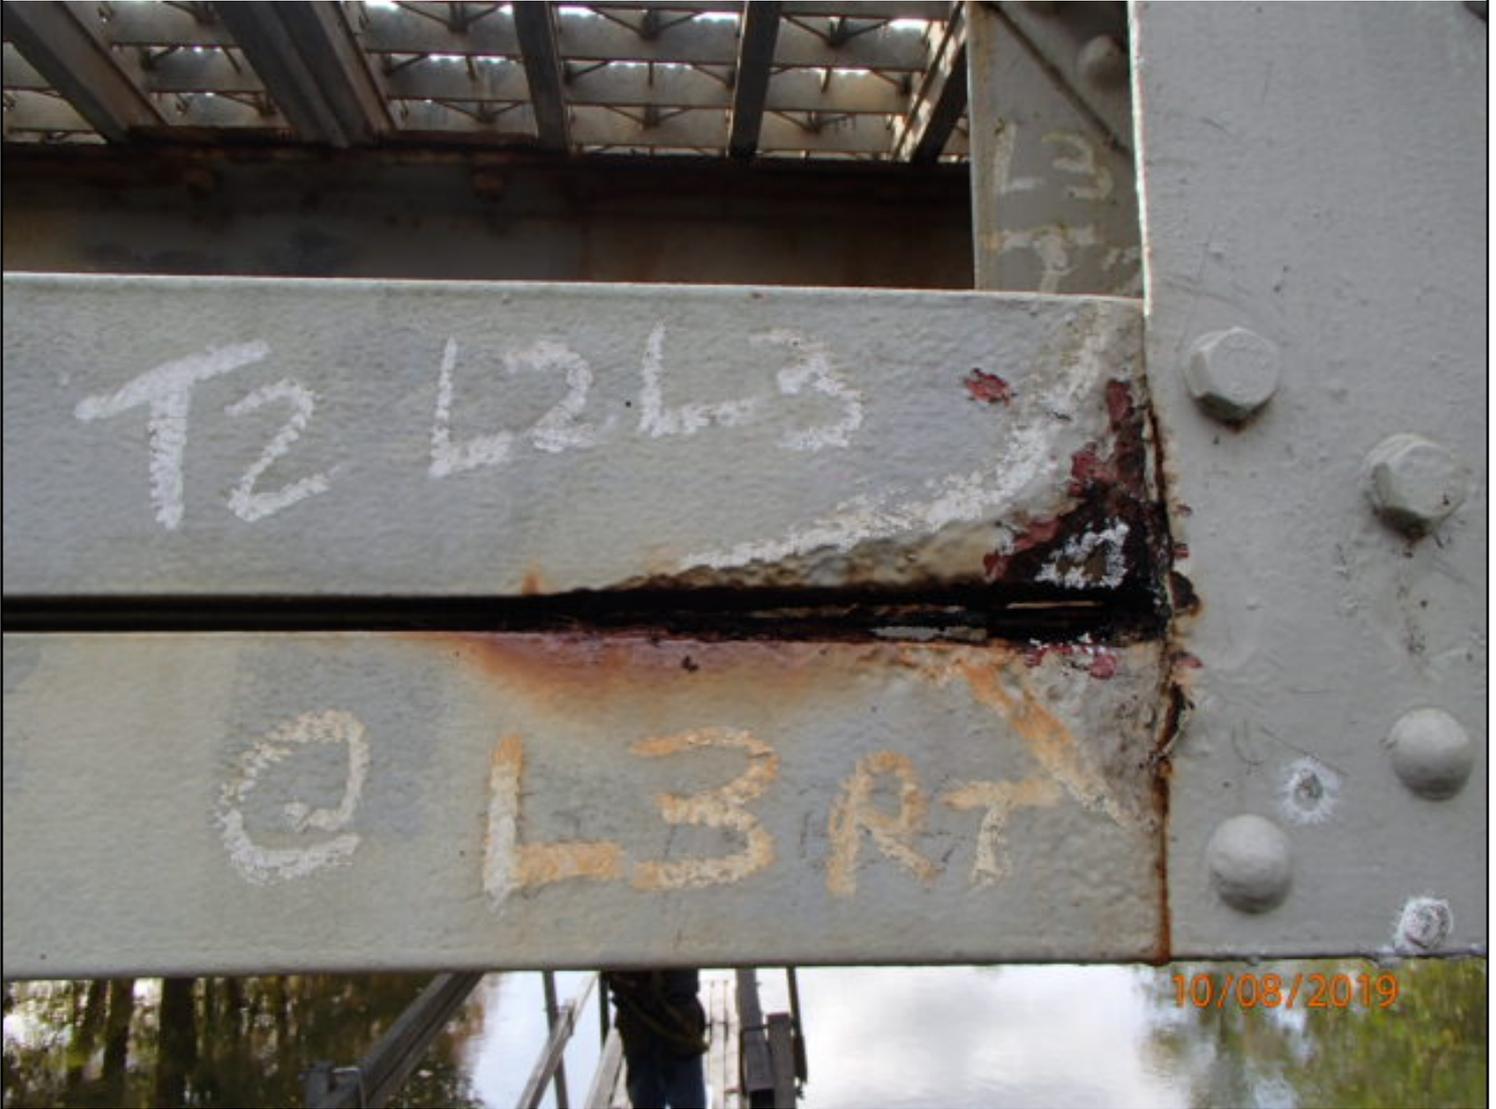
Photo Number: 2

No significant changes during this inspection. This flag is being reissued (supersedes YF 1B18Y0W017) due to the section losses to angles of the bottom chord, vertical, and diagonal members along or directly above the bottom chord. In addition the bridge is single span truss that is non-redundant and fracture critical.

**Attachment Description: Right Truss, L2L3 Right face at L3**

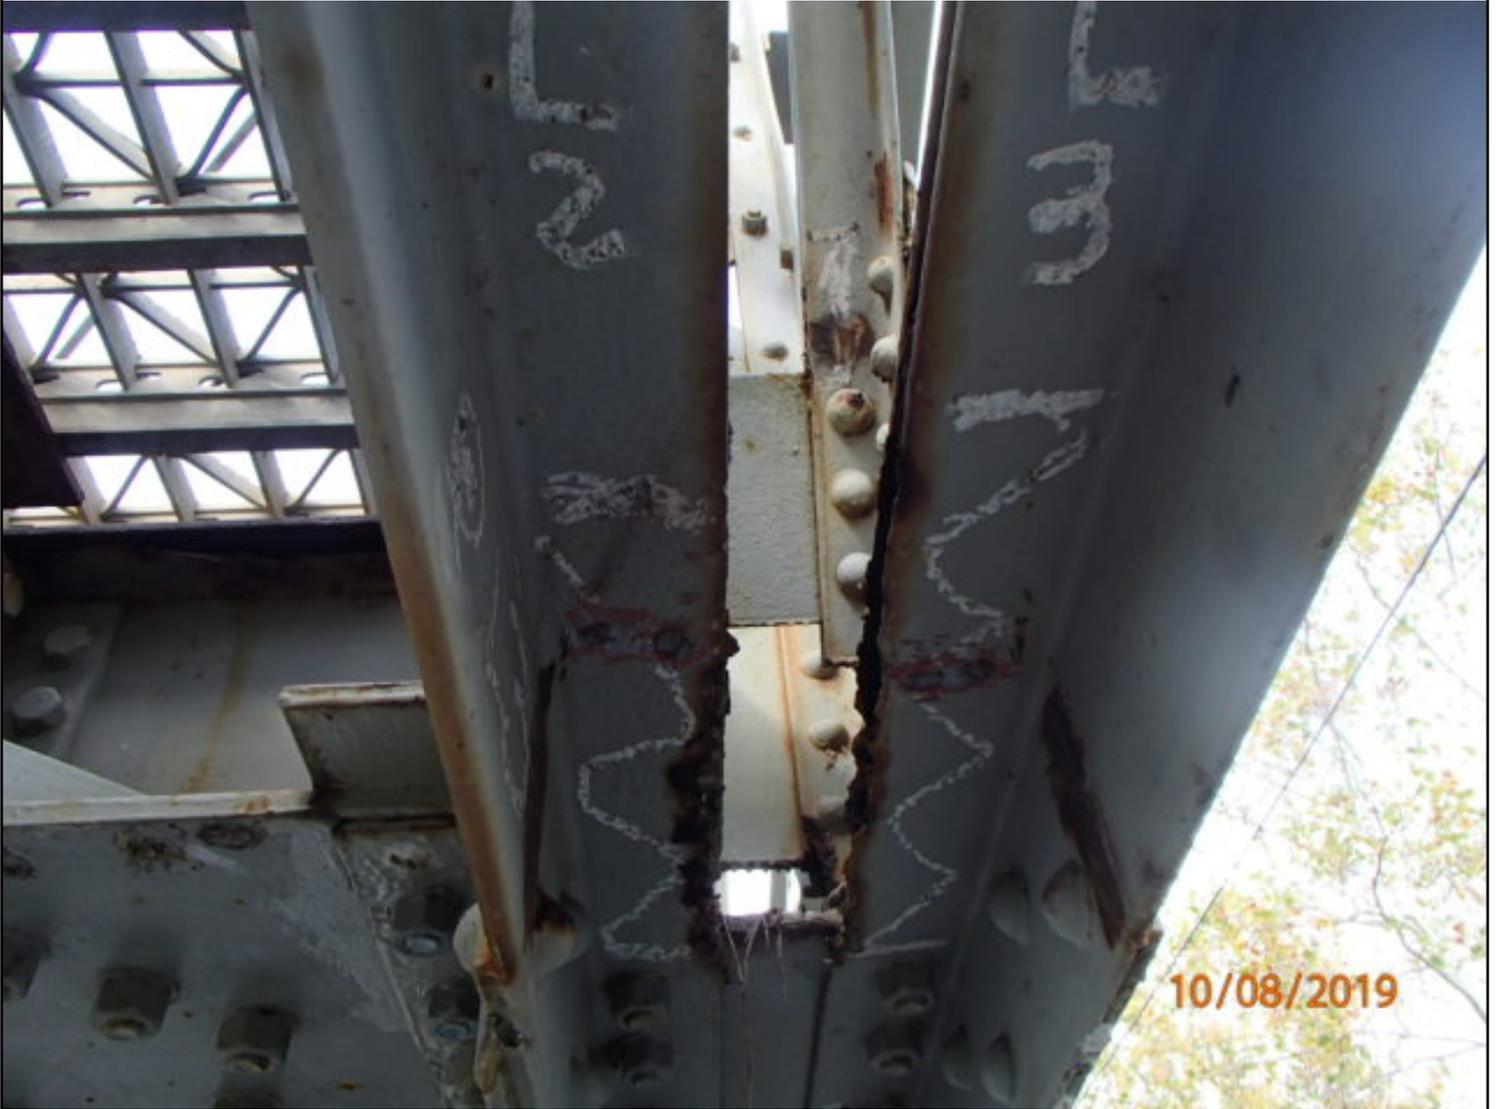
Photo Number: 3

***Attachment Description: Right Truss, L2L3 underside at L3***

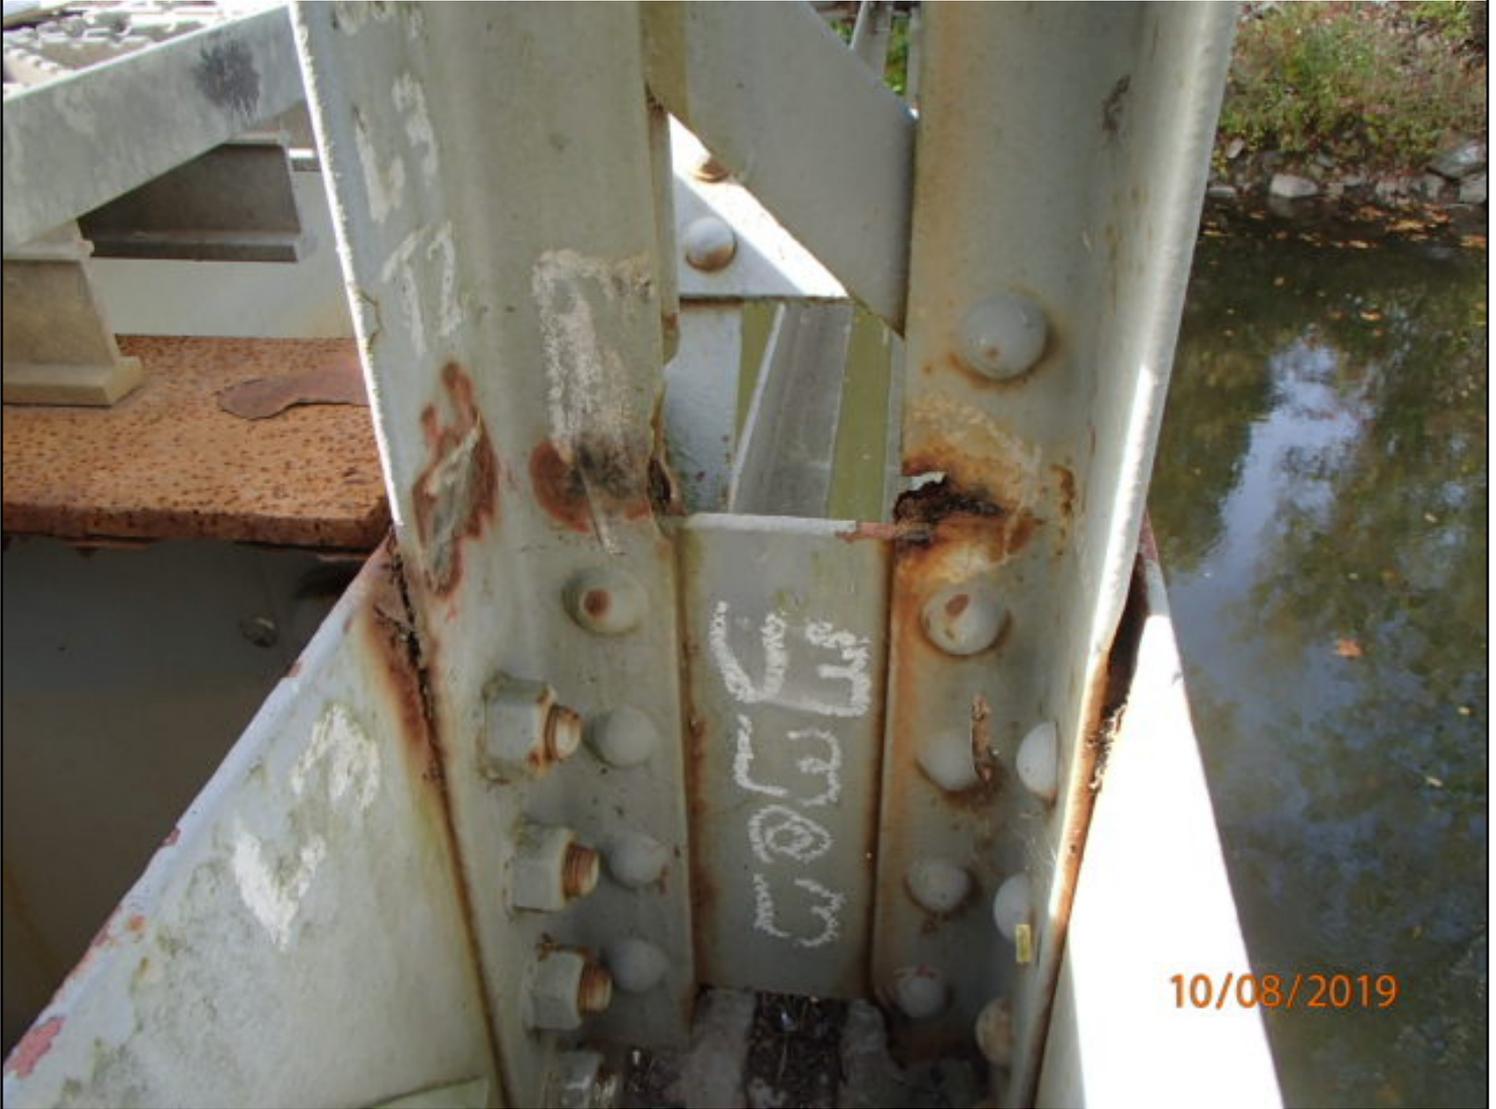
Photo Number: 4

**Attachment Description: Right Truss, U3L3 Begin face**

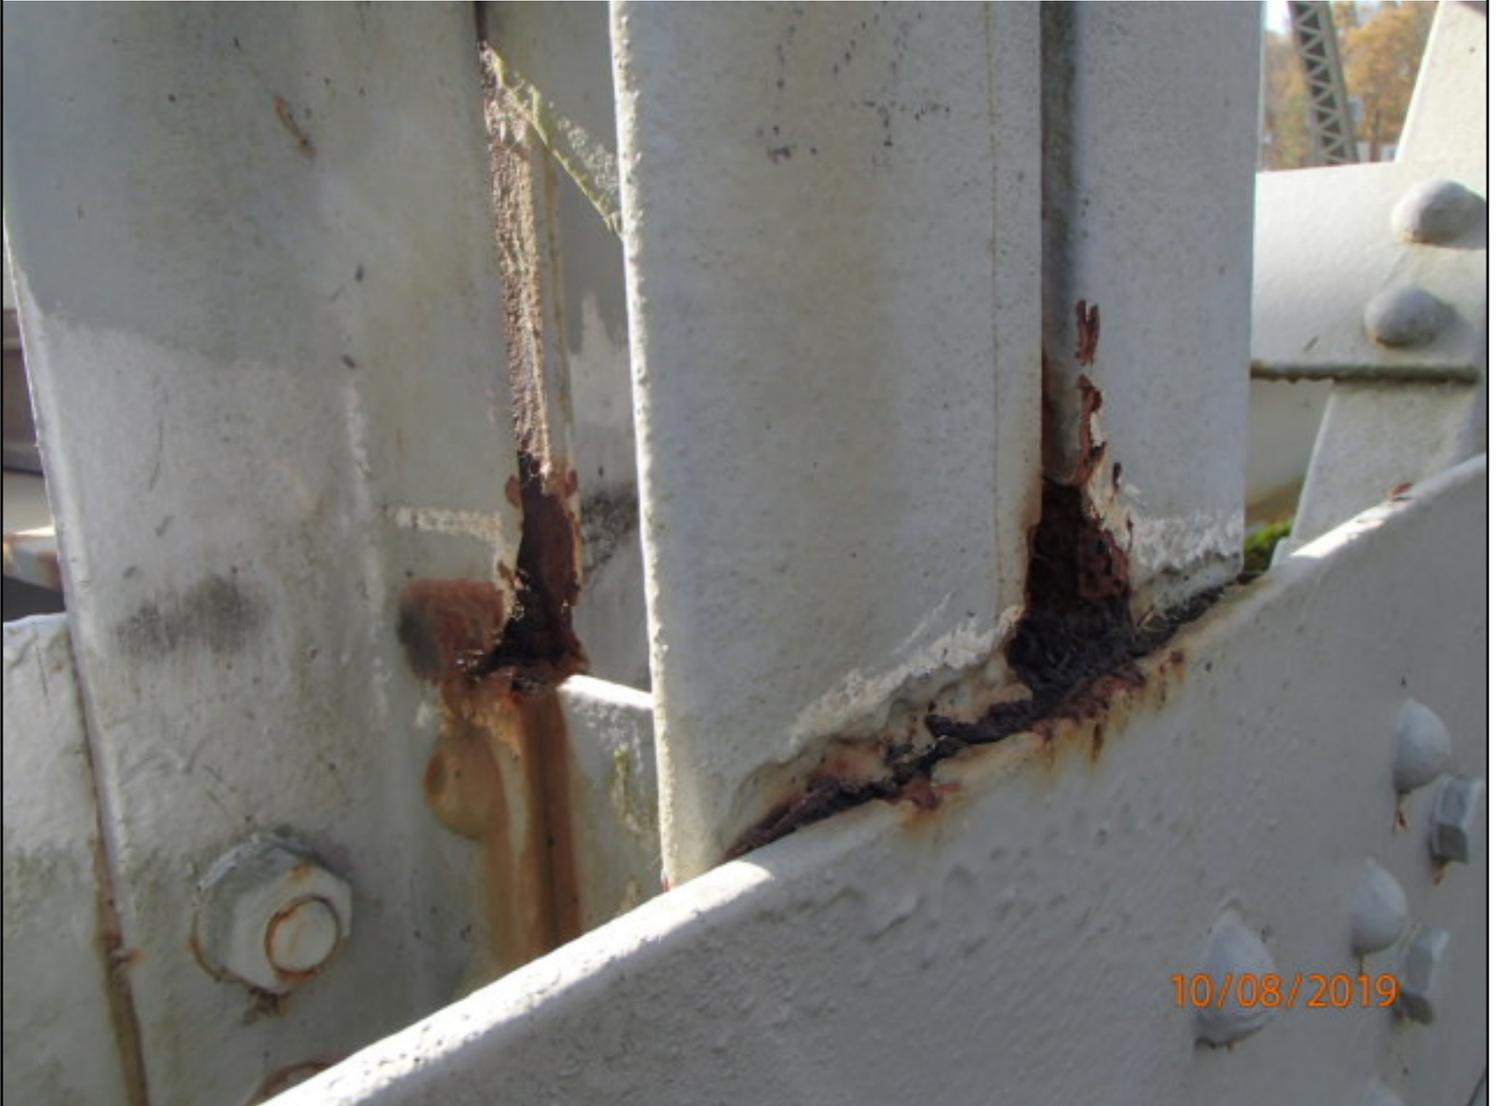
Photo Number: 5

**Attachment Description: Right Truss, U4L4 Begin face**

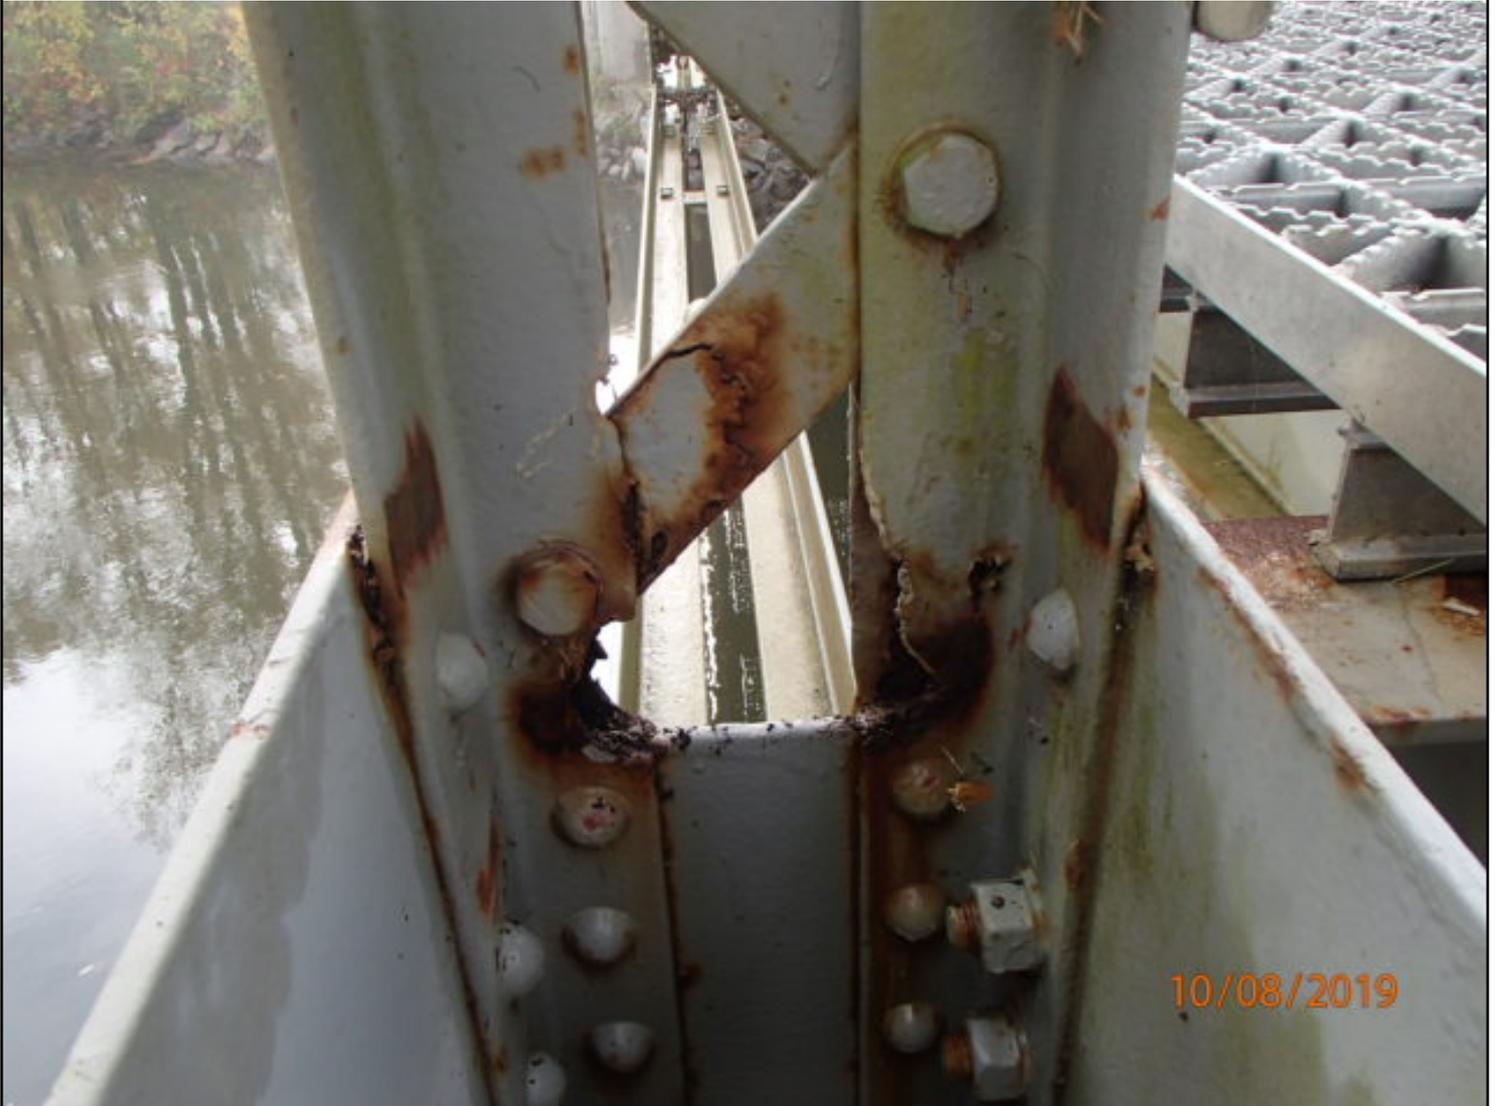
Photo Number: 6

***Attachment Description: Right Truss, U6L6 End face***
